EXISTING INFRASTRUCTURE REVIEW

1. Drainage & Culvert Review

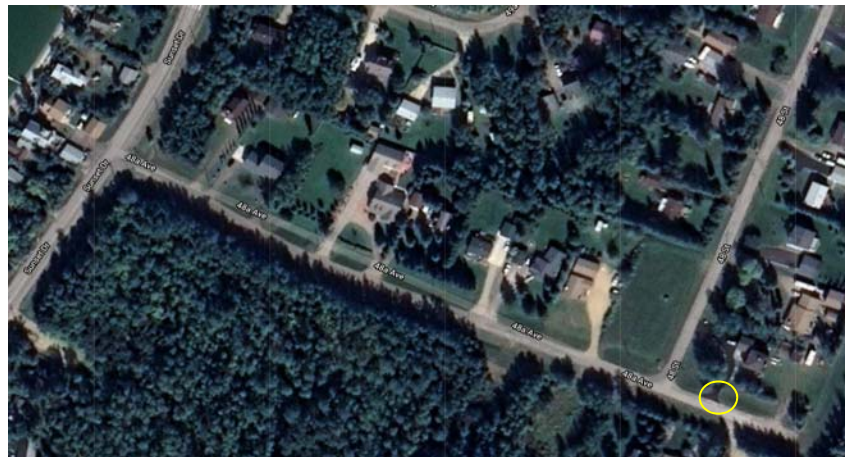
Comments
Paved Approach. Barrell pushed in on one end.

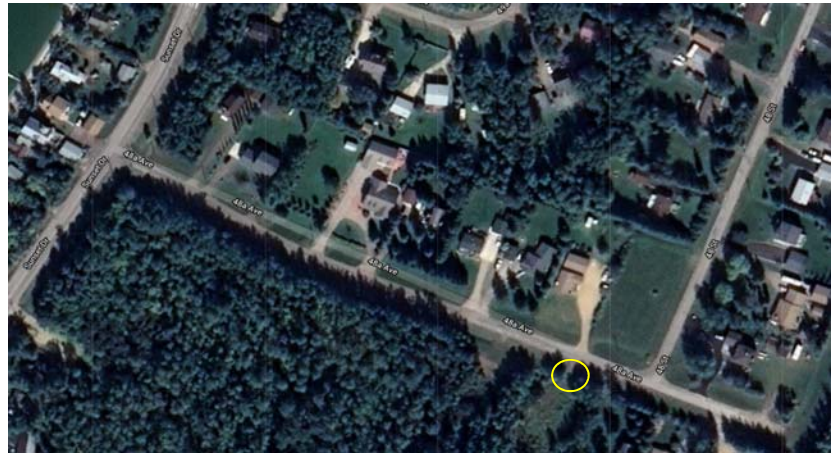
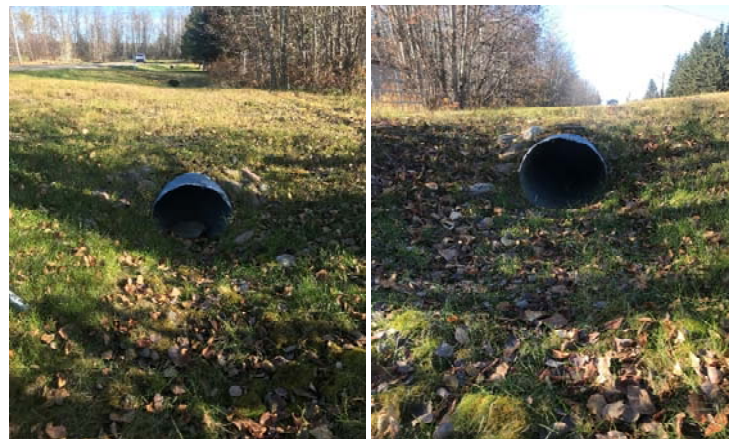
Comments
Very good condition. 0.3m cover. Rip rap on top. Poor rip rap apron. Grown over with grass Straight face end. Flow will be increased here due to changes upstream.

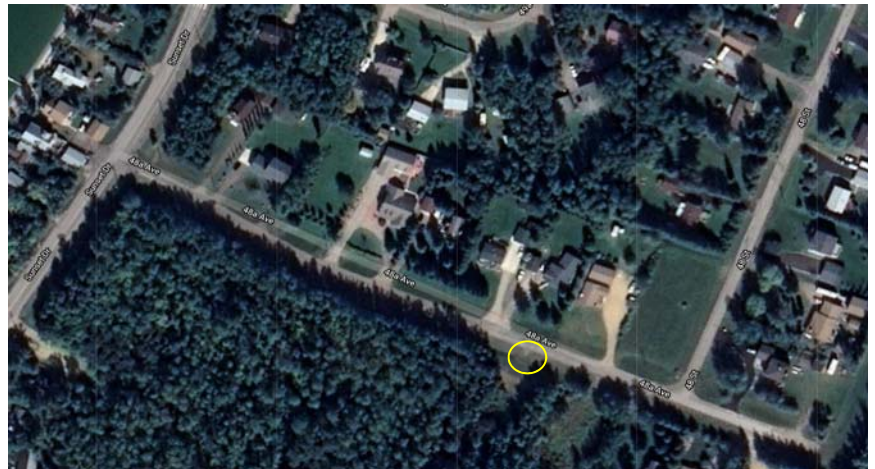
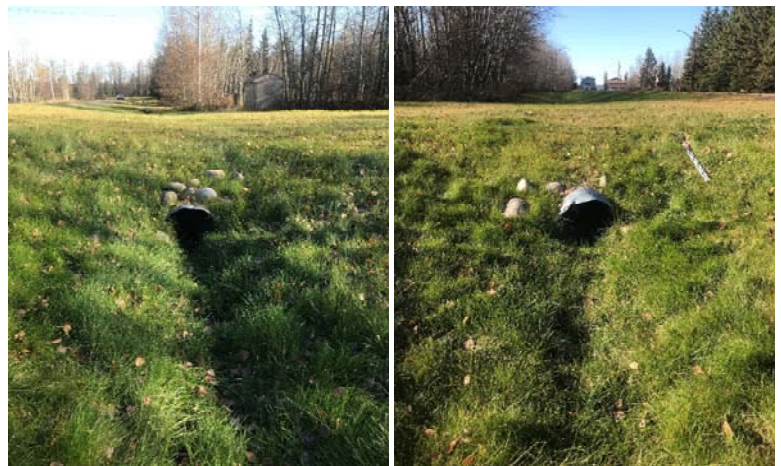
Flow will be increased here due to changes upstream.

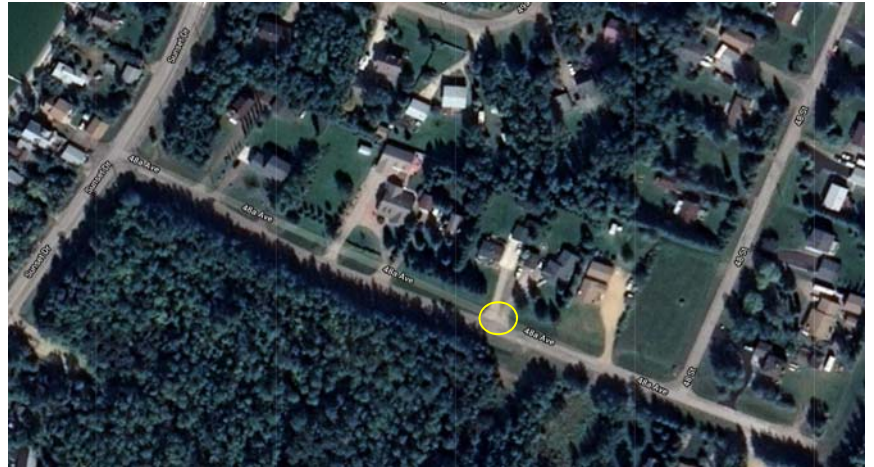
Comments
 Good shape. Straight face end - very slightly bent. Pavement failure on approaches, Centerline crac over culvert. Low cover <0.2m on East end. No rip rap, lots of grass Standing water in culvert, no rust. Cover on west end 0.7m .

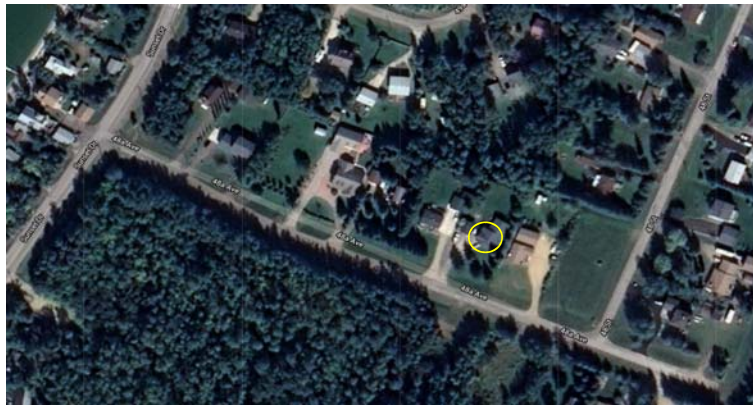
Comments
Ok shape, Small culvert and grass grown in. Lots of grass grown around ends. Dual approach for lot 24 & 23, being used. No sloped ends, no noticeable rust, no rip rap.

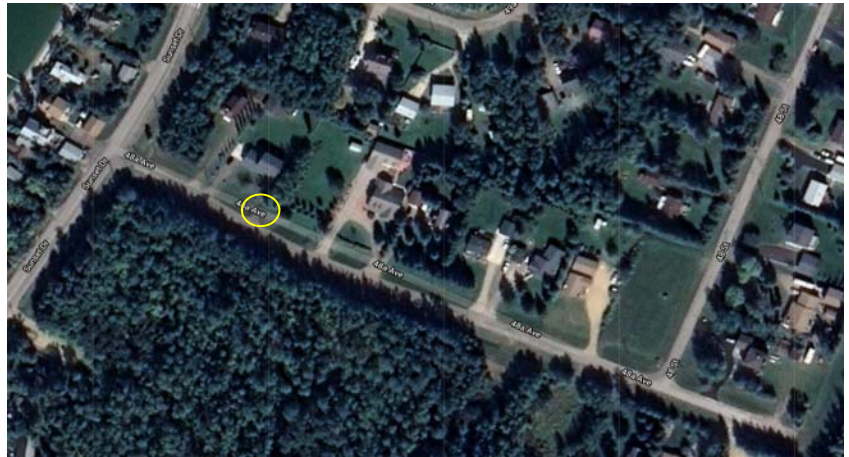
Comments
48 A Ave, North Side, 2nd approach to resident. 1.2 - 1.5 m cover. No rip rap. Clean grass away from culvert ends. Part of culvert is for dual approach but not used to Lot 25 to the East. No one in Lot 25. Water in pipe.

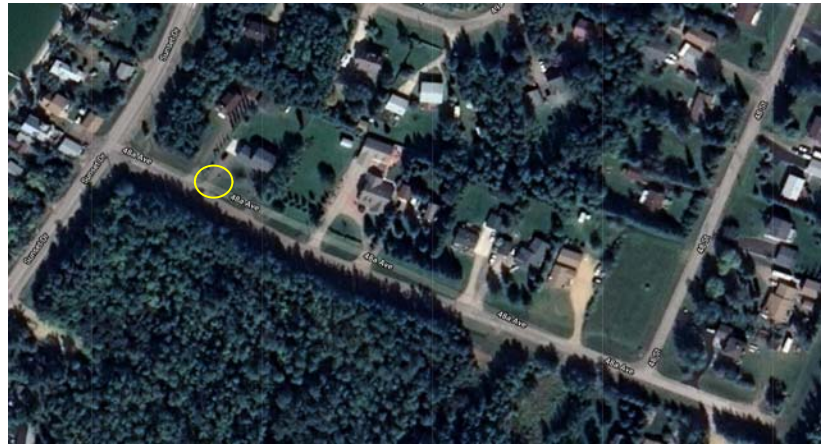
Comments
North side of 48A Ave. 0.3 to 0.5m cover. No rip rap. Clean grass away from culvert ends. Water in pipe.

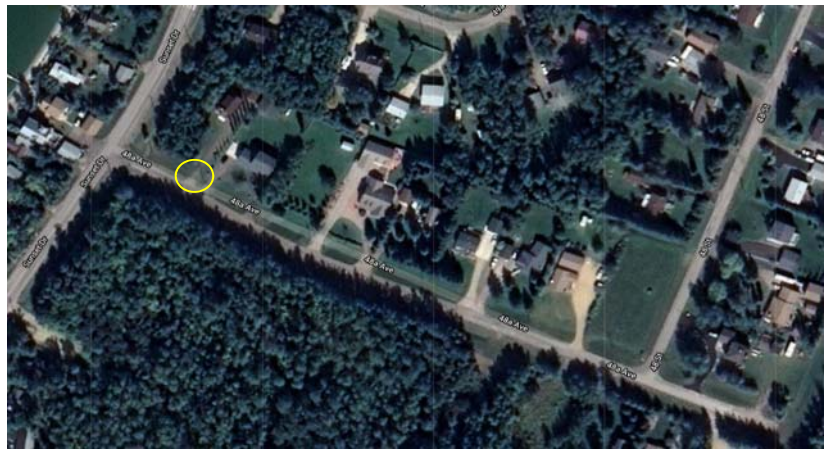
Comments
N. Side 48 A Avenue - Approach to Resident. Lots of grass at ends of culvert that could be cleaned out. No rip rap. Cover 0.6 to 0.9. No dip. Water in pipe.

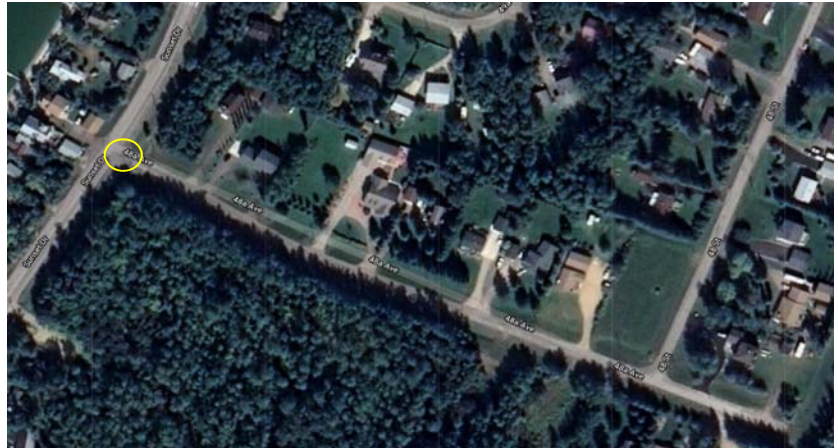
Comments
48A Avenue Culvert to Sunset Drive - East side of Sunset Drive. Damaged North end and South end. No rip rap. Ends need cleaning (very bad), Steep S/S N. end and S. End. Make longer 1m per end. Culvert clogged and can not see thru. Dipping in the center and towards the lake. Area is not draining and this culvert needs to be lowered as a overall area lowering of the ditches and culverts to the lake.

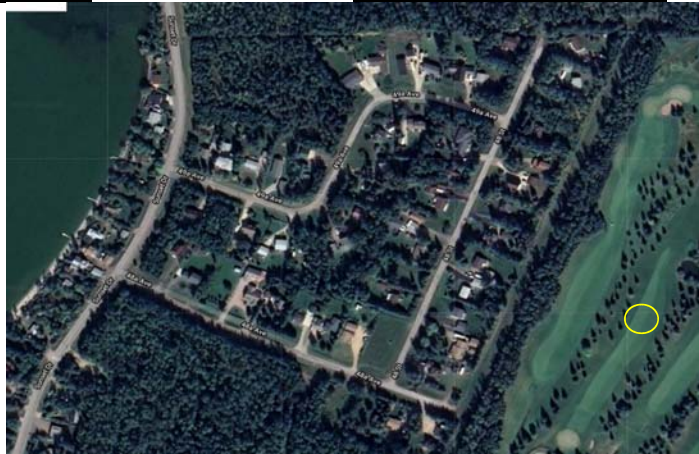
Comments
Flow is very high and flowing to the west and should be draining to the south along old railway embankment. Improvements are recommended to take flow coming from east of the old railway embankment which will take all of the flow away from this culvert. This culvert should be removed as it will become redundant. Improvement work will take flow from the Golf Course and re-direct to south ditch of 48A Avenue via an underground storm sewer.

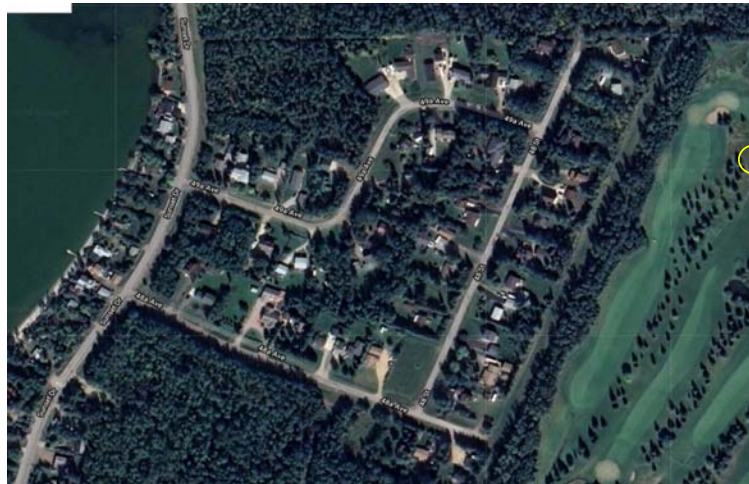
Did Not Find this Culvert

Comments
Could not find this culvert. Records from the old railway embankment construction indicate that a culvert did exist in this area. Flow is high in this area coming from the golf course. Flow should mostly go south along old railway embankment. Improvements are recommended to take this flow mostly to the south to 48A Avenue on both sides of the railway embankment. Some flow is to go to the north where a new drainage course is to be constructed north of the lots. This culvert will be redundant after improvements.

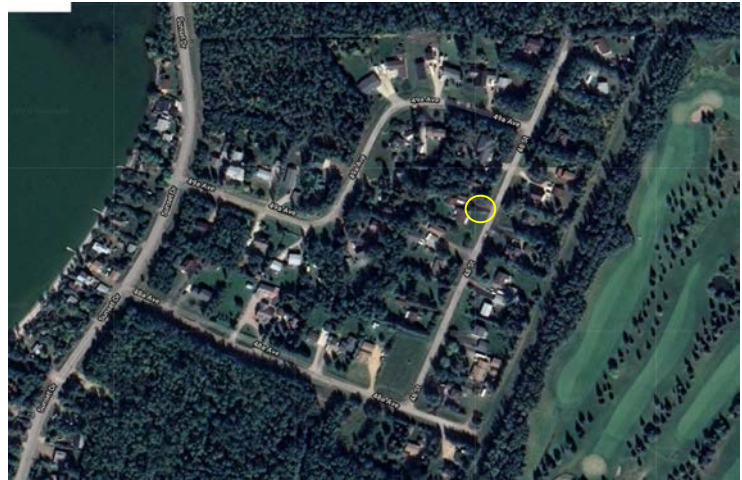
Comments
Culvert in fair to good condition. Little siltation. Flat grade but not within a major flow path. Capacity is noted as inadequate from capacity analysis however this is mainly due to pipe slope and not high flow. Recommend not to rate capacity as inadequate but as 25 year capacity.

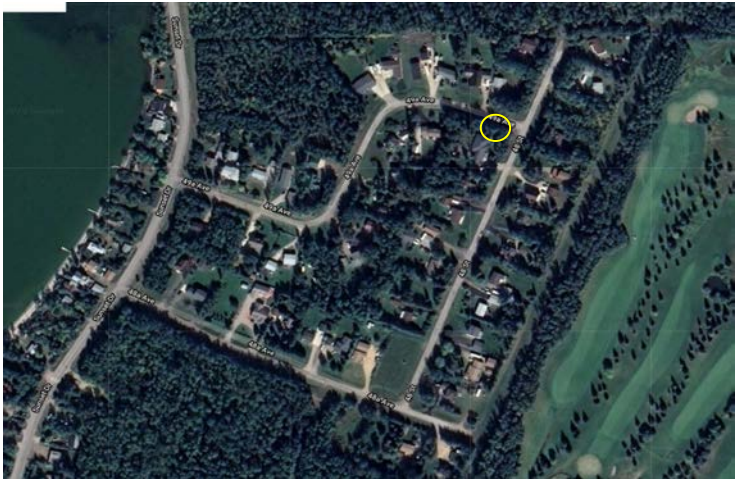
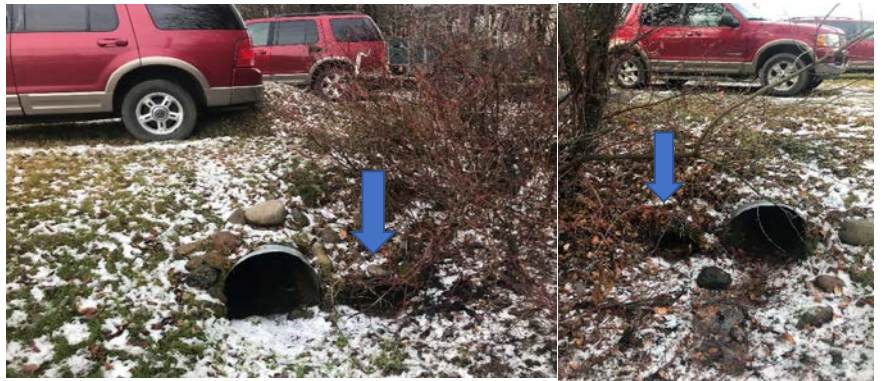
Comments
Culvert in fair condition (S. Culvert). Approach is not paved. Some issues with deformation. Bushes near ends will make drainage difficult and should be cleared. When replaced, it is important to re-set slope on culvert to ensure flow is from east to west.

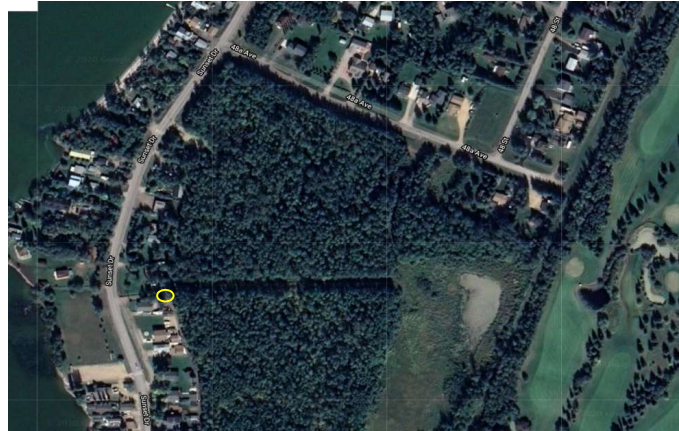
Comments
Small culvert that should be replaced with an 800mm Dia. CSP at minimum since area to the east is undeveloped and this drainage path will likely be increasing in flow.

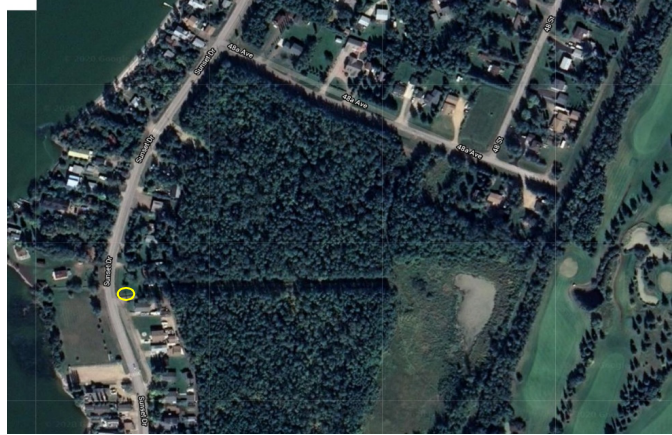
Comments
2 small culverts that should be replaced with an 800mm Dia. CSP at minimum since area to the east is undeveloped and this drainage path will likely be increasing in flow.

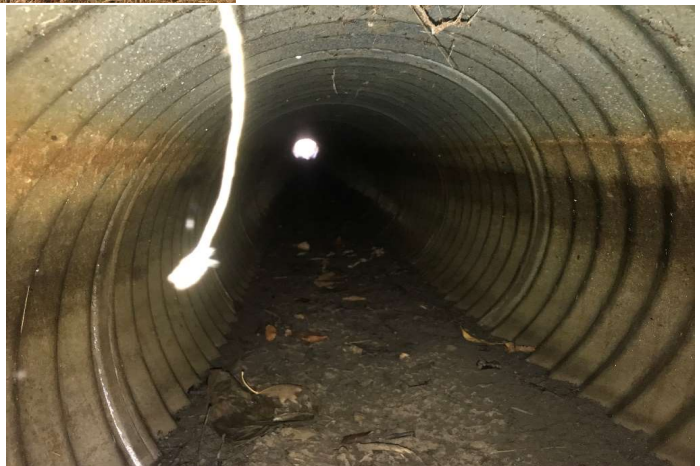
Comments
 The high water mark can clearly be seen in this culvert which is concerning and indicates that this culvert should be upgraded to at least an 800mm Dia. CSP when time for this culvert to be replaced. If more development to occur upstream, this crossing should be reviewed in order to determine if this crossing is sufficient. Culvert should be longer with sloped ends and sideslopes should be flattened. Ideally, 2 - 800mm Dia. CSPs should be installed.

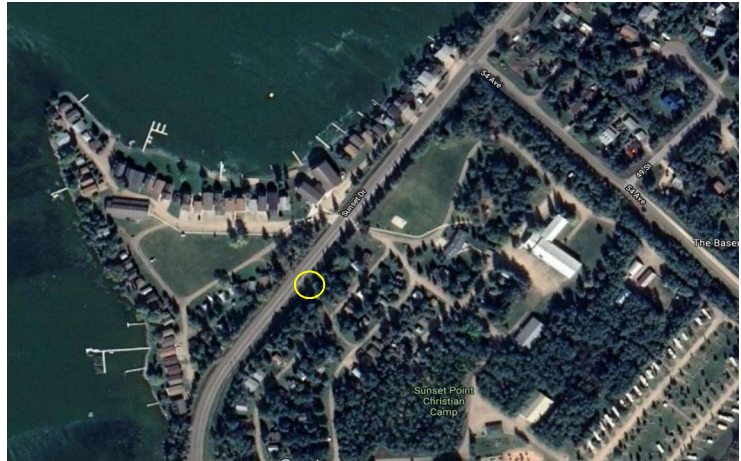
Comments
Culvert in fair to good condition. Approach is not paved. Culvert too small. Should be replaced with a 500mm CSP minimum with sloped ends and rip rap. Flatten out sideslopes to at least 5:1. Excess vegetation removed.
