Stormwater Management Plan
Final Report - Issued for Approval

Summer Village of Sunset Point

Sections W26 54-3-5, NW23 54-3-5, and
NE22 54-3-5
Lac Ste. Anne County

Summer Village of Sunset Point
June 2020

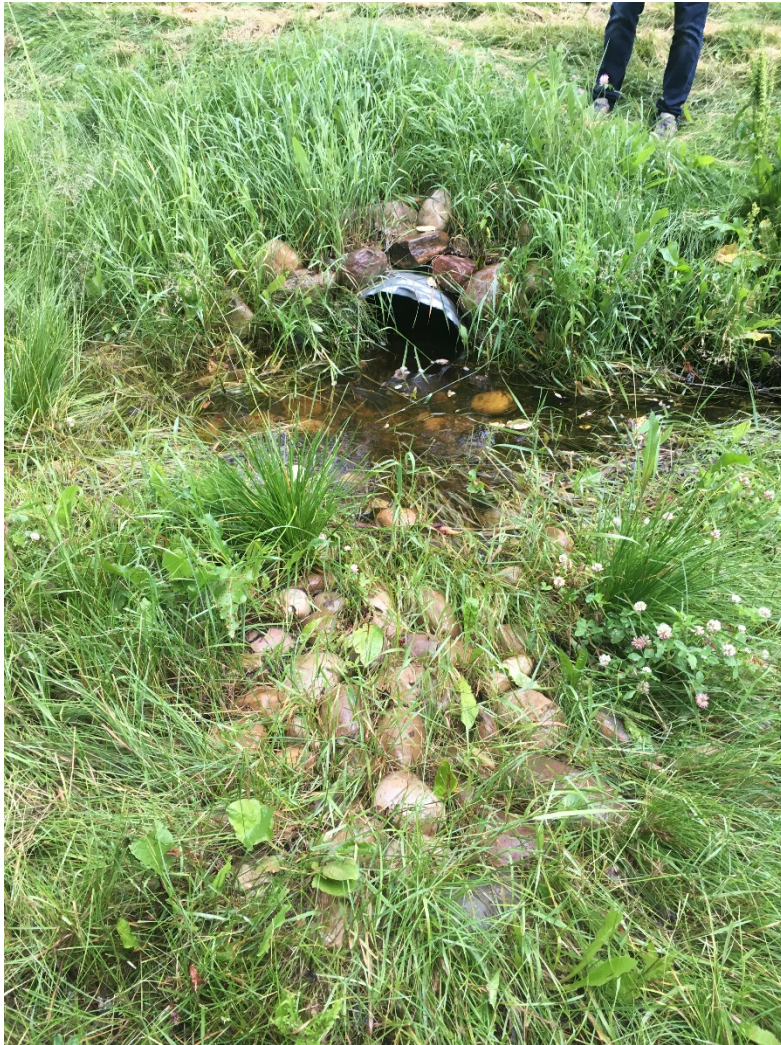
The north railway embankment crossing, culvert RE02, crosses the embankment 125m northeast of the 48A Avenue centreline (behind Lot 51, Block 15) and drains to the ditch on the west side of the embankment, as shown in **Appendix A, Figure A-14**. The existing culvert RE02 is 600mm in size, has 31 hectares of contributing area and is graded from east to west at a slope of 1.8%. With such a large contributing area, the service level of the culvert is inadequate in all scenarios studied. The RE02 culvert inlet (east invert) is too high to allow the standing water in the east ditch to drain across the embankment, so it is directly contributing to the embankment ponding and seepage issues.

Photo 3 – Culvert RE02 outlet, facing east.

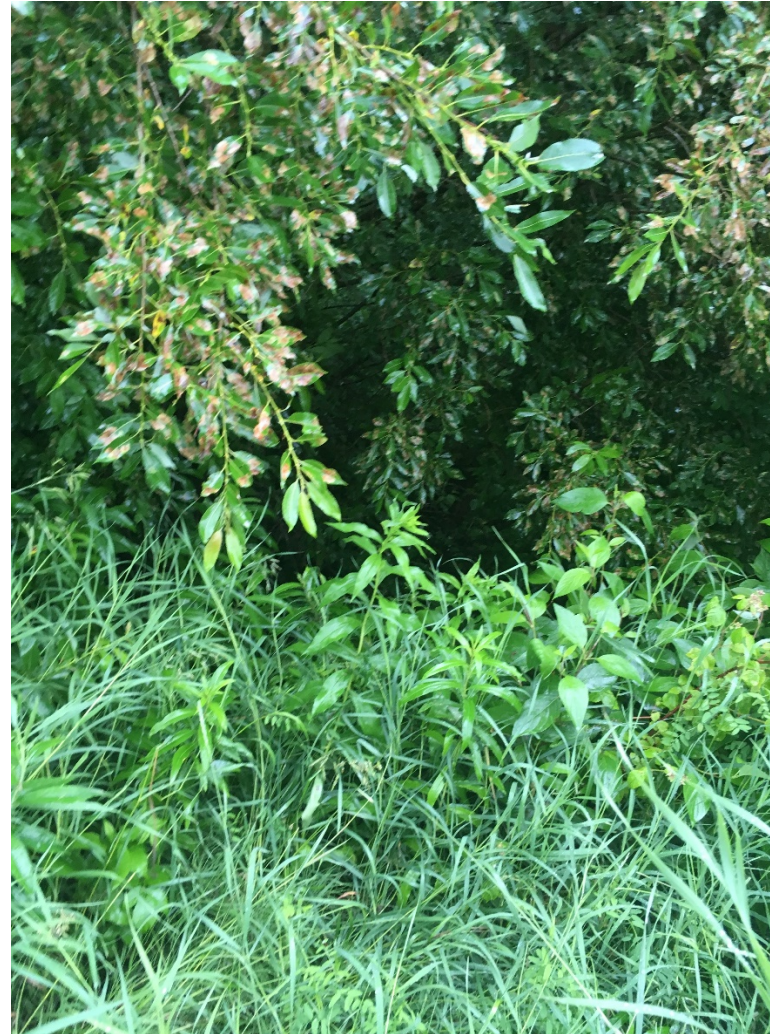
Photo 4 – Culvert RE02 inlet, facing east.

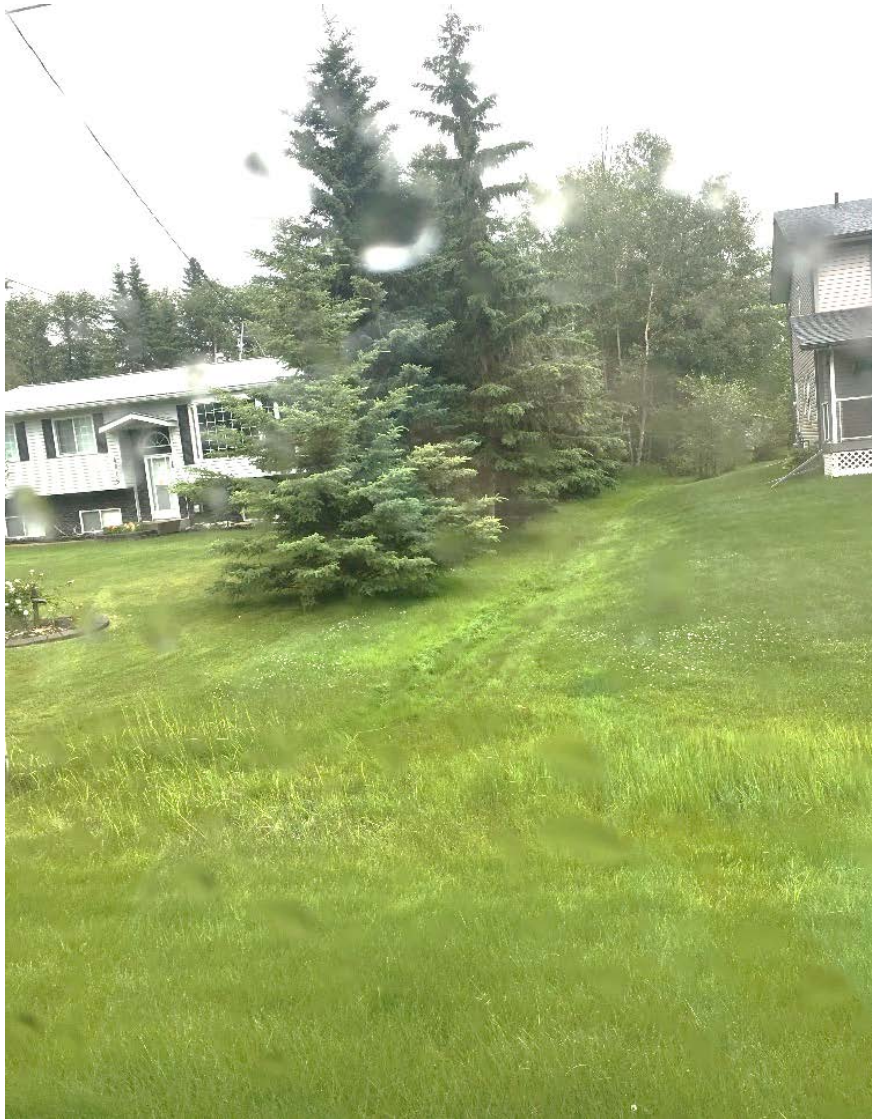
To address their lot drainage issues, most of the affected landowners have installed property line swales to improve the drainage from the back-of-lots to the 48 Street east ditch. The Outlet F flow paths along 48 Street and 49A Avenue are shown in **Appendix A Figure A-7**. Although the property line swales provide some relief for lot drainage, they inadvertently cause downstream flooding issues by diverting large quantities of runoff to a system that was not sized to accommodate the additional external flows. Photos of the property line swales are shown in **Appendix C, Photos 11-15**.

Photo 11 – 48 Street property line swale, facing east.

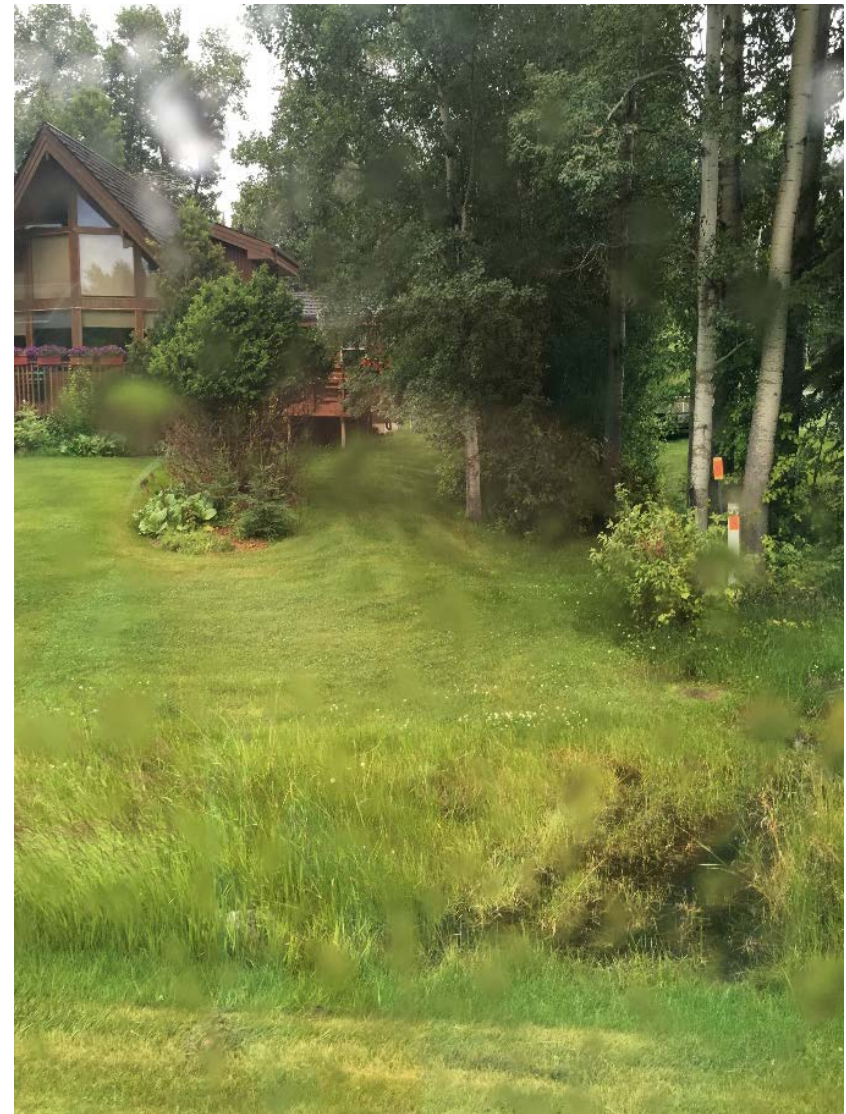
Photo 12 – 48 Street property line swale, facing east.

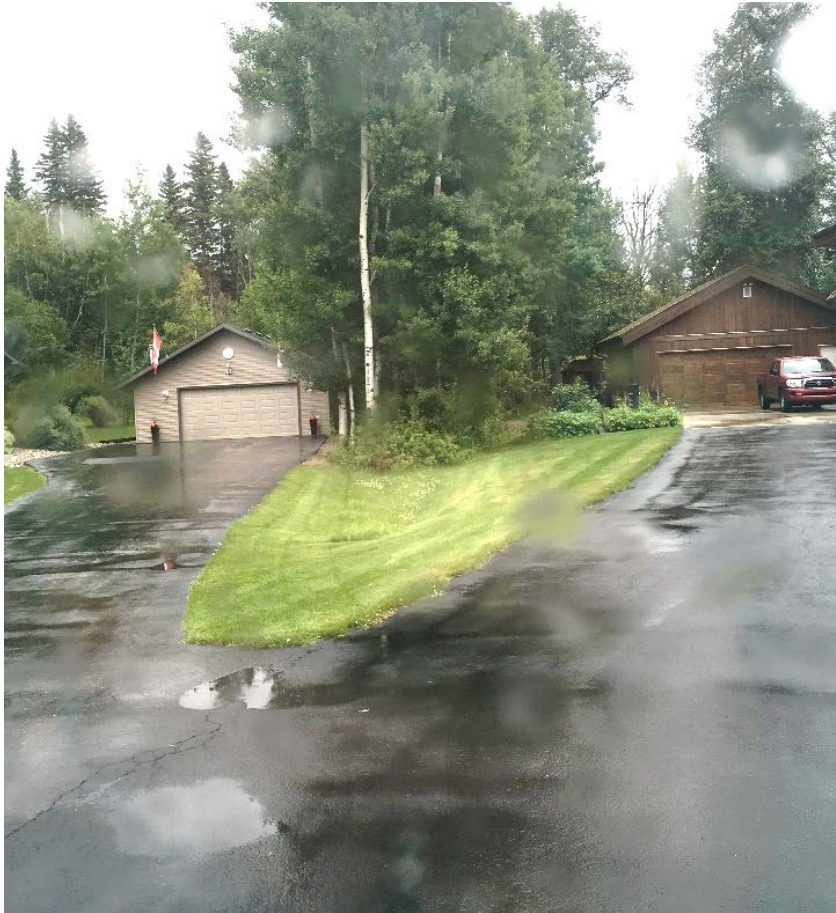
Photo 13 – 48 Street property line swale, facing east.

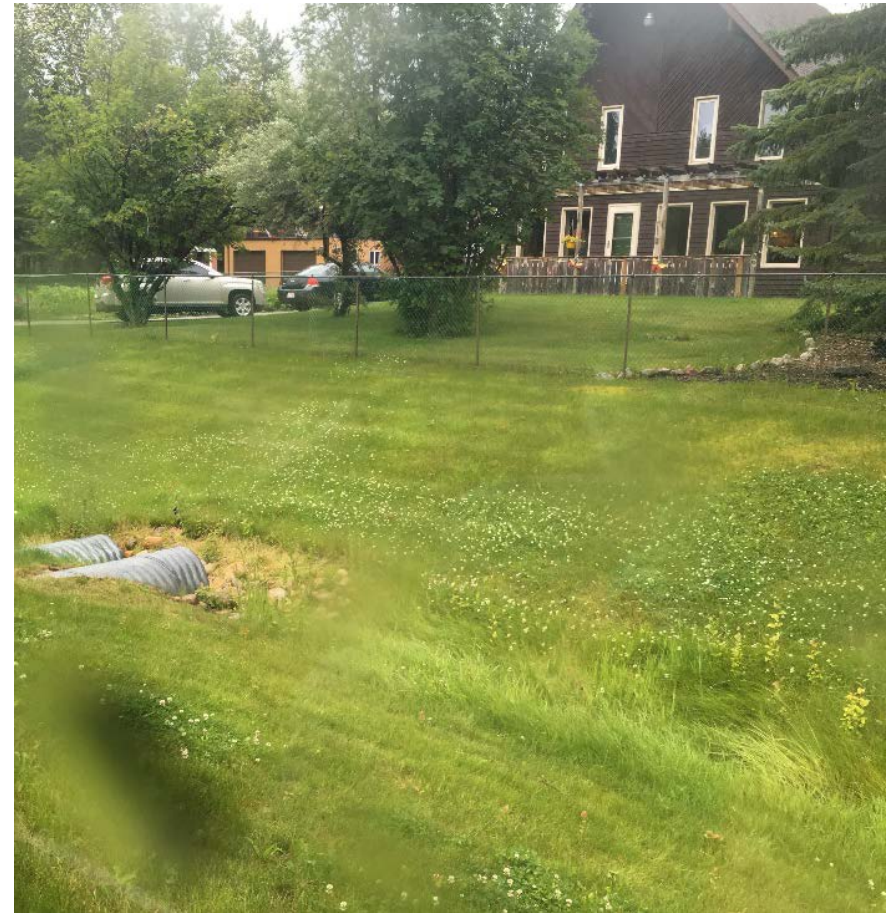
The F11-F12 culvert crossing consists of two 600mm culvert and meets the required service level. All downstream culverts must have the equivalent or greater capacity to adequately convey the flow. Hence, F07a-F07b (one 400mm culvert and one 600mm culvert, respectively) and F05-F06 (two 400mm culverts) are inadequate bottleneck points and are likely significantly contributing to flooding issues along this flow path. Culvert crossing F03-F04 (two 600mm culverts) have a 10-year service level due to low grades and are also causing a bottleneck at the 49A Avenue crossing during runoff events exceeding 10-years.

Photo 14 – Culvert F11 and F12 48 Street crossing inlet, facing east.

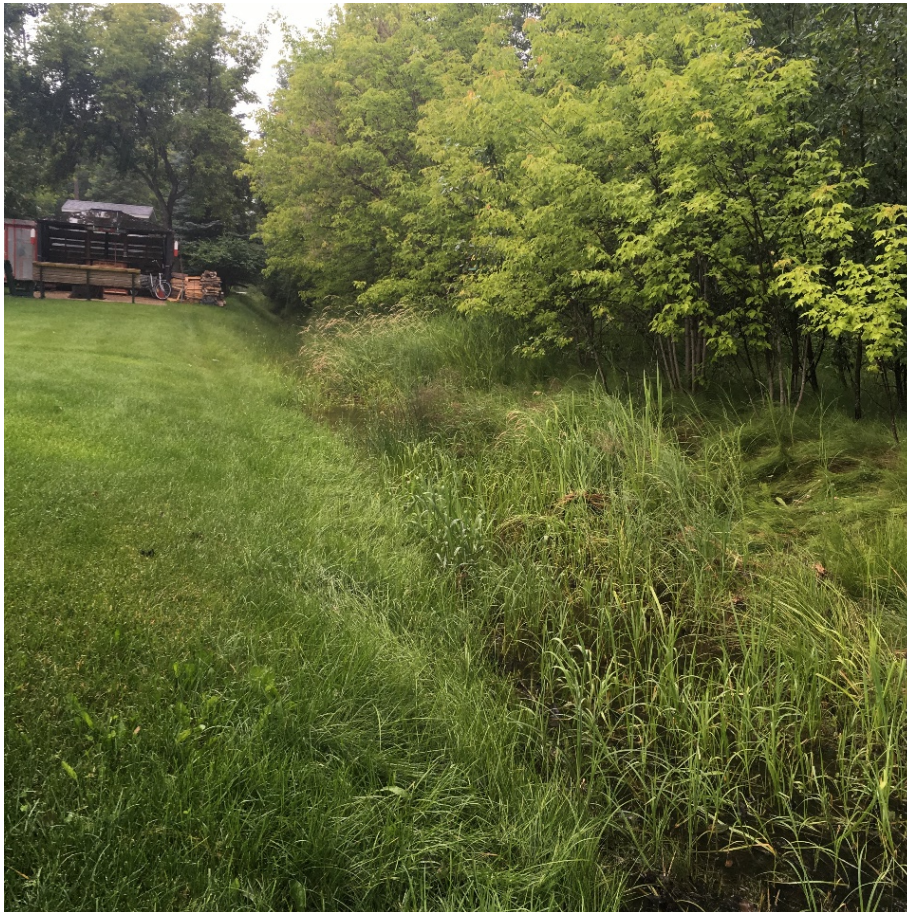
Photo 19 – Lot 7 rear lot ditch (to be filled), facing west.

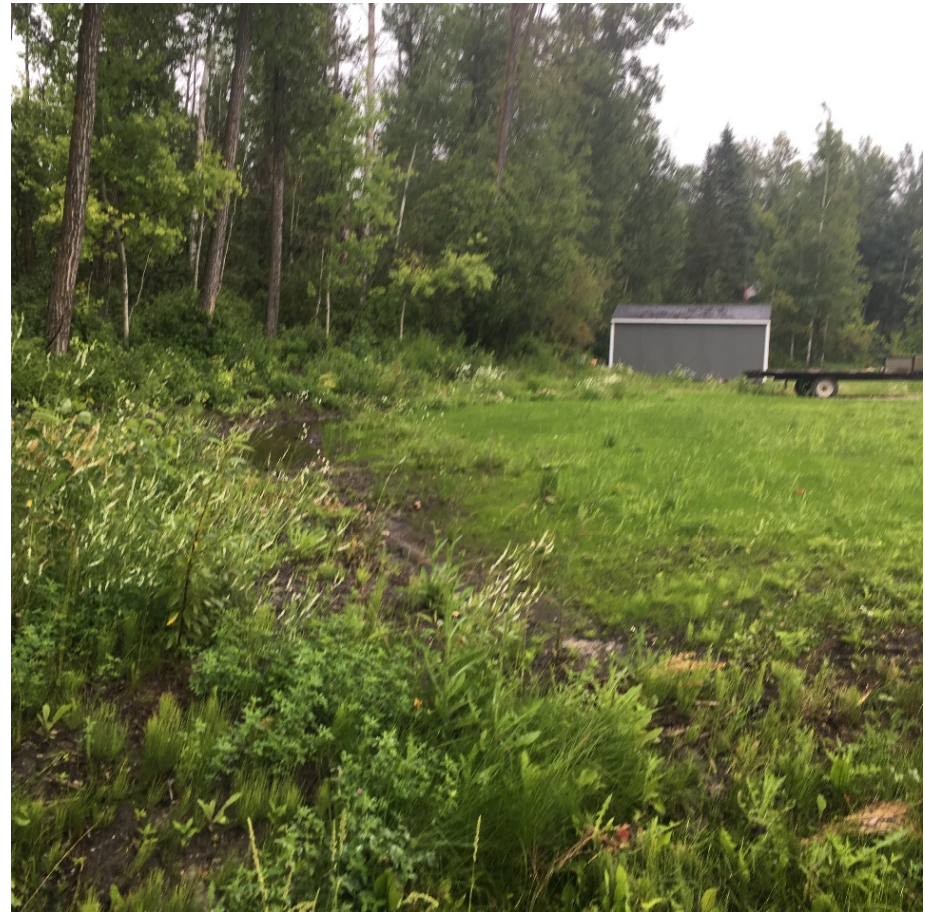
Photo 20 – Lot 8 rear lot ditch (to be filled), facing east.

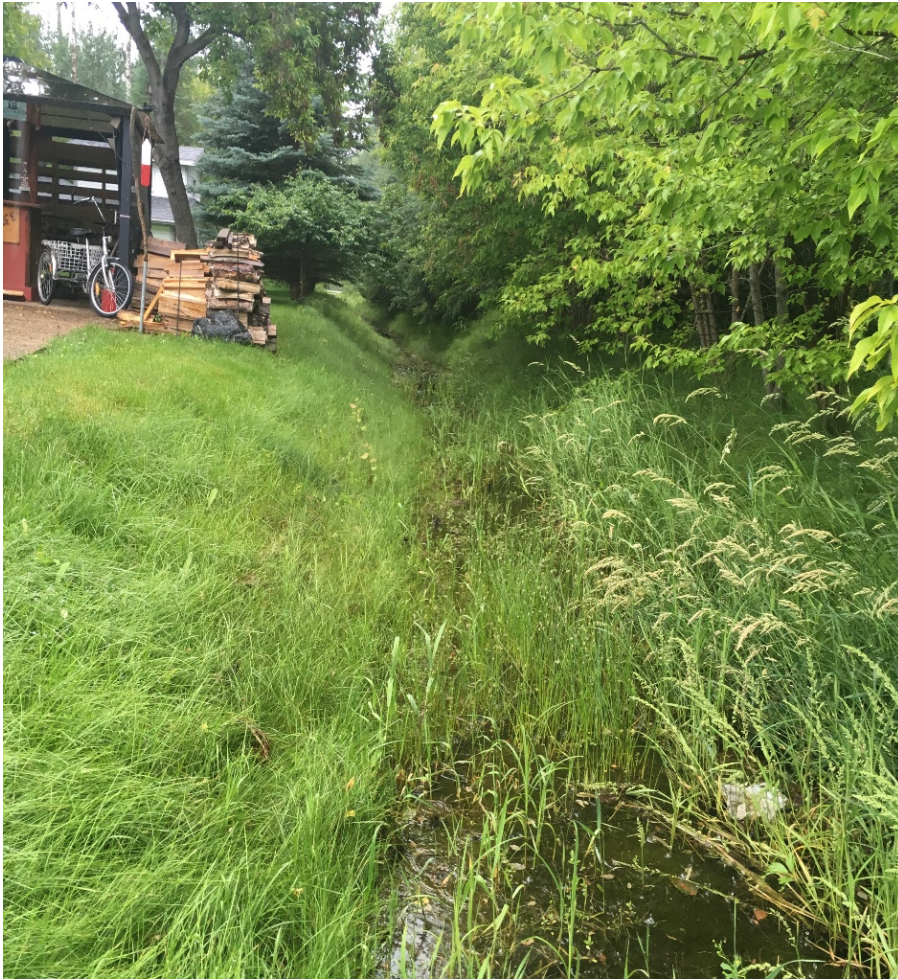
Photo 21 – Lot 7 rear lot ditch (to be filled), facing west toward Lot 6 and MR.

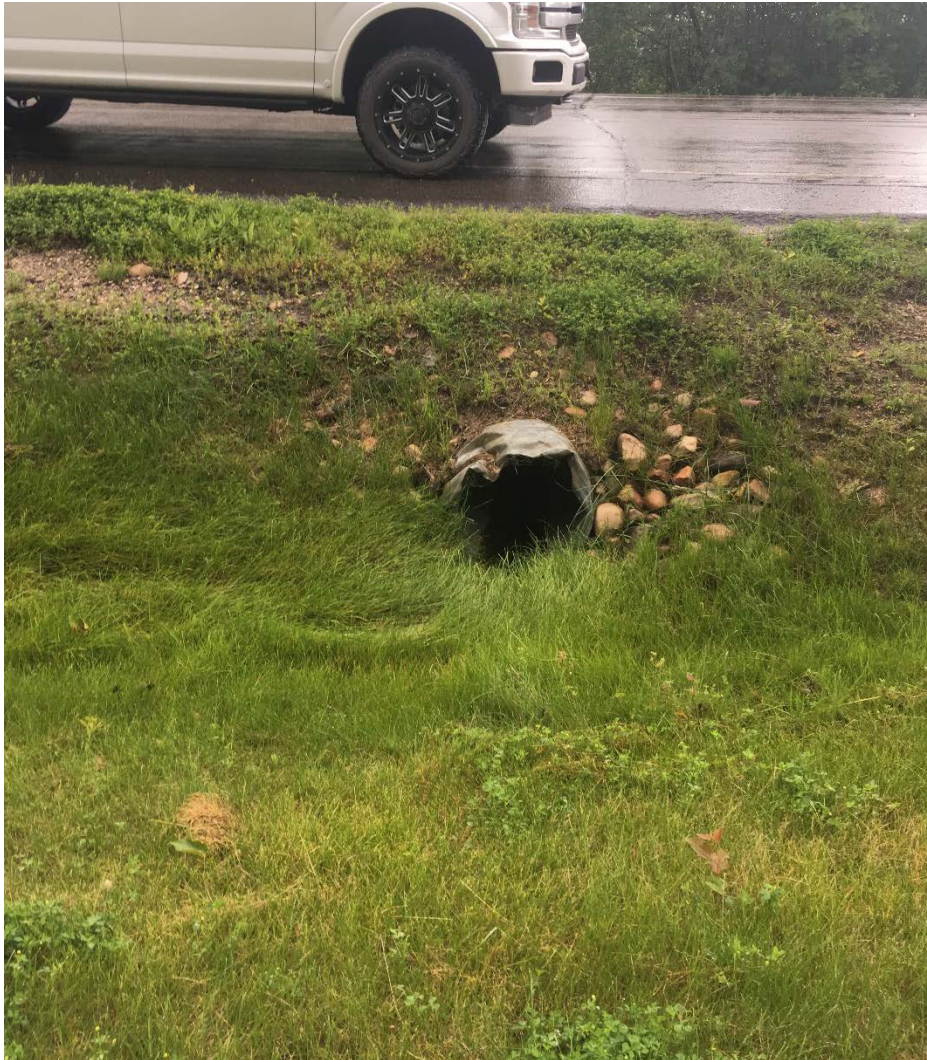
Photo 25 – Culvert F01 inlet, facing west.

6. Rehabilitate culvert F01 (crossing Sunset Drive) as required. Install a second major culvert crossing Sunset Drive so that the combined capacity of F01 and the new culvert (F01b) accommodates the proposed Drainage Parkway flows. F01 shall now be designated F01a, for clarity.
7. Rehabilitate and armour the ditch (P Ditch-03) at the outlet of culvert F01a and F01b as needed to ensure the flow path to the lake is accommodated within the existing road right of way and adequately protected from erosion and scour.

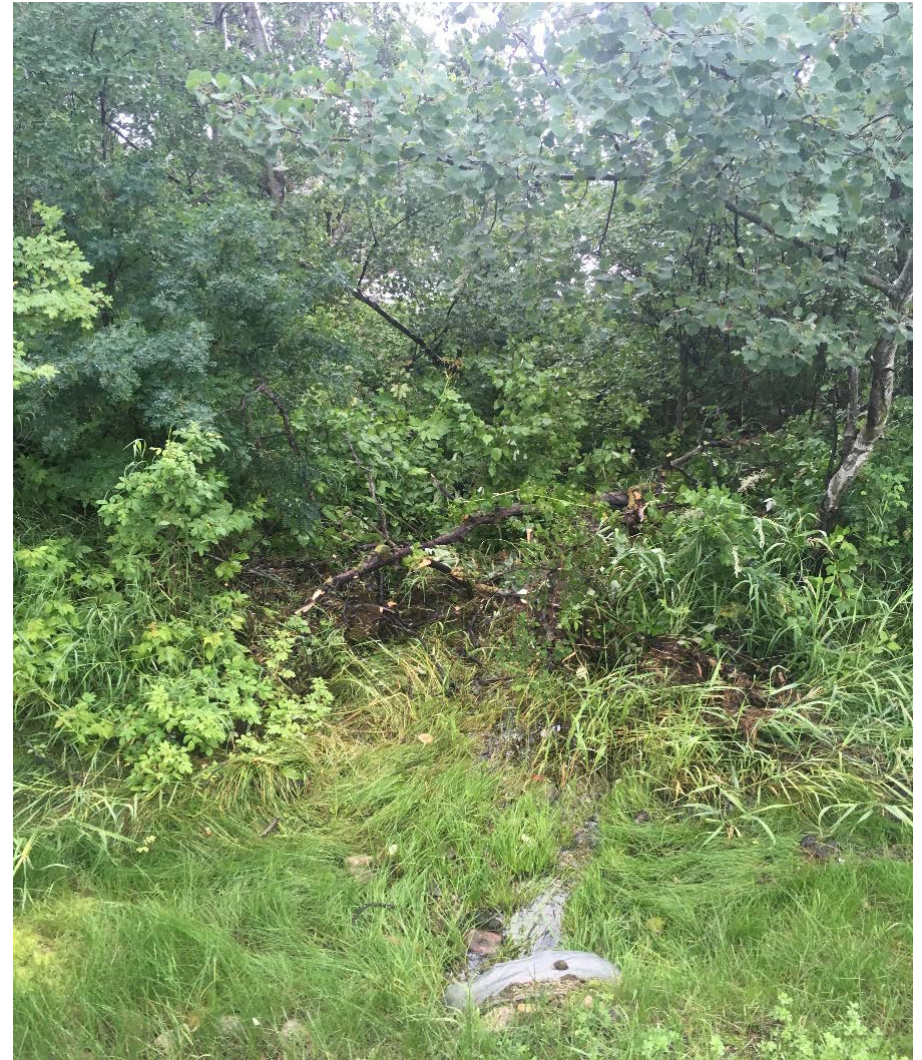
Photo 26 – Culvert F01 outlet, facing west.

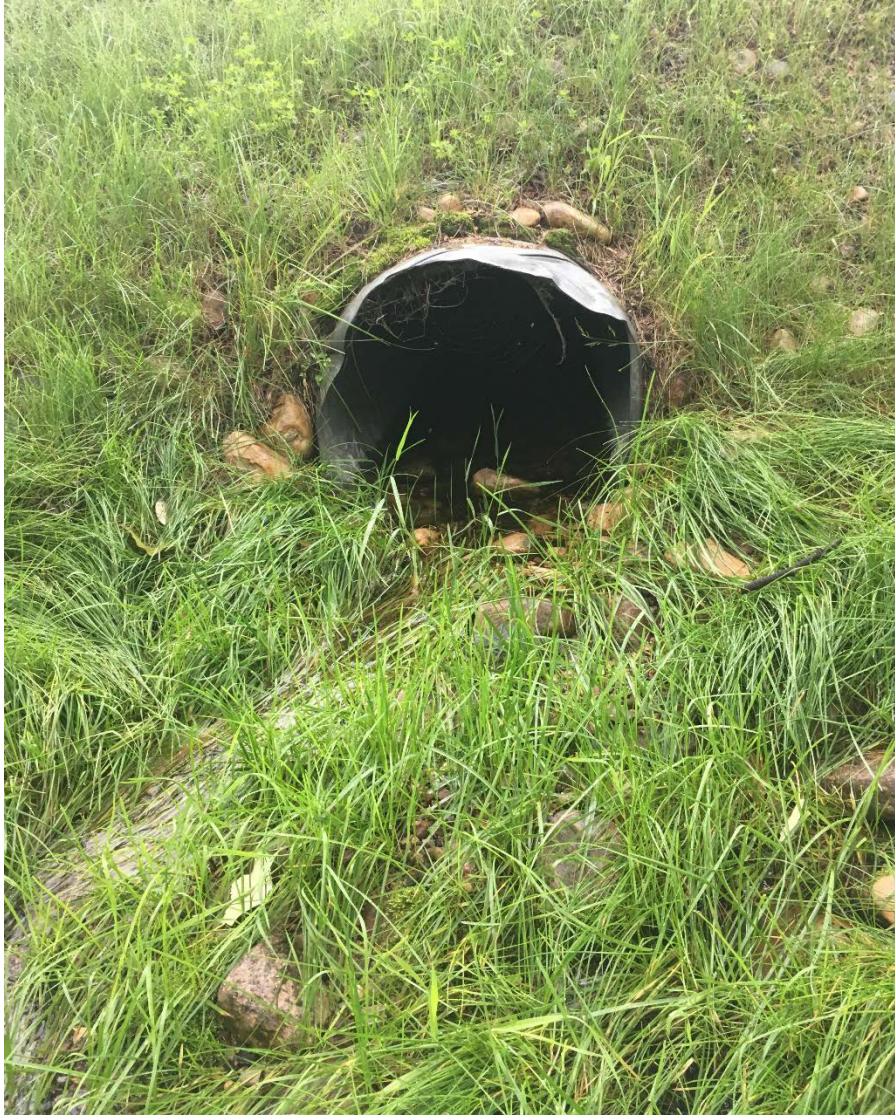
Photo 27 – Culvert F01 outlet, facing east.

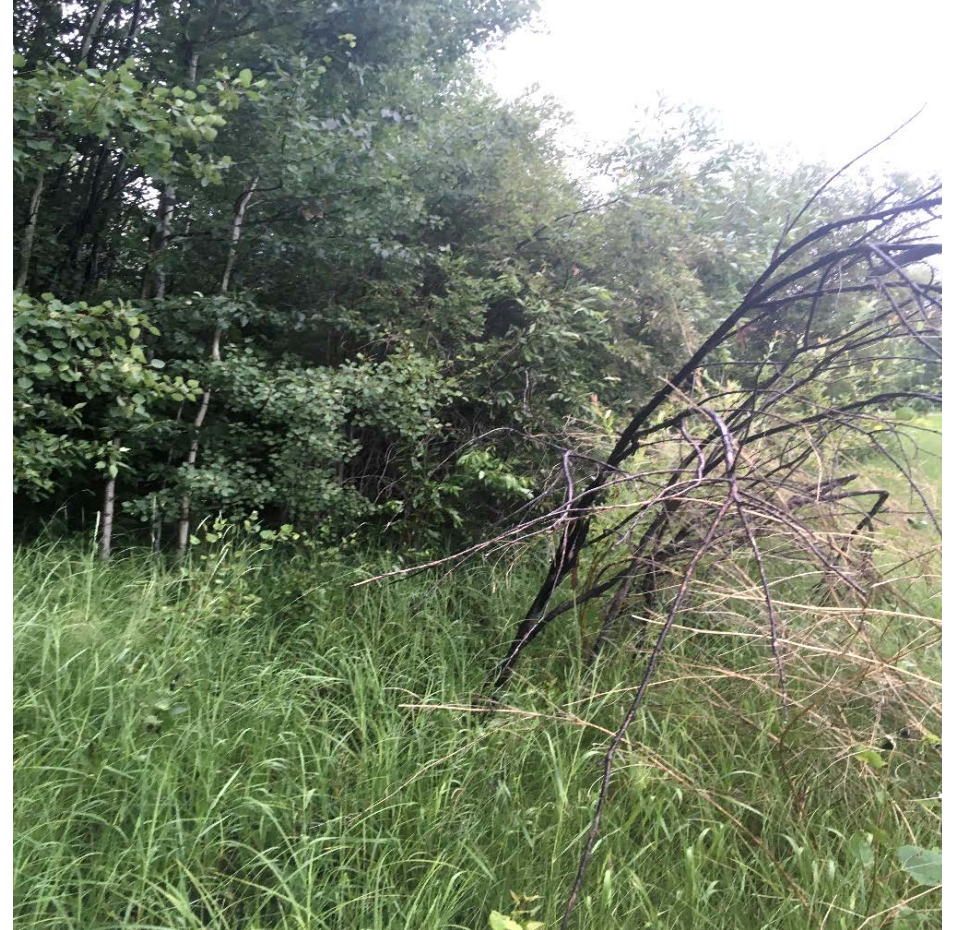
Photo 30 – Culvert I04 outlet, blocked by shrubs, facing east.

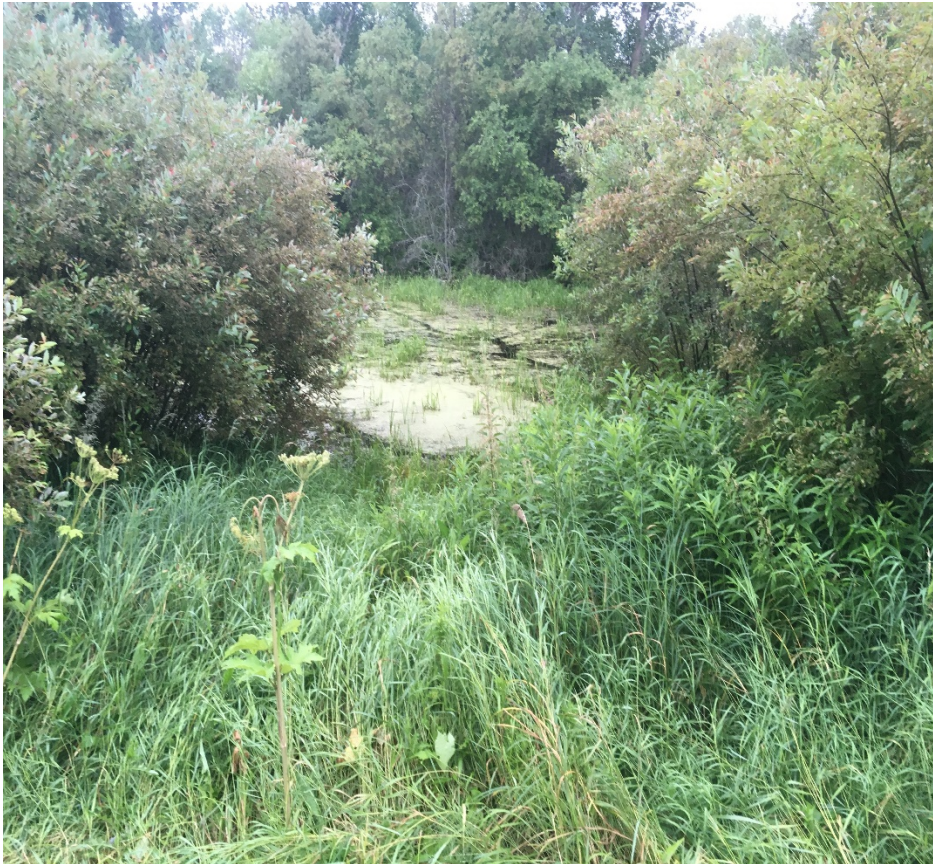
- ❖ Major Outlet I could not be located. It appears that the flow path enters a wetland on the east side of Ste. Anne Trail, but a culvert crossing could not be located, so it is unclear whether this flow path has been accommodated.

Photo 32 – Wetland at possible Flow Path I(i) crossing, no visible evidence of culvert crossing to Outlet I, facing east.

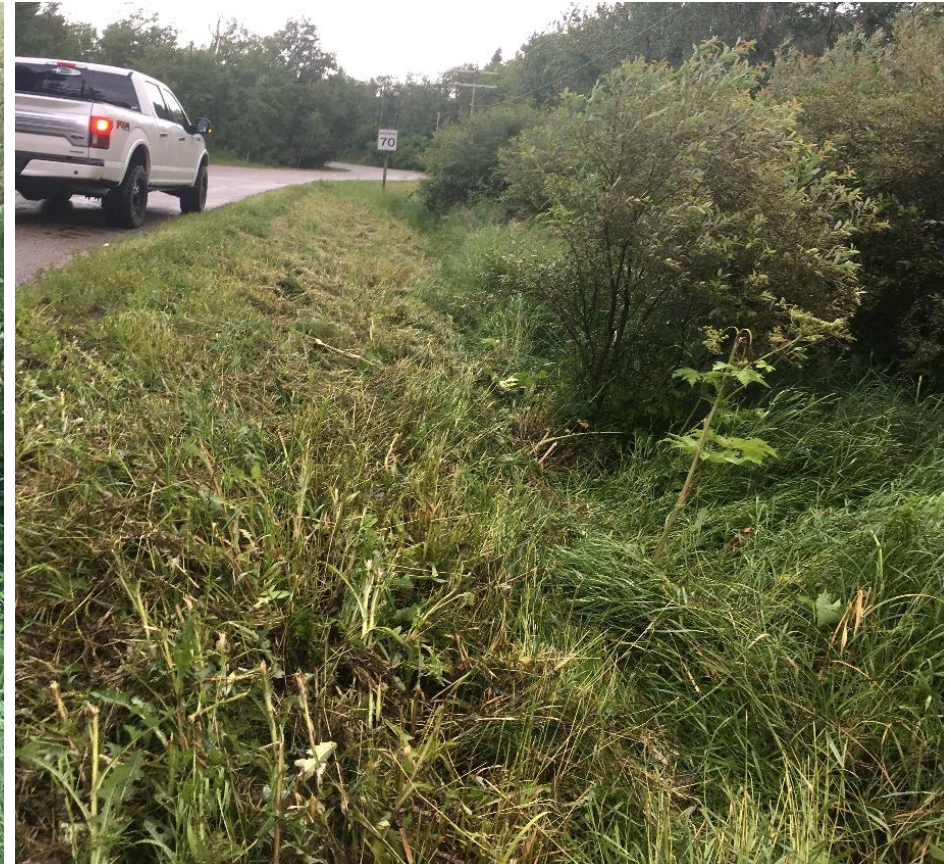
Photo 33 – East ditch of Sunset Drive/Ste. Anne Trail and Flow Path I(i), no visible evidence of culvert crossing to Outlet I, facing north.
