Stormwater Management Plan
Final Report - Issued for Approval

Summer Village of Sunset Point

Sections W26 54-3-5, NW23 54-3-5, and
NE22 54-3-5
Lac Ste. Anne County

*Summer Village of Sunset Point
June 2020*

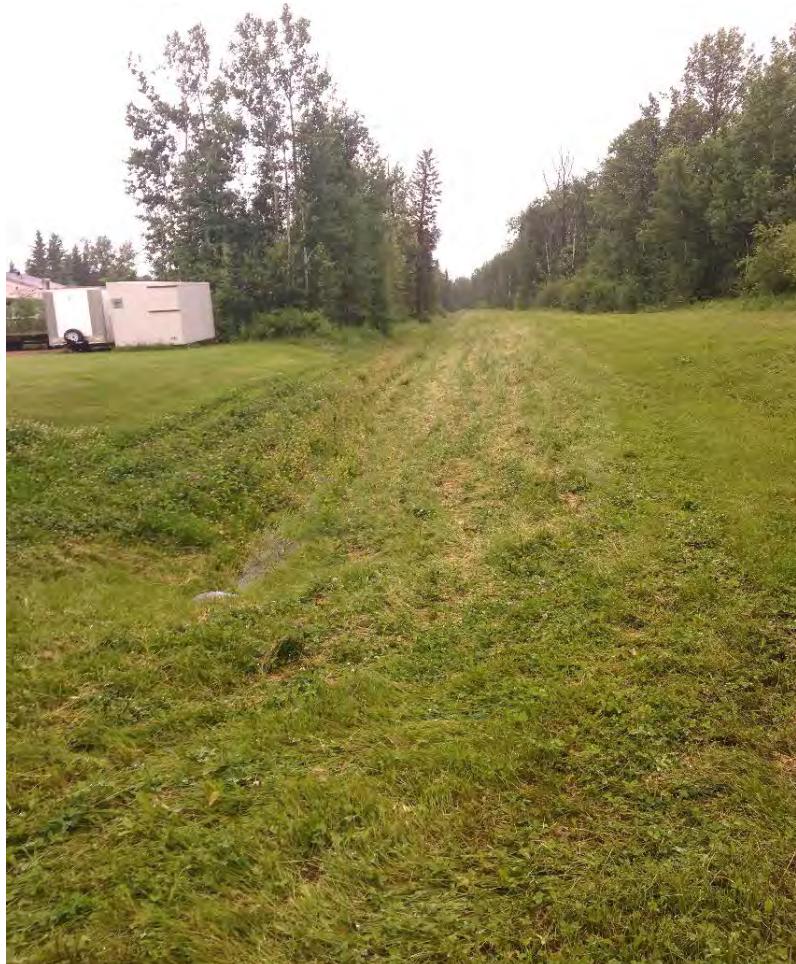
Photo 1 – Railway embankment west ditch, culvert D08 inlet, facing north.

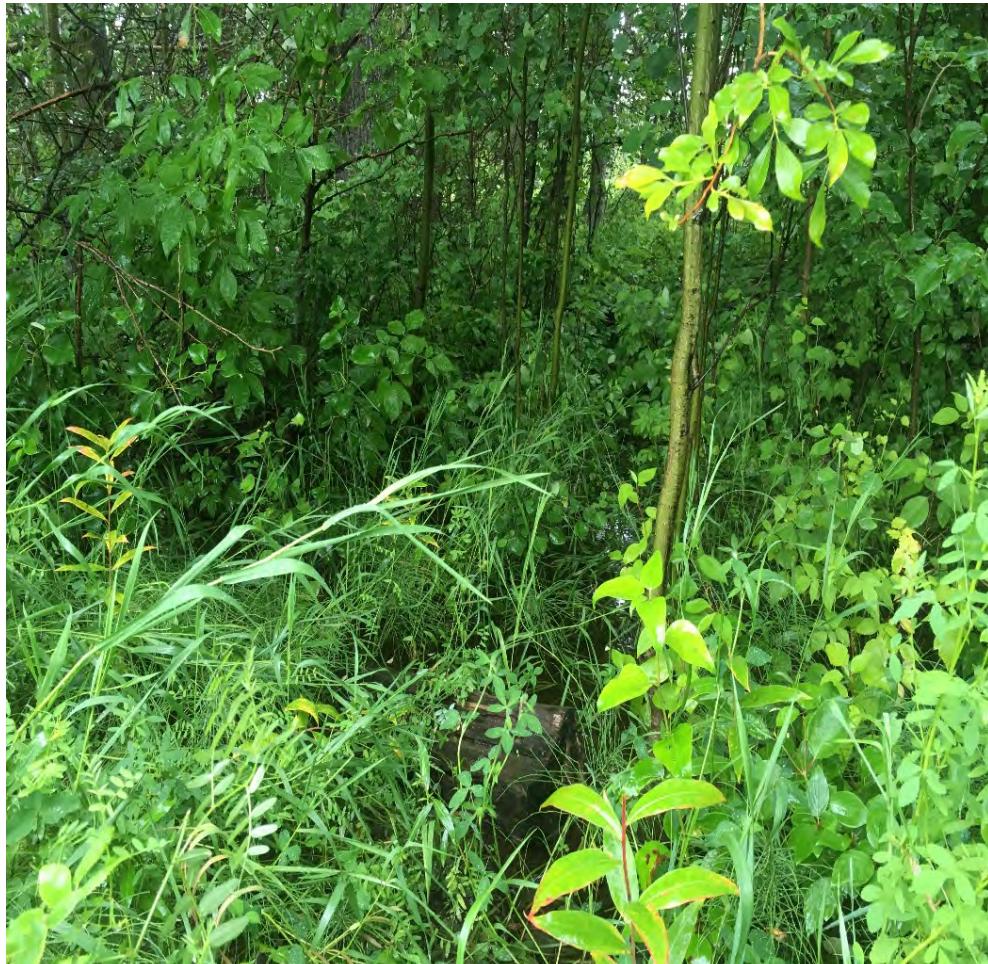
Photo 2 – Railway embankment east ditch, facing east.

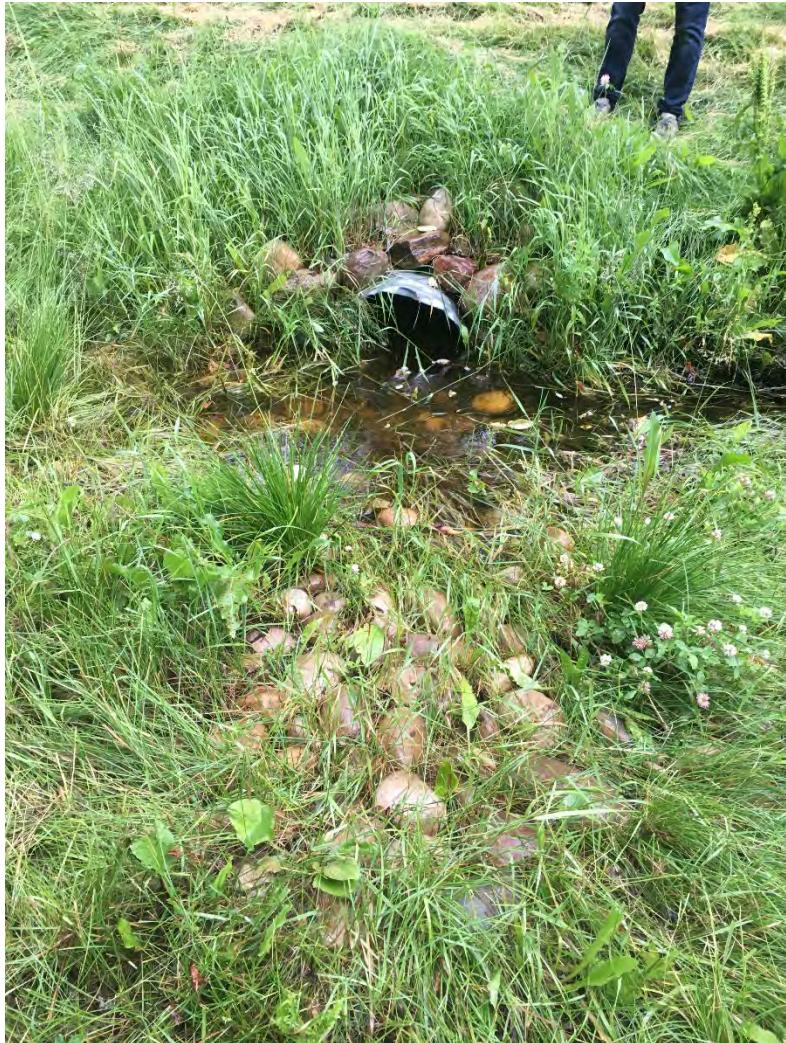
The north railway embankment crossing, culvert RE02, crosses the embankment 125m northeast of the 48A Avenue centreline (behind Lot 51, Block 15) and drains to the ditch on the west side of the embankment, as shown in **Appendix A, Figure A-14**. The existing culvert RE02 is 600mm in size, has 31 hectares of contributing area and is graded from east to west at a slope of 1.8%. With such a large contributing area, the service level of the culvert is inadequate in all scenarios studied. The RE02 culvert inlet (east invert) is too high to allow the standing water in the east ditch to drain across the embankment, so it is directly contributing to the embankment ponding and seepage issues.

Photo 3 – Culvert RE02 outlet, facing east.

- a. Remove and dispose of existing culvert RE02.

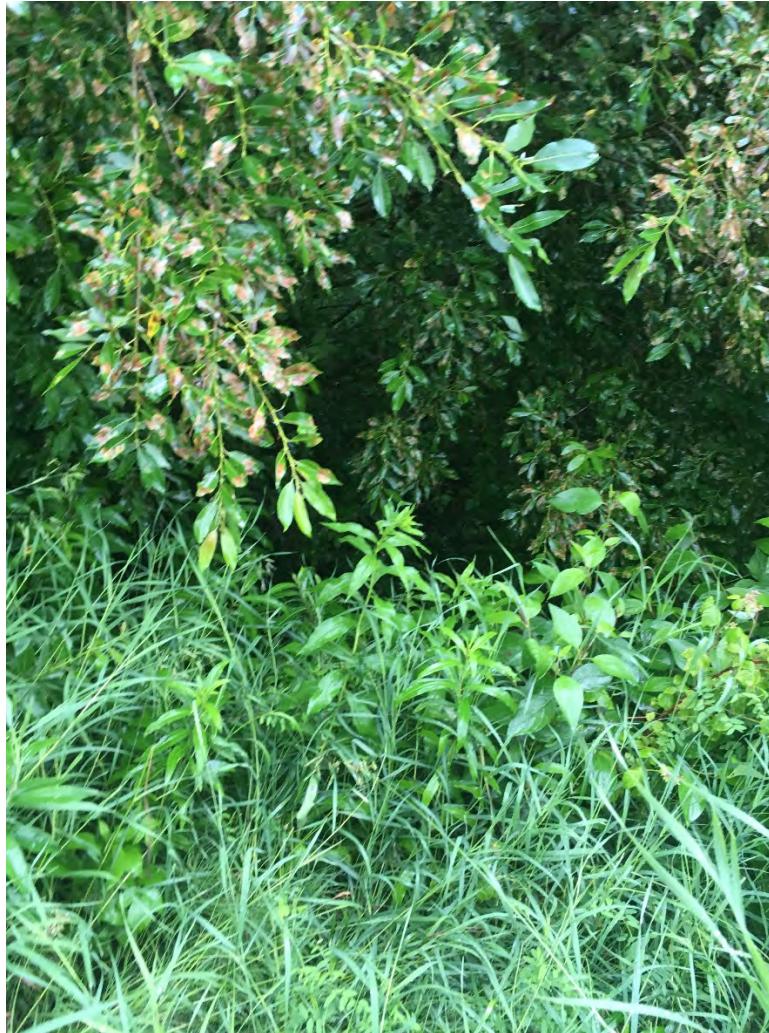
Photo 4 – Culvert RE02 inlet, facing east.

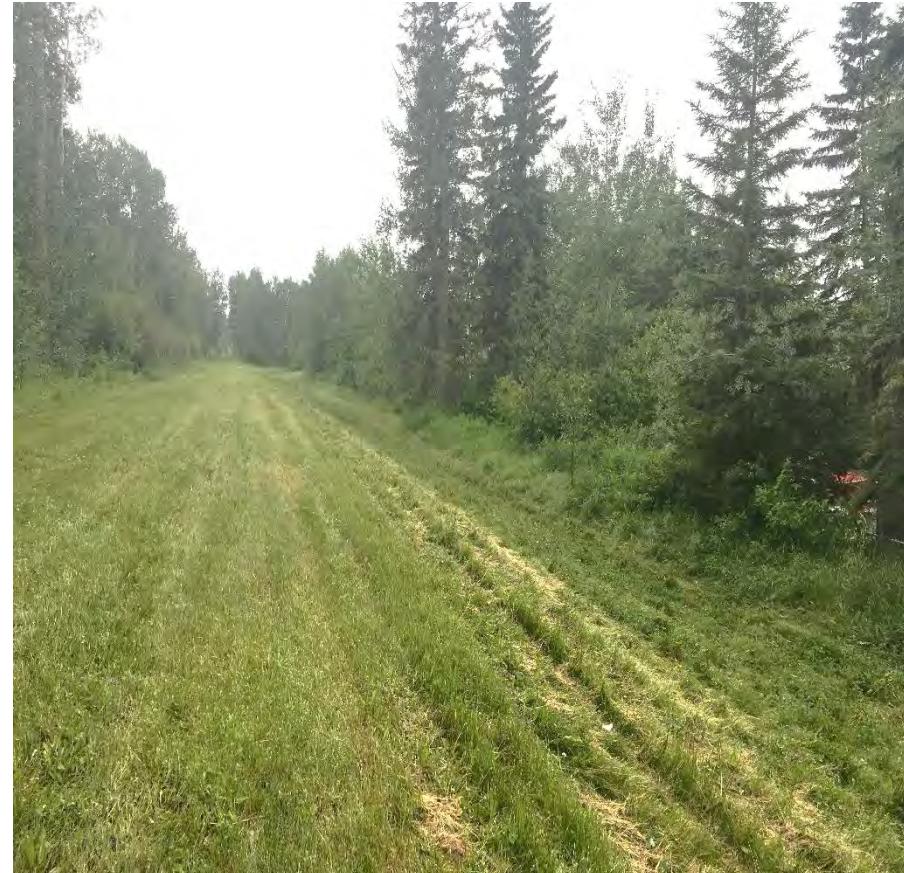
Photo 6 – Railway embankment north of Lot 49 (48 Street), facing north.

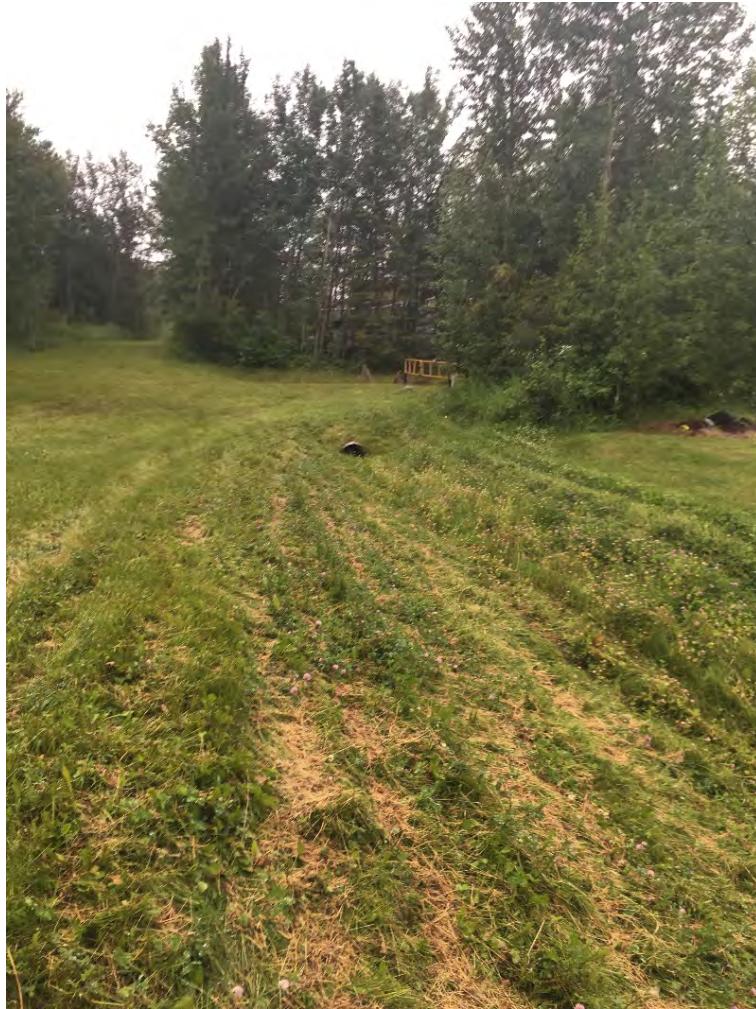
Photo 7 – Railway embankment from behind Lot 53 (48 Street), culvert D08 inlet (center), facing south.

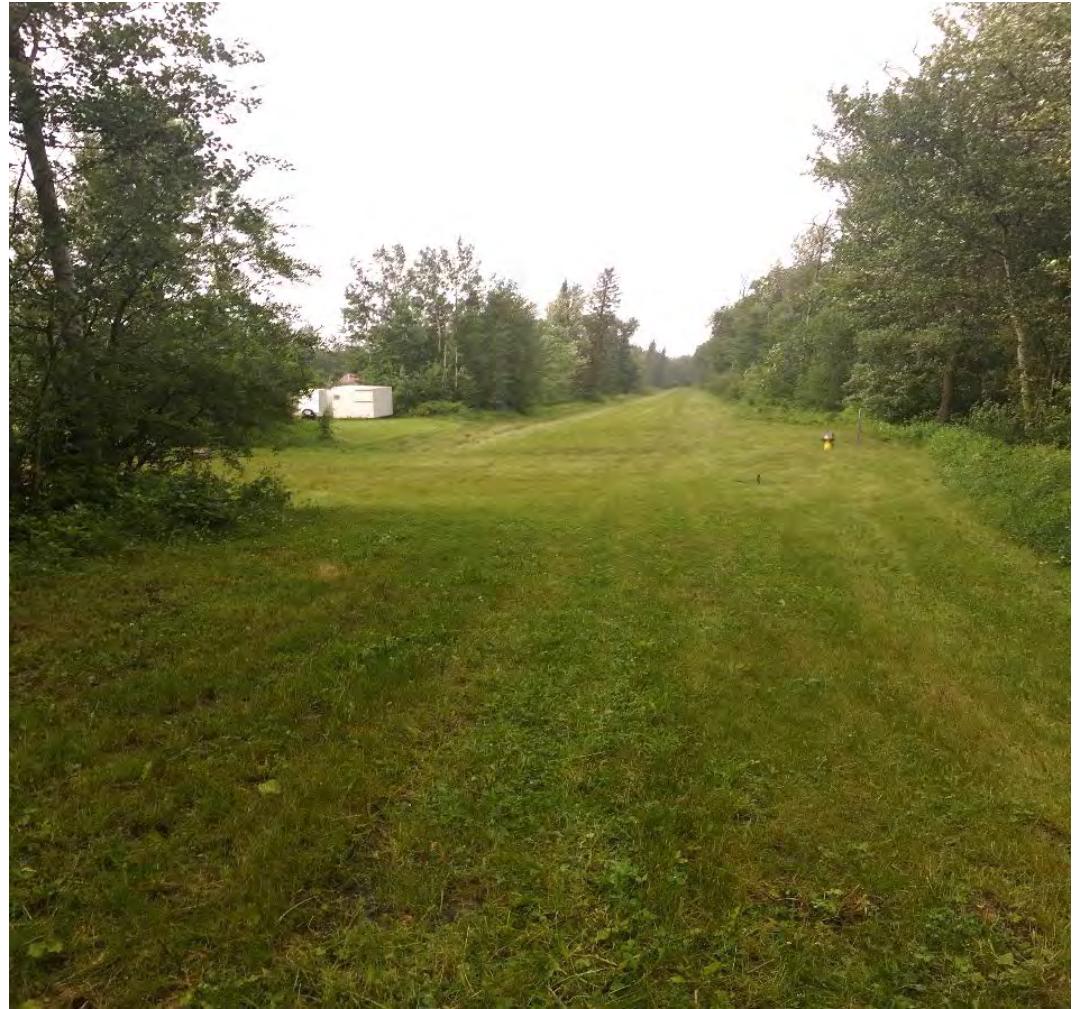
Photo 8 – Existing railway embankment recreational trail, facing north.

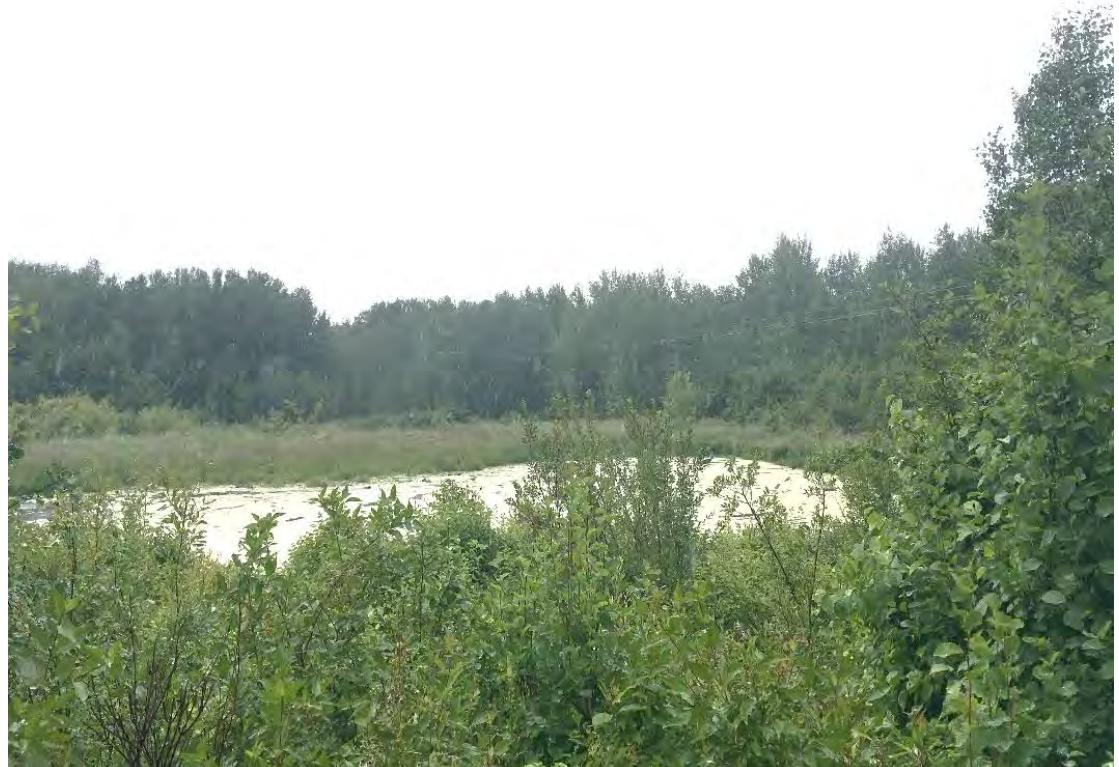
Photo 10 – Existing Dugout, facing northwest.

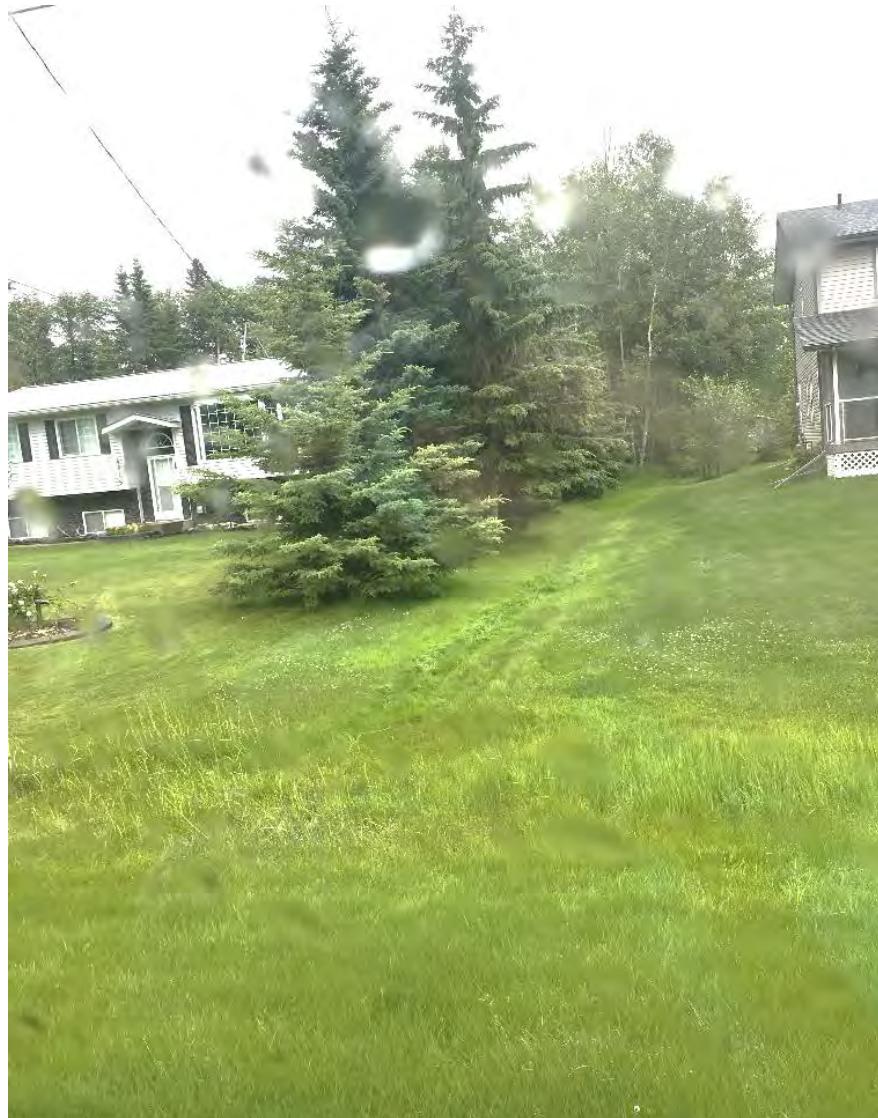
To address their lot drainage issues, most of the affected landowners have installed property line swales to improve the drainage from the back-of-lots to the 48 Street east ditch. The Outlet F flow paths along 48 Street and 49A Avenue are shown in **Appendix A Figure A-7**. Although the property line swales provide some relief for lot drainage, they inadvertently cause downstream flooding issues by diverting large quantities of runoff to a system that was not sized to accommodate the additional external flows. Photos of the property line swales are shown in **Appendix C, Photos 11-15**.

Photo 11 – 48 Street property line swale, facing east.

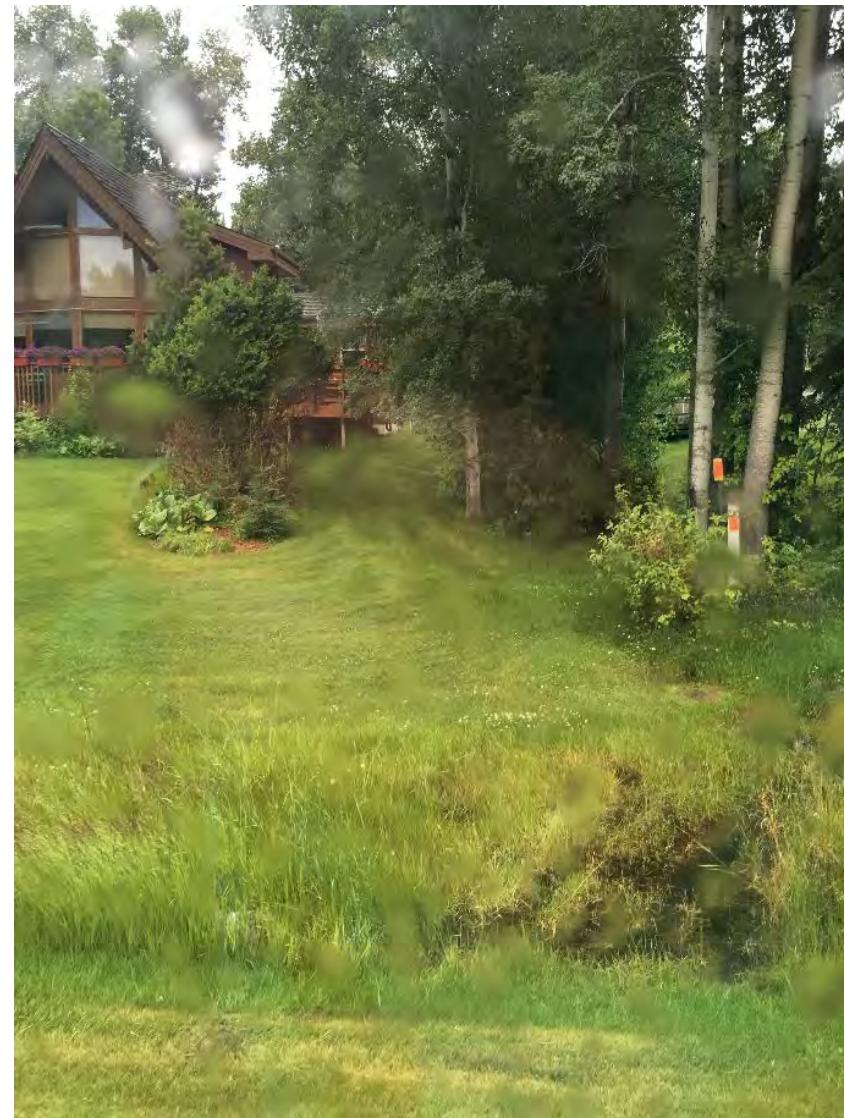
Photo 12 – 48 Street property line swale, facing east.

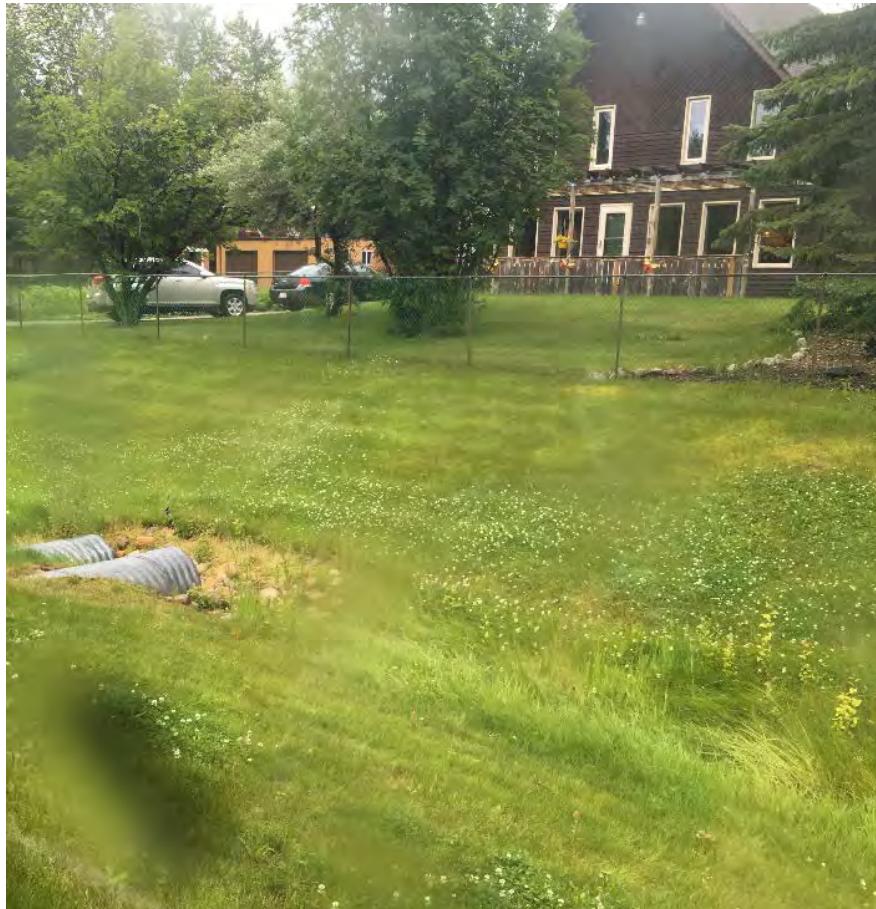
The F11-F12 culvert crossing consists of two 600mm culvert and meets the required service level. All downstream culverts must have the equivalent or greater capacity to adequately convey the flow. Hence, F07a-F07b (one 400mm culvert and one 600mm culvert, respectively) and F05-F06 (two 400mm culverts) are inadequate bottleneck points and are likely significantly contributing to flooding issues along this flow path. Culvert crossing F03-F04 (two 600mm culverts) have a 10-year service level due to low grades and are also causing a bottleneck at the 49A Avenue crossing during runoff events exceeding 10-years.

Photo 14 – Culvert F11 and F12 48 Street crossing inlet, facing east.

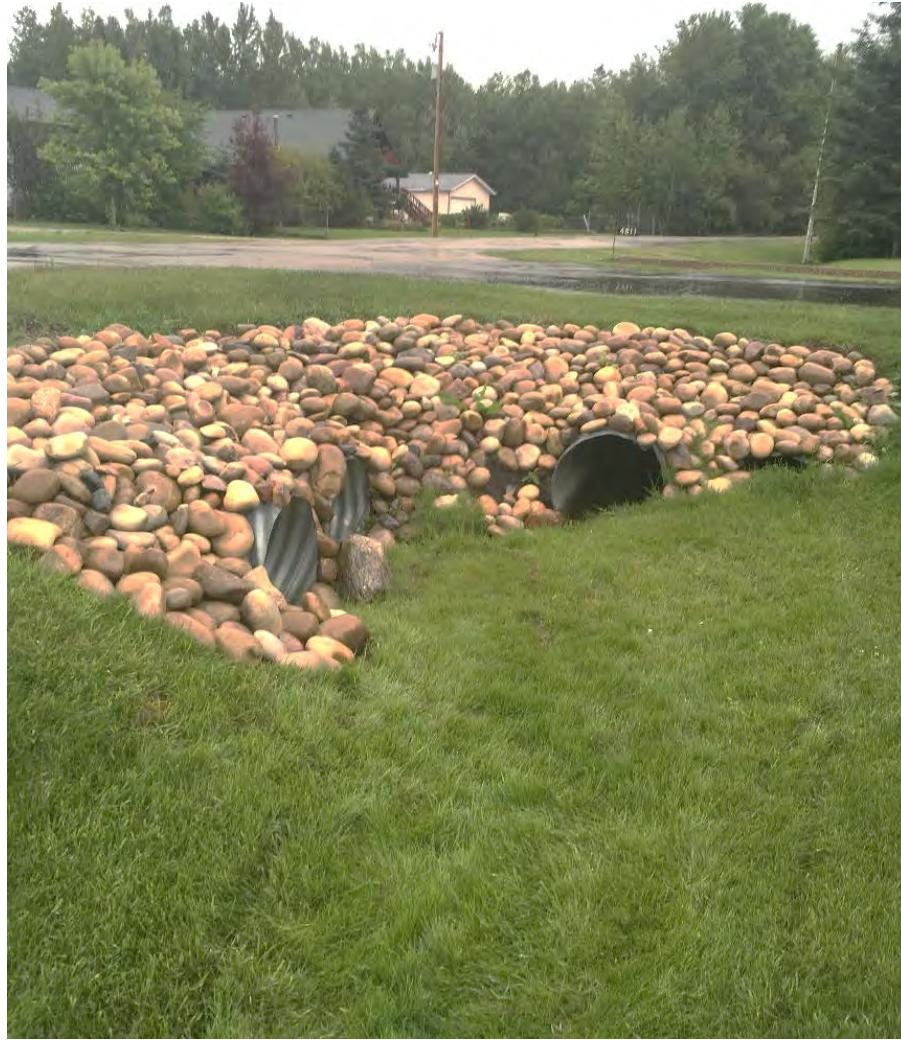
Photo 15 – F03 and F04 culvert inlet (left) and F05/F06 culvert outlet (right), facing east.

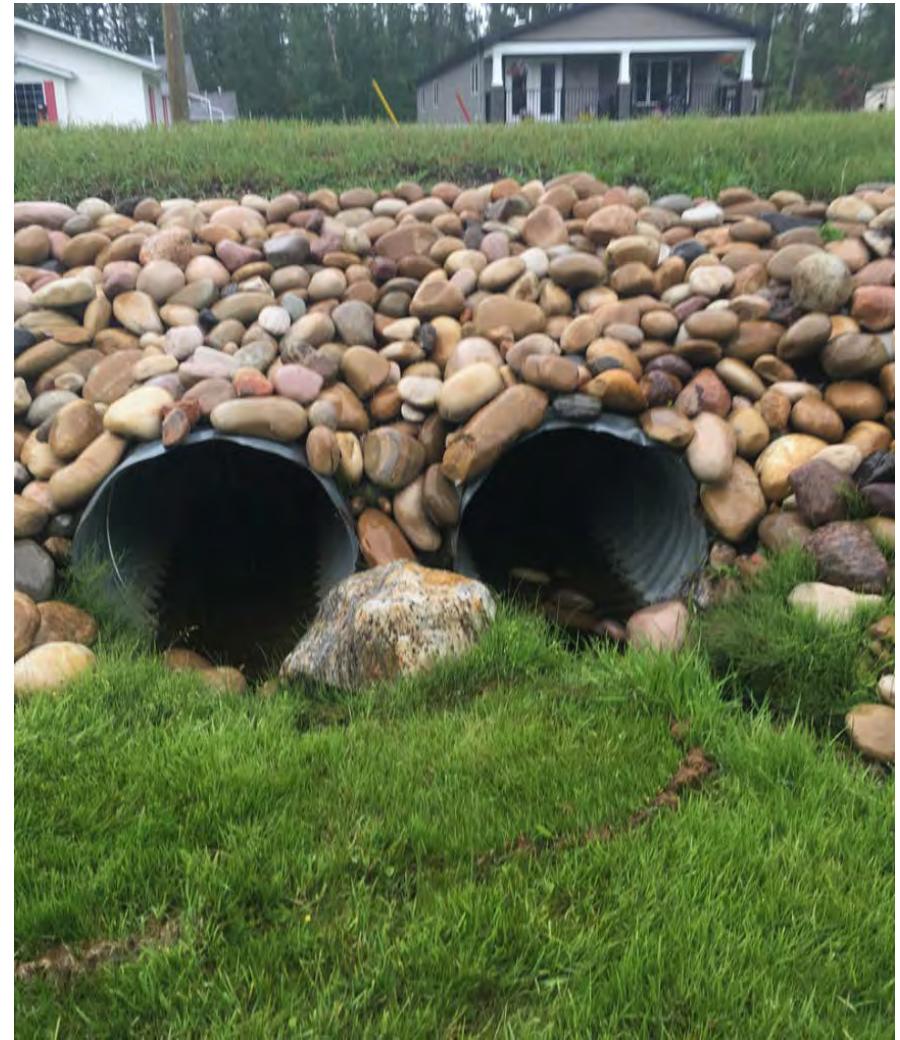
Photo 16 – F03 and F04 culvert inlet (facing north).

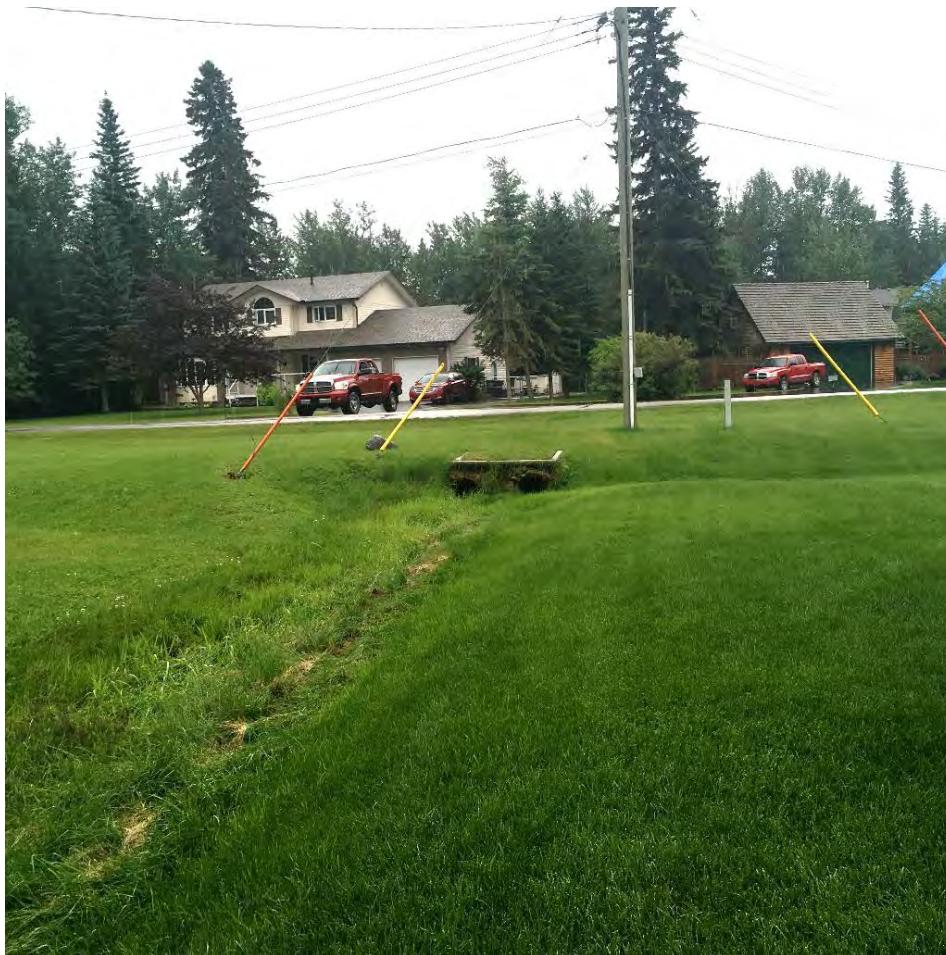
Photo 17 – Lot 7/8 swale and culvert F03 and F04 outlet, facing south.

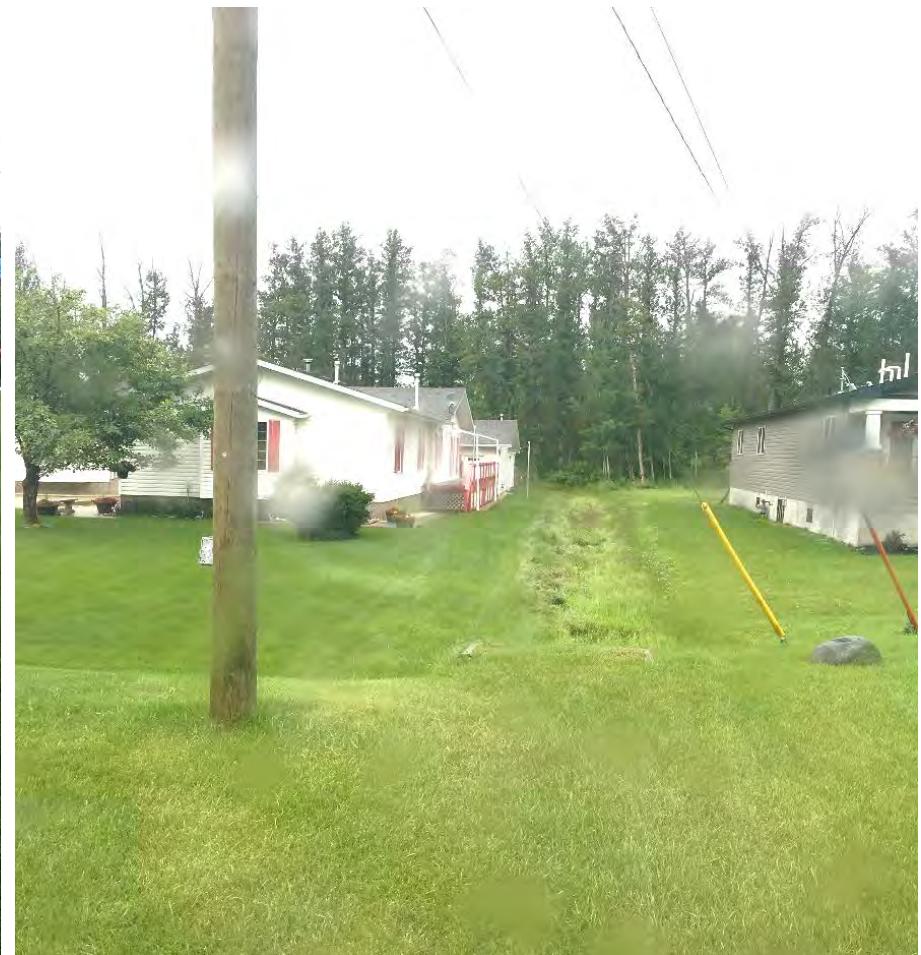
Photo 18 – Lot 7/8 swale facing north.

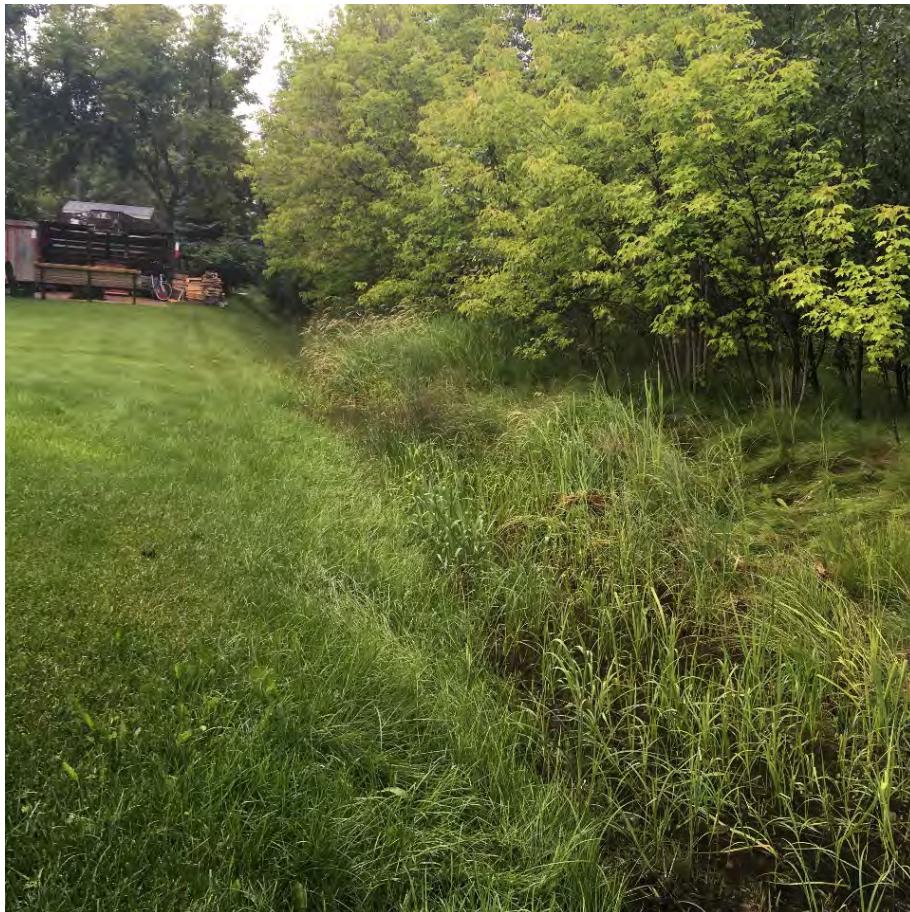
Photo 19 – Lot 7 rear lot ditch (to be filled), facing west.

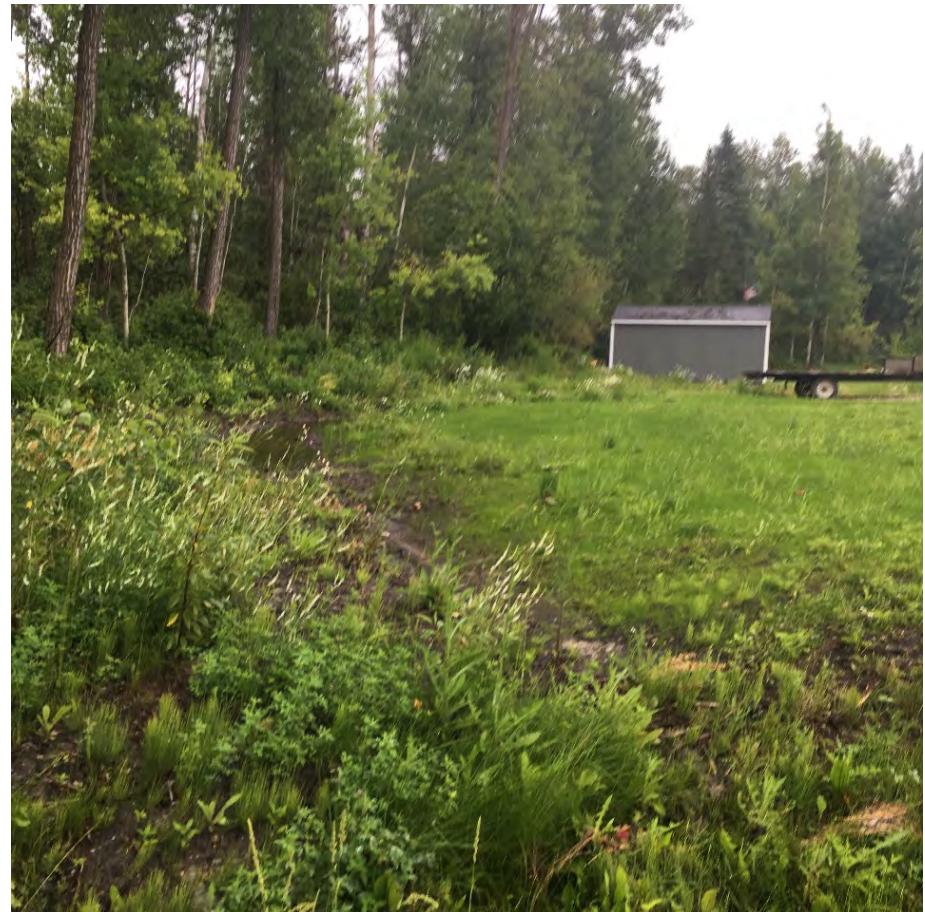
Photo 20 – Lot 8 rear lot ditch (to be filled), facing east.

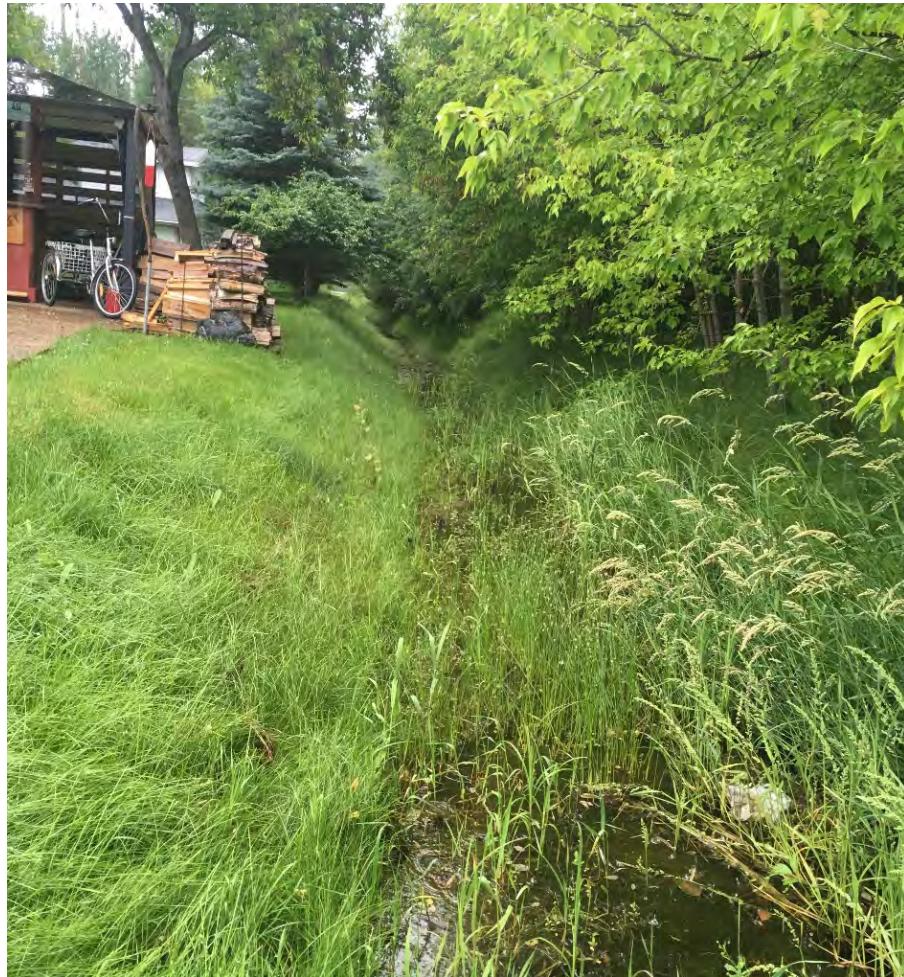
Photo 21 – Lot 7 rear lot ditch (to be filled), facing west toward Lot 6 and MR.

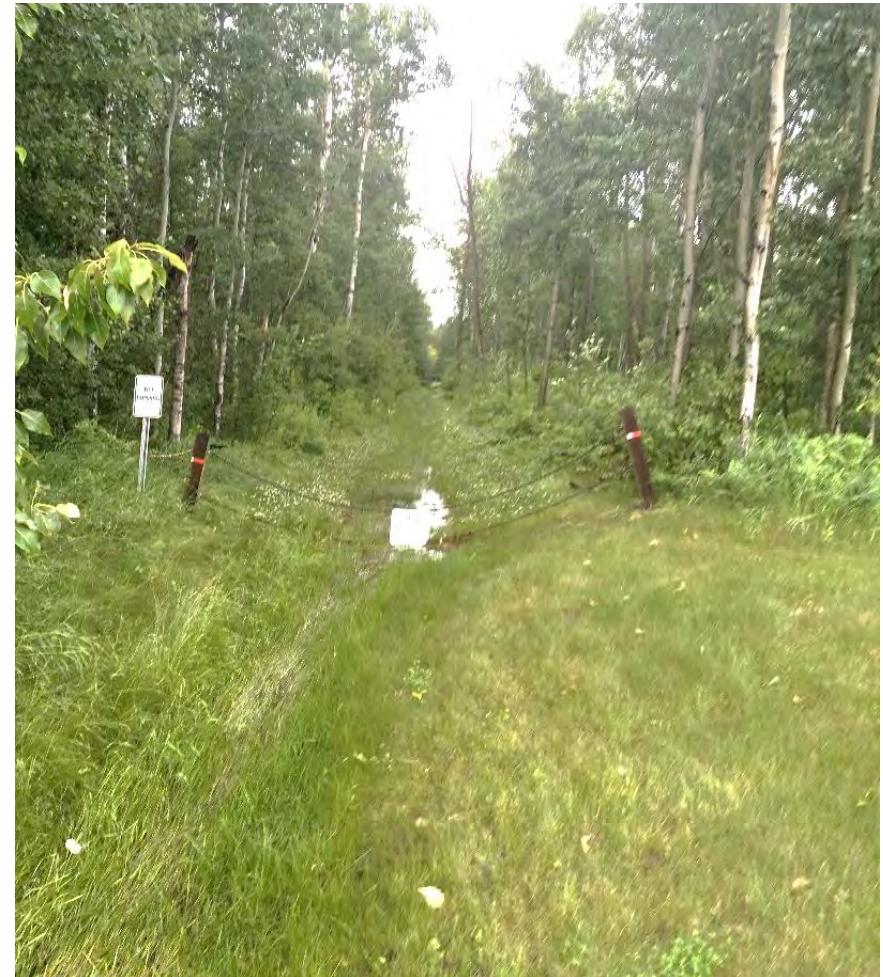
Photo 22 – Existing stormwater ditch through the MR, Major Flow Path F(i), facing east.

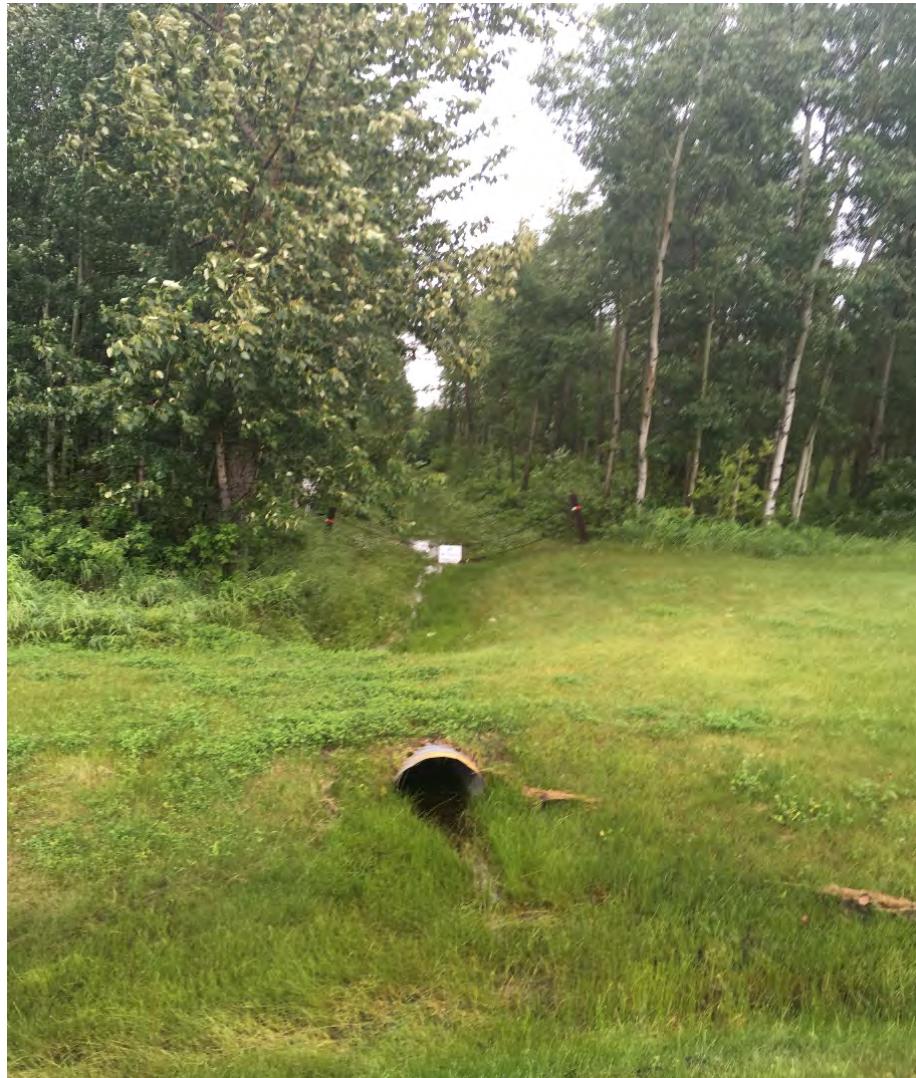
Photo 23 – Culvert F02 outlet (Sunset Drive Recreational Trail Crossing), facing east.

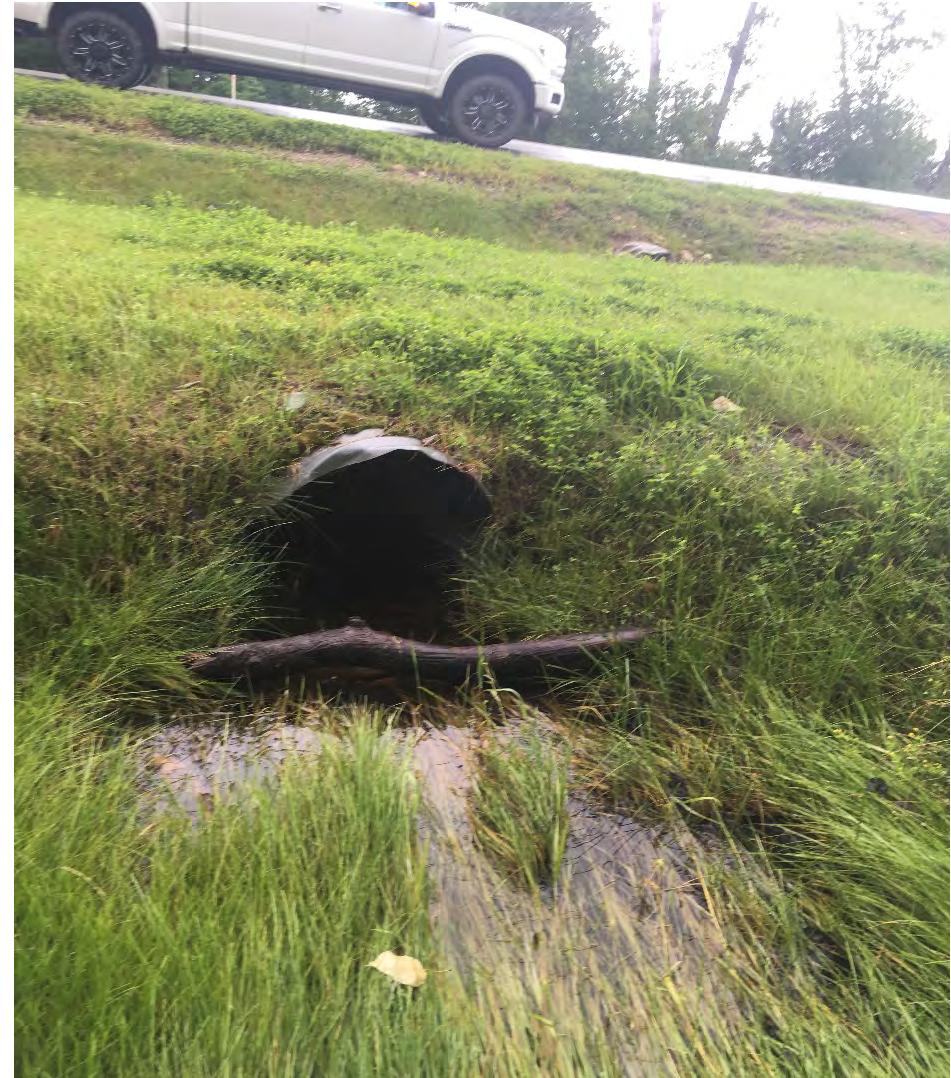
Photo 24 – Culvert F02 inlet, facing northwest.

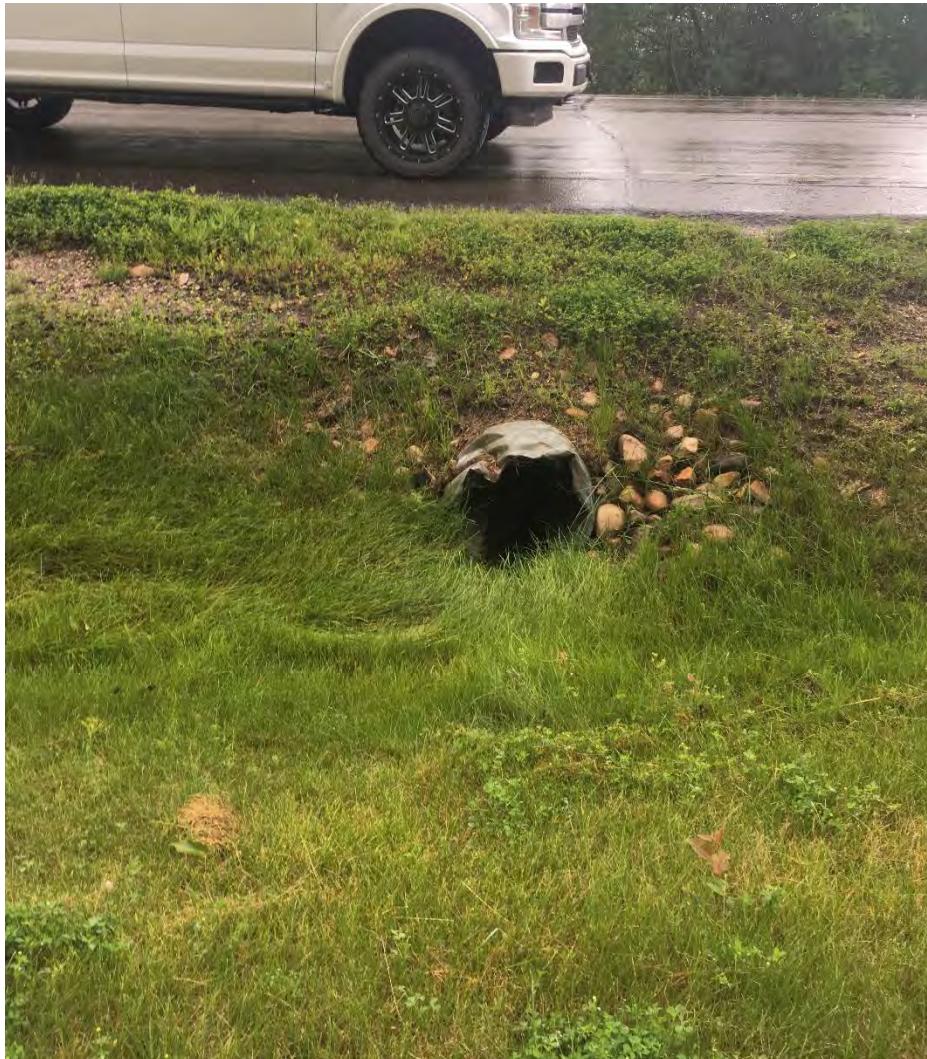
Photo 25 – Culvert F01 inlet, facing west.

6. Rehabilitate culvert F01 (crossing Sunset Drive) as required. Install a second major culvert crossing Sunset Drive so that the combined capacity of F01 and the new culvert (F01b) accommodates the proposed Drainage Parkway flows. F01 shall now be designated F01a, for clarity.
7. Rehabilitate and armour the ditch (P Ditch-03) at the outlet of culvert F01a and F01b as needed to ensure the flow path to the lake is accommodated within the existing road right of way and adequately protected from erosion and scour.

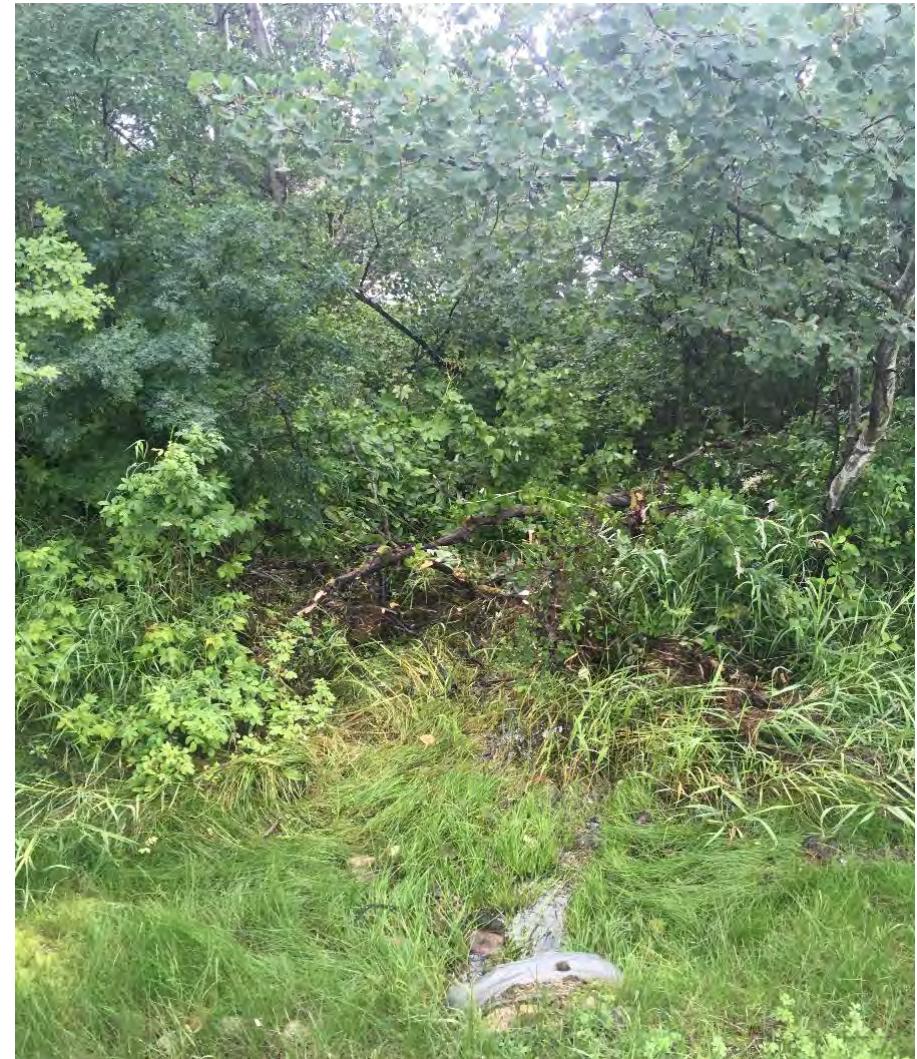
Photo 26 – Culvert F01 outlet, facing west.

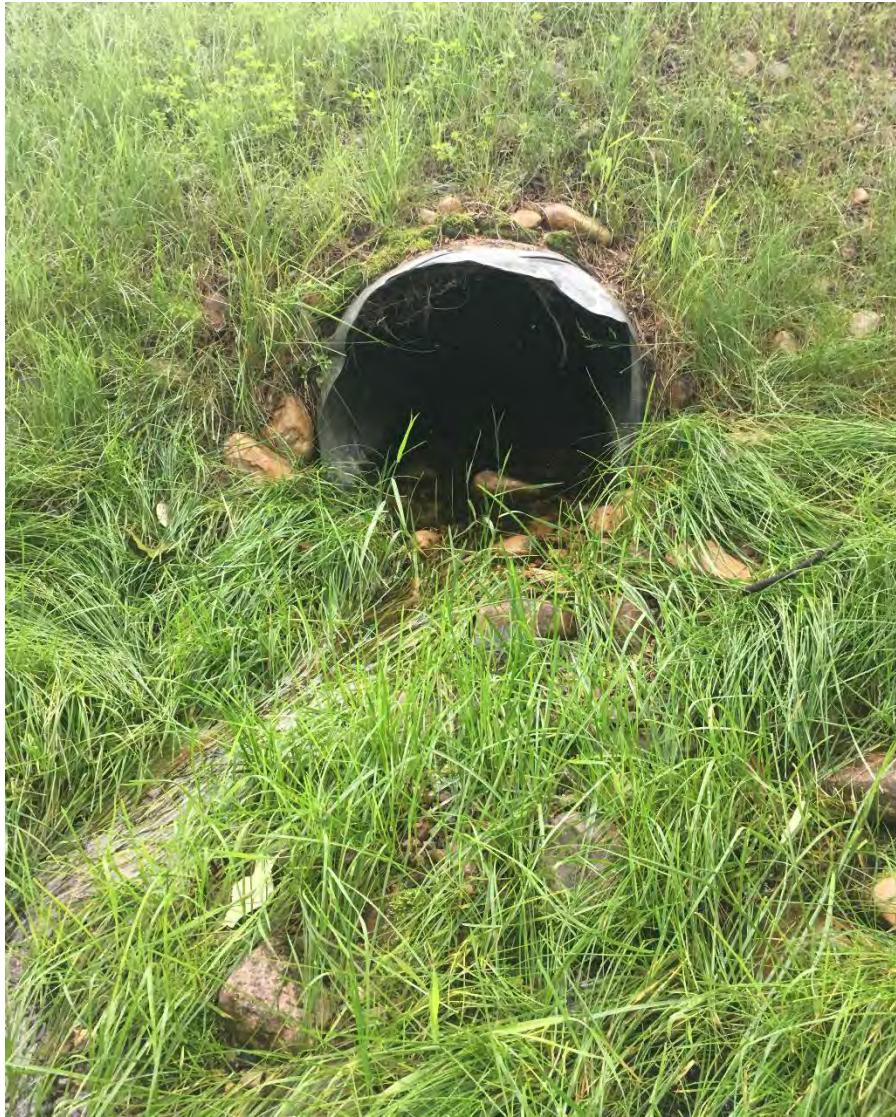
Photo 27 – Culvert F01 outlet, facing east.
