Stormwater Management Plan
Final Report - Issued for Approval

Summer Village of Sunset Point

Sections W26 54-3-5, NW23 54-3-5, and
NE22 54-3-5
Lac Ste. Anne County

*Summer Village of Sunset Point
June 2020*

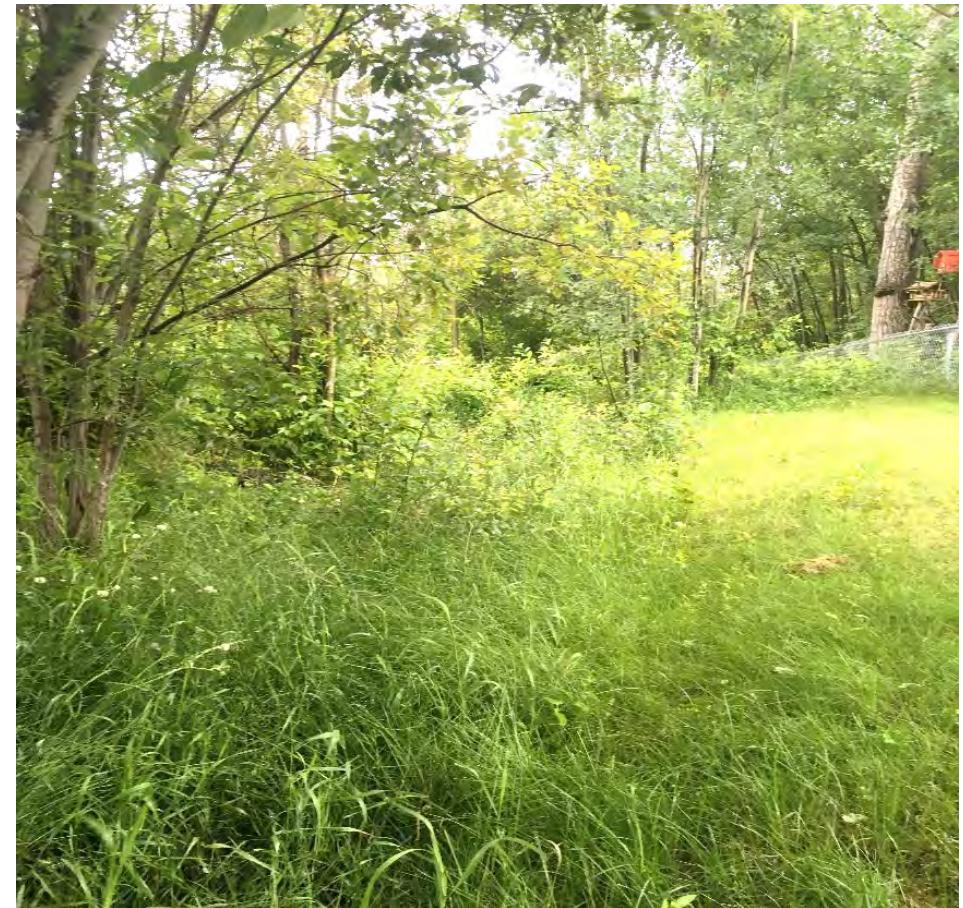
Photo 28 – Ditch along rear yard of Lots 20 and 21, Block 2 (49 Street),
Path I(i), facing south.

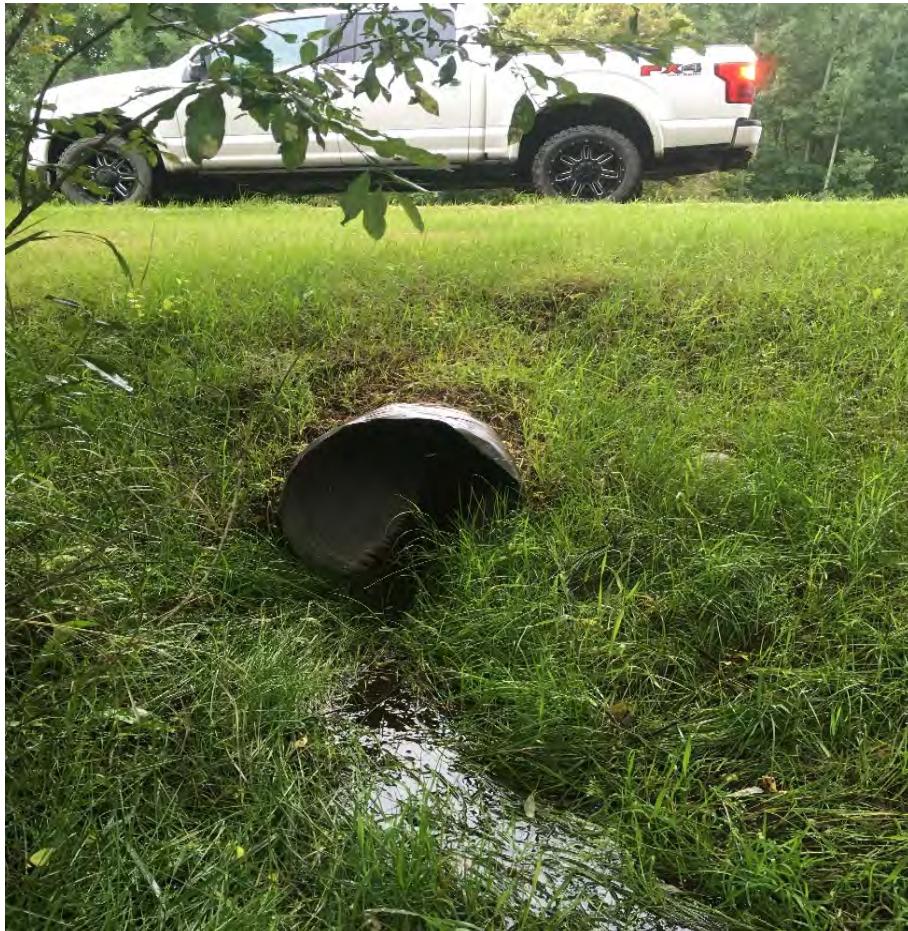
Photo 29 – Culvert I04 inlet, facing north

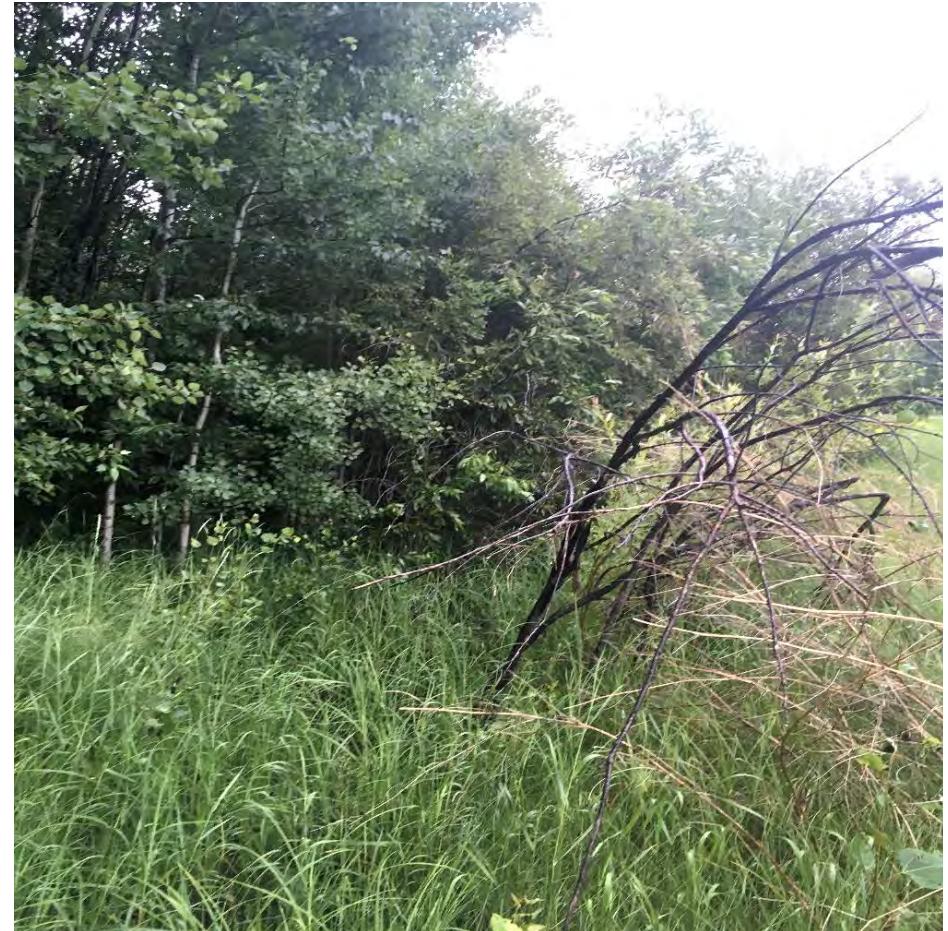
Photo 30 – Culvert I04 outlet, blocked by shrubs, facing east.

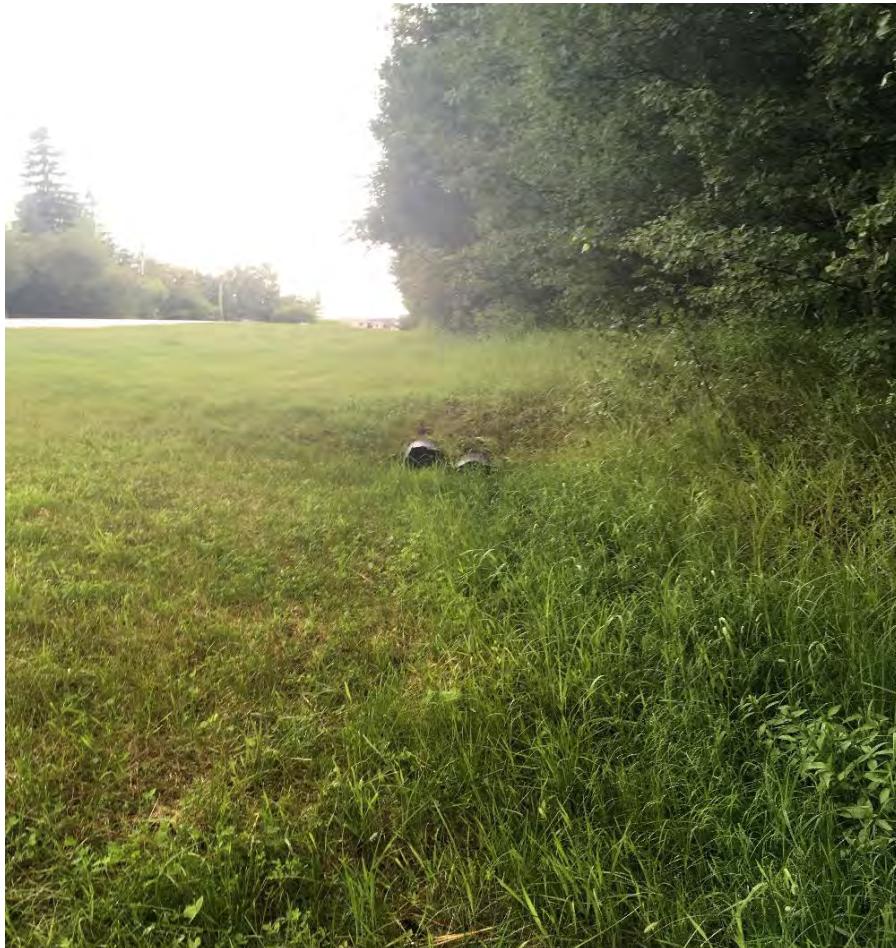
Photo 31 – Culvert I03/I02 inlet, facing west.

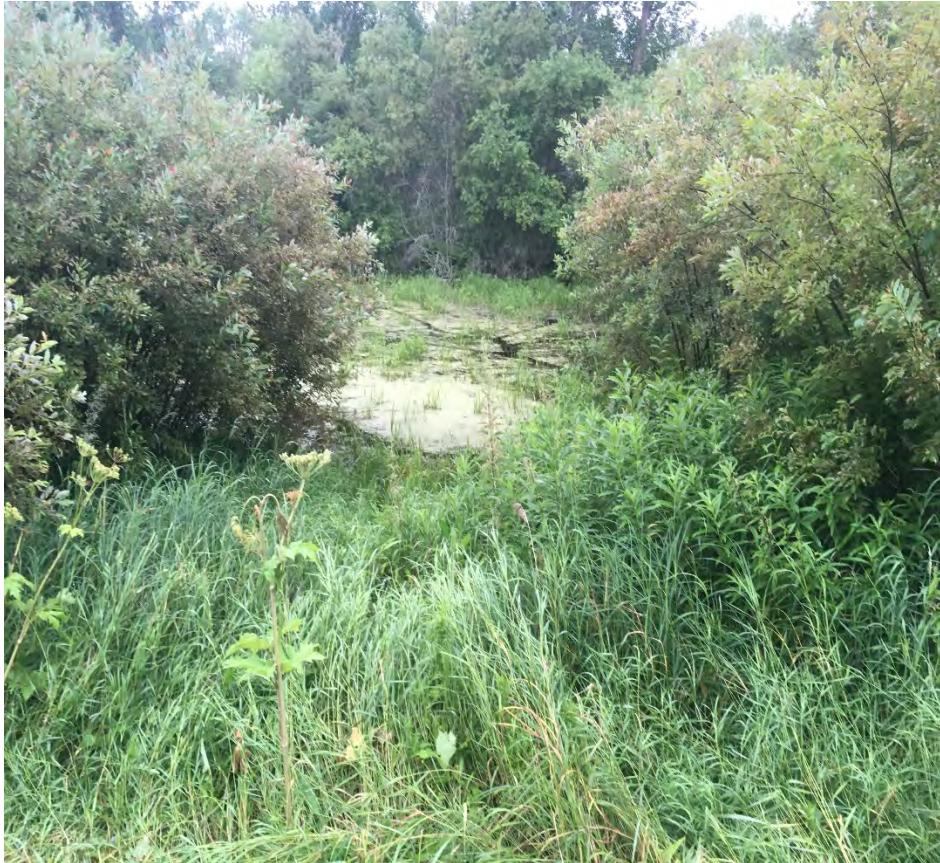
- ❖ Major Outlet I could not be located. It appears that the flow path enters a wetland on the east side of Ste. Anne Trail, but a culvert crossing could not be located, so it is unclear whether this flow path has been accommodated.

Photo 32 – Wetland at possible Flow Path I(i) crossing, no visible evidence of culvert crossing to Outlet I, facing east.

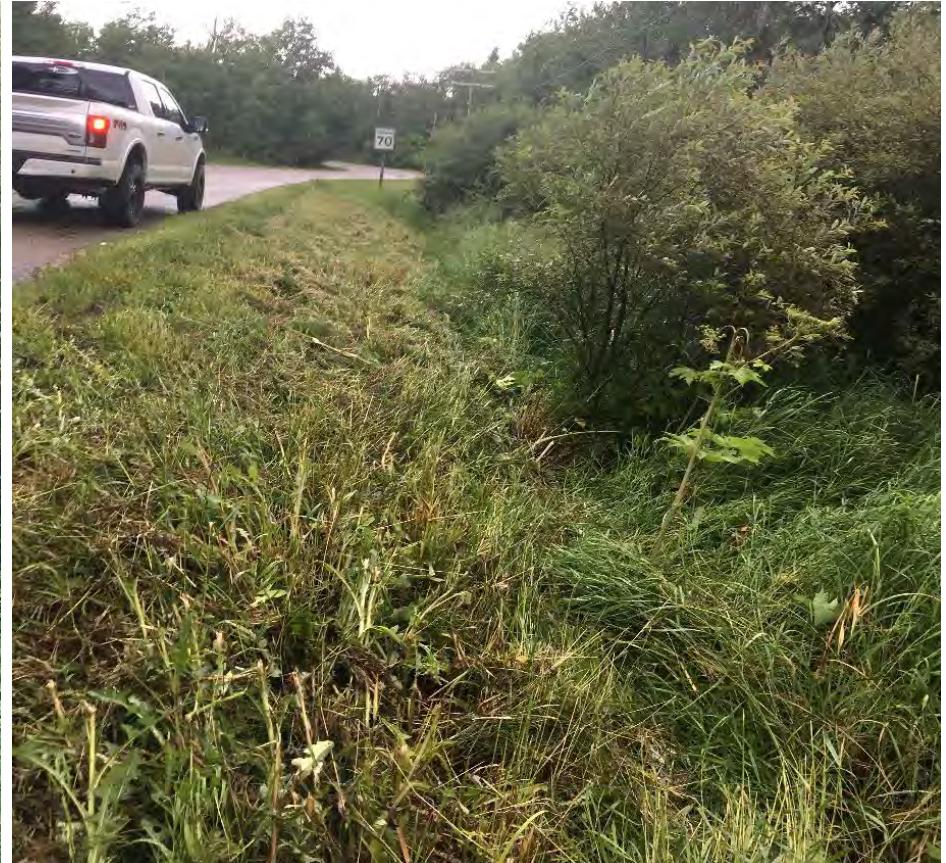
Photo 33 – East ditch of Sunset Drive/Ste. Anne Trail and Flow Path I(i), no visible evidence of culvert crossing to Outlet I, facing north.
