SE DESIGN AND CONSULTING INC.
ENGINEERS • CONSULTANTS • SURVEYORS

EXISTING INFRASTRUCTURE REVIEW

1. Drainage & Culvert Review

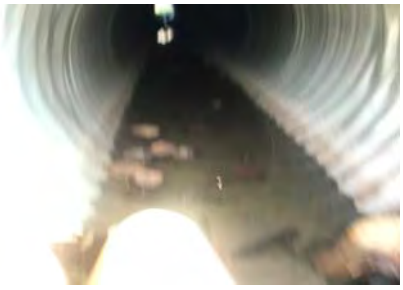
Roadway Over Pipe	Response
Pavement crackes or Patches	Yes
Sag in Roadway	No
Recent signs of high water	No
Amount of Cover (m)	0.3

Pipe Barrel	Rating
Blockage	No
Submerged in Water	No
Inlet Damage	No
Outlet damage	No
Corrosion / Abrasion	No
Out of Round	No
Settlement	No
Sag / Bow	No
Infiltration	No
Piping	No
Cracking	No

Capacity	Rating
Flow Path Type	Major
Function of size, slope and condition	<5 Year

No Backslope along ditch; risk of flow going into Lot.
Flow will be increased here due to changes upstream.

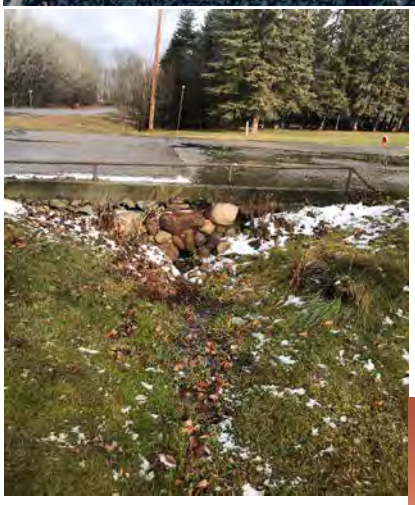
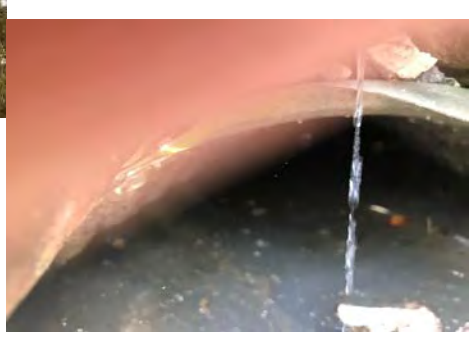
Inlet / Outlet Protection	Rating
Channel scour at Inlet/Outlet	No
Embankment Erosion	No
Sideslopes too Steep	No
Drift - wood, debris around pipe	No
Vegetation - trees, brush etc.	No
Silt	Yes
Rip Rap	None

Pipe Barrel	Rating
Blockage	No
Submerged in Water	Yes
Inlet Damage	No
Outlet damage	Yes
Corrosion / Abrasion	No
Out of Round	No
Settlement	No
Sag / Bow	No
Infiltration	No
Piping	No
Cracking	No

Capacity	Rating
Flow Path Type	Minor
Function of size, slope and condition	100 Year

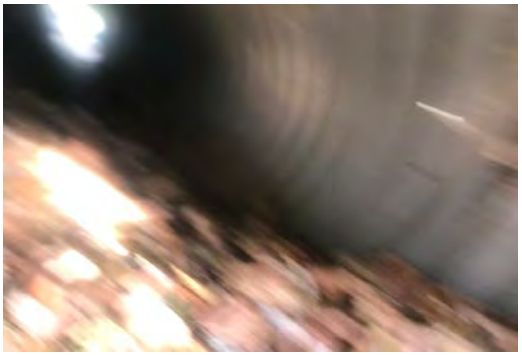
Pipe Barrel	Rating
Blockage	No
Submerged in Water	No
Inlet Damage	No
Outlet damage	No
Corrosion / Abrasion	No
Out of Round	No
Settlement	No
Sag / Bow	No
Infiltration	No
Piping	No
Cracking	No

Capacity	Rating
Flow Path Type	Major
Function of size, slope and condition	100

Culvert interior is in very good condition. Some water and little siltation. With future drainage re-direction upstream at the old railway embankment, this flow path will change from a Major Flow path to a Minor Flow path. Recommend once this culvert has aged and reached its design life, remove and will be replaced by 2674/F09.

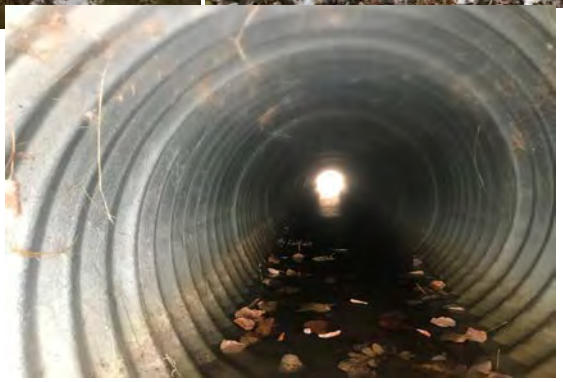
Comments
Culvert interior is in very good condition. Culverts stick out too much and need sloped ends. With future drainage re-direction upstream at the old railway embankment, this flow path will change from a Major Flow path to a Minor Flow path. Recommend once this culvert has aged and reached its design life, replace with one 800mm diameter culvert.

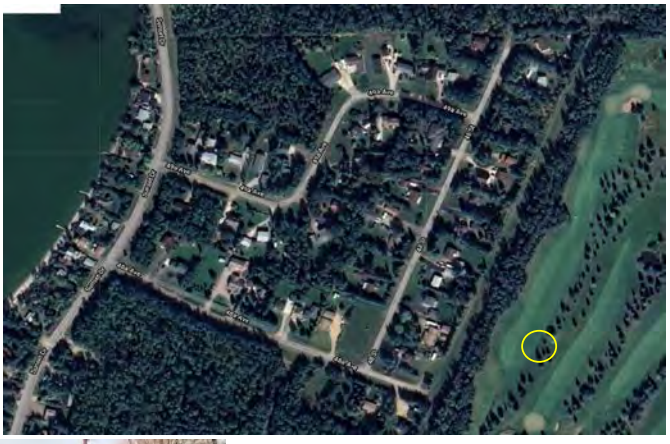
Culvert in very good condition. Ponding in the ditch due to poor ditch grading. Culvert is sticking out on one end which is hazardous.

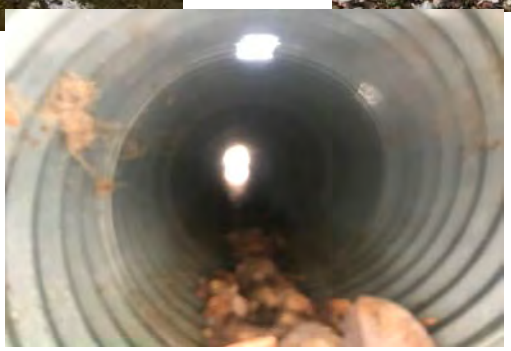
Pipe Barrel	Rating
Blockage	No
Submerged in Water	No
Inlet Damage	No
Outlet damage	No
Corrosion / Abrasion	No
Out of Round	No
Settlement	No
Sag / Bow	No
Infiltration	No
Piping	No
Cracking	No

Capacity	Rating
Flow Path Type	Major
Function of size, slope and condition	100 Year

Culvert interior is in very good condition. Culverts stick out too much and need sloped ends. With future drainage re-direction upstream at the old railway embankment, this flow path will change from a Major Flow path to a Minor Flow path. Recommend once this culvert has aged and reached its design life, replace with one 800mm diameter culvert.

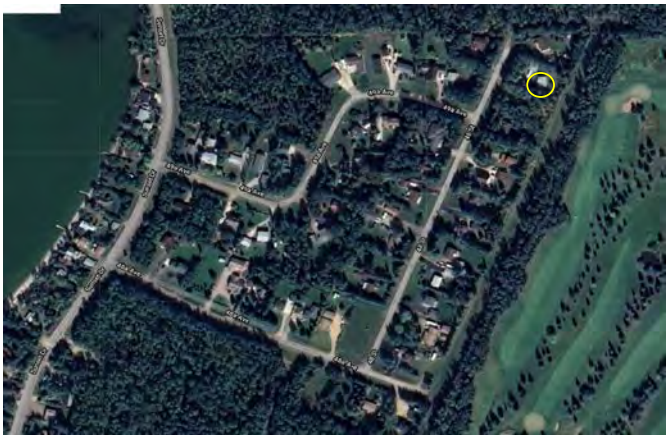
Overall Rating
12

Pipe Barrel	Rating
Blockage	Yes
Submerged in Water	No
Inlet Damage	Yes
Outlet damage	Yes
Corrosion / Abrasion	No
Out of Round	No
Settlement	No
Sag / Bow	No
Infiltration	No
Piping	No
Cracking	No

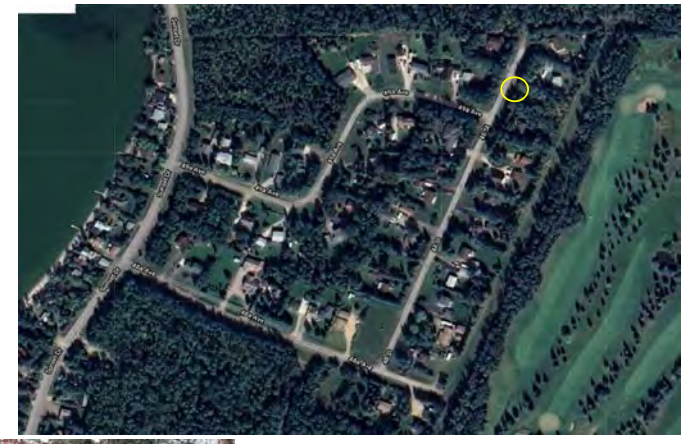
Overall Rating
3

Roadway Over Pipe	Response
Pavement Cracks or Patches	Yes
Sag in Roadway	No
Recent signs of high water	No
Amount of Cover (m)	0.35

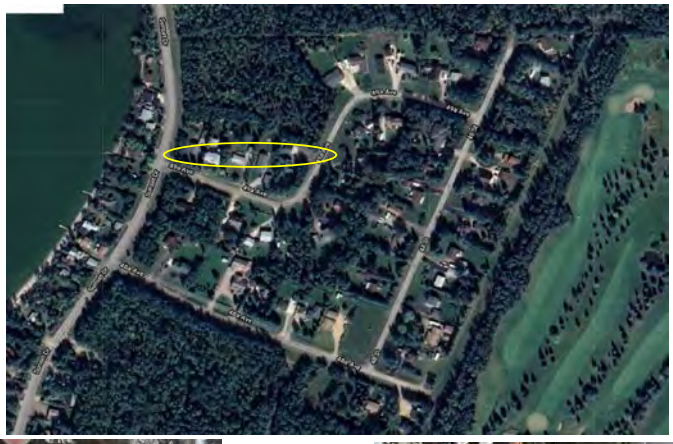
Overall Rating
6

Roadway Over Pipe	Response
Pavement Cracks or Patches	No
Sag in Roadway	No
Recent signs of high water	No
Amount of Cover (m)	0.00

Pipe Barrel	Rating
Blockage	No
Submerged in Water	No
Inlet Damage	Yes
Outlet damage	Yes
Corrosion / Abrasion	No
Out of Round	No
Settlement	No
Sag / Bow	No
Infiltration	No
Piping	No
Cracking	No

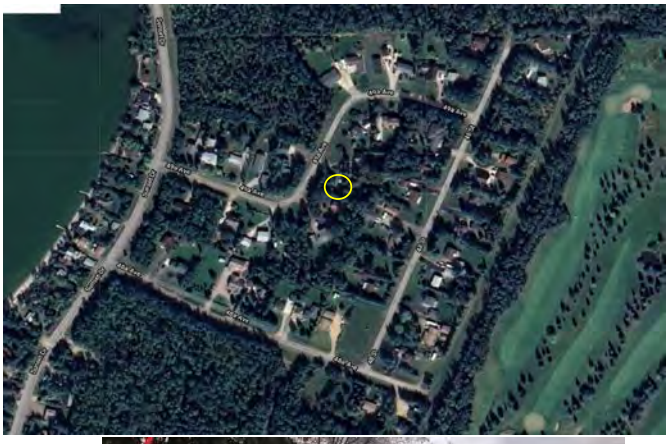
Overall Rating
6

Pipe Barrel	Rating
Blockage	No
Submerged in Water	No
Inlet Damage	No
Outlet damage	No
Corrosion / Abrasion	Yes
Out of Round	No
Settlement	No
Sag / Bow	No
Infiltration	No
Piping	No
Cracking	No

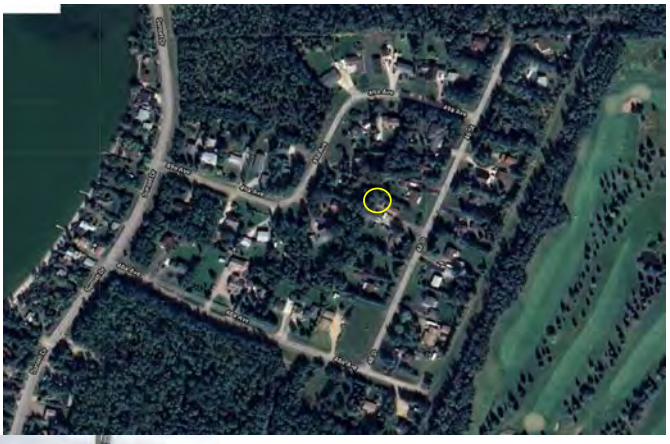
Overall Rating
6

Inlet / Outlet Protection	Rating
Channel scour at Inlet/Outlet	No
Embankment Erosion	No
Sideslopes too Steep	No
Drift - wood, debris around pipe	No
Vegetation - trees, brush etc.	No
Silt	Yes
Rip Rap	None

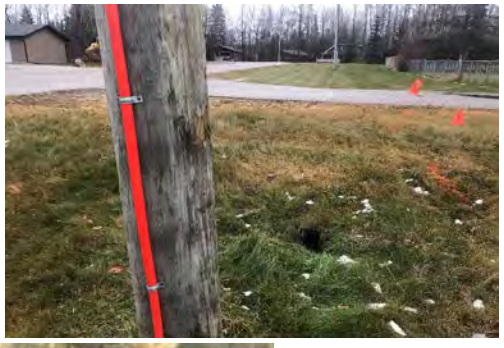
Pipe Barrel	Rating
Blockage	**Yes**
Submerged in Water	No
Inlet Damage	No
Outlet damage	No
Corrosion / Abrasion	No
Out of Round	No
Settlement	No
Sag / Bow	No
Infiltration	No
Piping	No
Cracking	No

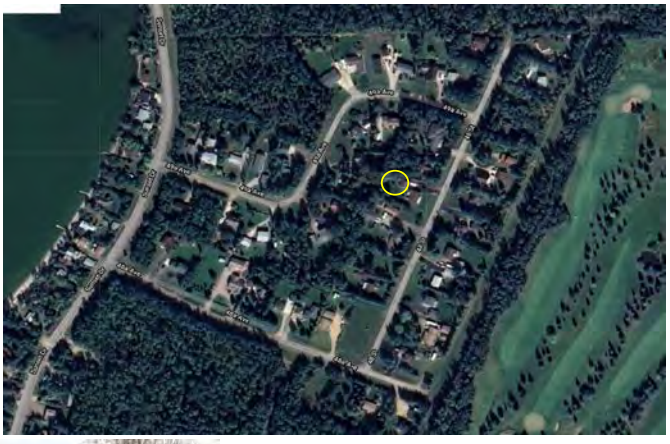
Overall Rating
3

Pipe Barrel	Rating
Blockage	No
Submerged in Water	No
Inlet Damage	No
Outlet damage	No
Corrosion / Abrasion	No
Out of Round	Yes
Settlement	No
Sag / Bow	No
Infiltration	No
Piping	No
Cracking	No

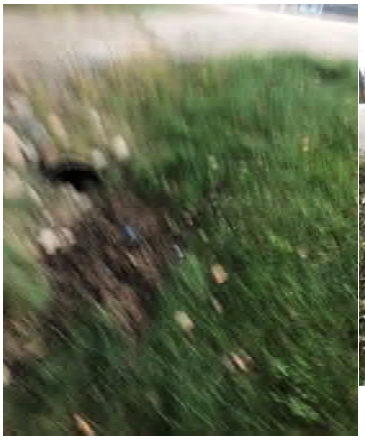
Inlet / Outlet Protection	Rating
Channel scour at Inlet/Outlet	No
Embankment Erosion	No
Sideslopes too Steep	No
Drift - wood, debris around pipe	No
Vegetation - trees, brush etc.	No
Silt	No
Rip Rap	Needs Aprons

Capacity	Rating
Flow Path Type	Minor
Function of size, slope and condition	100-Year

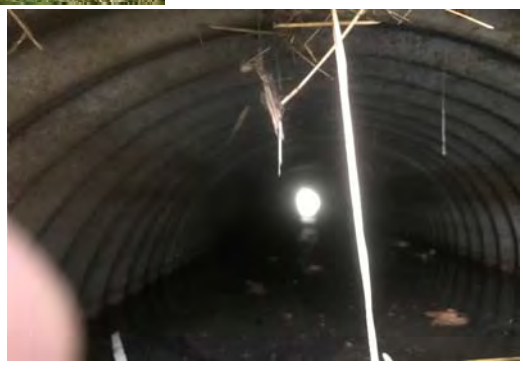
Comments
Culvert is in fair to good condition. Need to clean out heavy grass at inlet and outlet. Widen out ditch. Re-check elevations as there is too much water being held within pipe which lowers capacity. Culvert needs sloped end on outlet side. Recommend once this culvert has aged and reached its design life, replace with one 800mm diameter culvert.

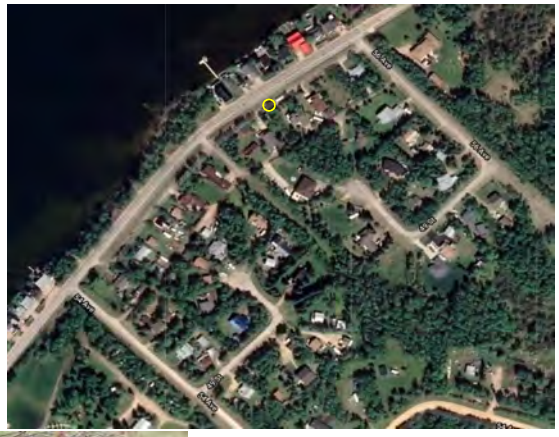
Overall Rating
7

Inlet / Outlet Protection	Rating
Channel scour at Inlet/Outlet	No
Embankment Erosion	No
Sideslopes too Steep	No
Drift - wood, debris around pipe	No
Vegetation - trees, brush etc.	Yes
Silt	No
Rip Rap	None

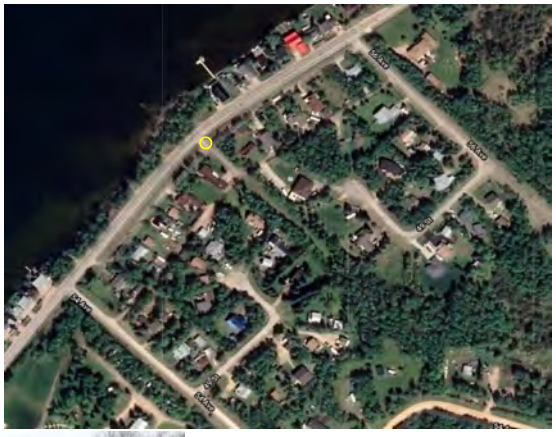
Overall Rating
7

Inlet / Outlet Protection	Rating
Channel scour at Inlet/Outlet	No
Embankment Erosion	No
Sideslopes too Steep	No
Drift - wood, debris around pipe	No
Vegetation - trees, brush etc.	Yes
Silt	No
Rip Rap	None

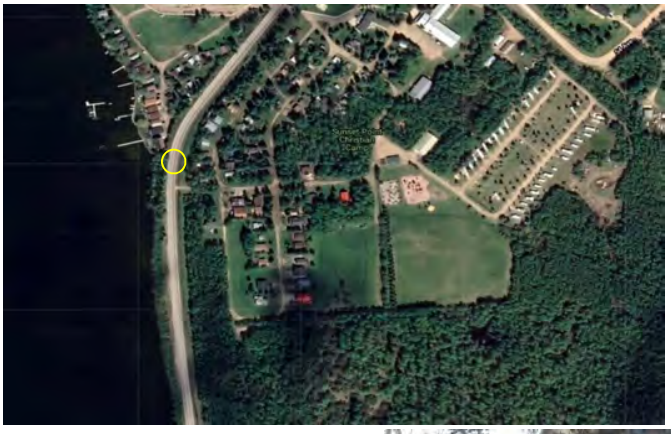
Overall Rating
11

Inlet / Outlet Protection	Rating
Channel scour at Inlet/Outlet	No
Embankment Erosion	No
Sideslopes too Steep	Yes
Drift - wood, debris around pipe	No
Vegetation - trees, brush etc.	Yes
Silt	No
Rip Rap	None

Pipe Barrel	Rating
Blockage	No
Submerged in Water	No
Inlet Damage	Yes
Outlet damage	No
Corrosion / Abrasion	Some
Out of Round	No
Settlement	No
Sag / Bow	No
Infiltration	No
Piping	No
Cracking	No

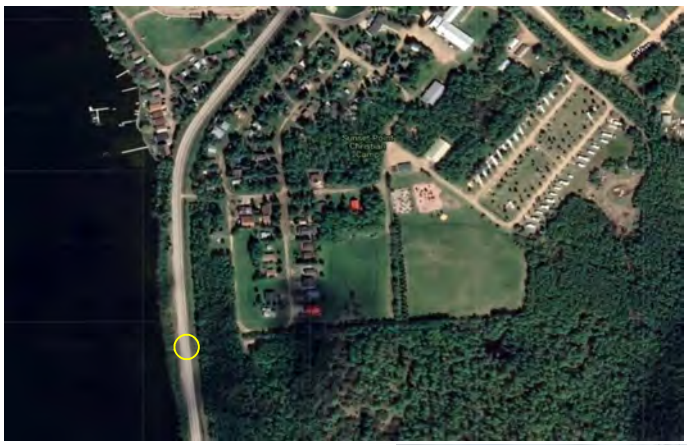
This crossing is for a Minor Flow Path from the Christian Camp. The existing 600mm Dia. culvert is near capacity for a 25-Year Storm and it is recommended that it be upgraded to at least an 800mm Dia. CSP when time for this culvert to be replaced. If more development to occur upstream, this crossing should be reviewed in order to determine if this crossing is sufficient. Culvert should be longer with sloped ends and sideslopes should be flattened. Ideally, 2 - 800mm Dia. CSPs should be installed.

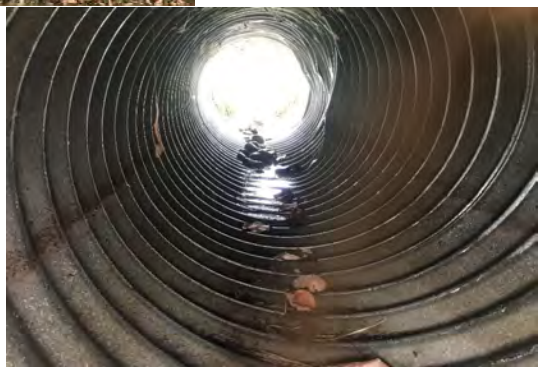
Capacity	Rating
Flow Path Type	Major
Function of size, slope and condition	10-Year

This culvert wil need to be replaced in conjunction with Culvert 2713, the centerline culvert under Sunset Drive. To match the centreline culvert, this culvert should be replaced with 2 800mm diameter CSPs.

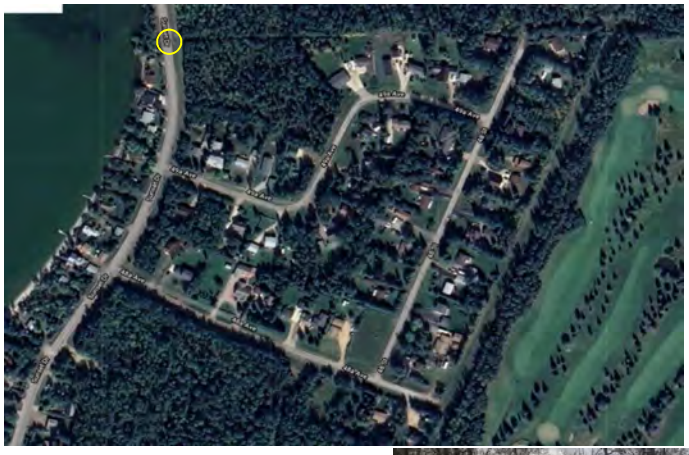
This crossing is for a Major Flow Path for the subdivision in the 49A Avenue and 48th Street area. The existing 600mm Dia. culvert is too small and needs to be lowered by 0.8m at the inlet and 0.4m at the outlet in order to improvement flow upstream. Recommend 2 - 800mm Dia. CSPs since more flow may be directed this way in future. Needs sloped ends with rip rap. Make longer 1m per end. Replacement is part of PROJECT #1 as a larger improvement project. Sideslopes should be flattened.

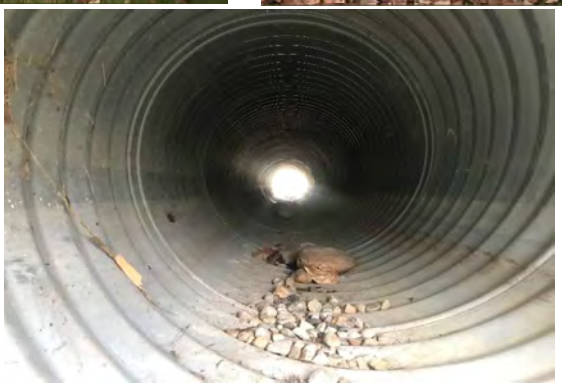
Pipe Barrel	Rating
Blockage	No
Submerged in Water	No
Inlet Damage	Yes
Outlet damage	No
Corrosion / Abrasion	No
Out of Round	No
Settlement	No
Sag / Bow	No
Infiltration	No
Piping	No
Cracking	No

Capacity	Rating
Flow Path Type	**MAJOR**
Function of size, slope and condition	**5-Year**

Culvert appears to be in good condition but undersized for re-directed flow and future development. Small culvert that should be larger just to maintain flow and availability for cleaning out. Part of **PROJECT #1 improvements. Recommend to install new 800mm Dia. CSP in parallel.**

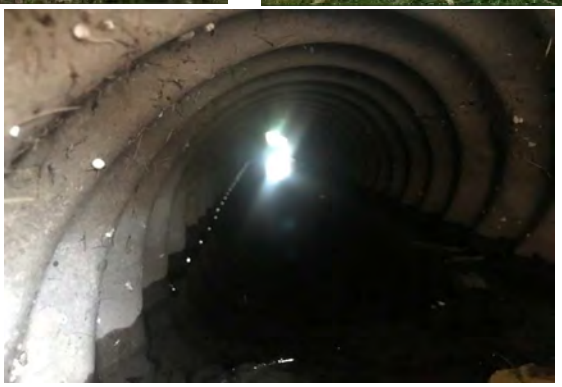
Pipe Barrel	Rating
Blockage	No
Submerged in Water	No
Inlet Damage	No
Outlet damage	No
Corrosion / Abrasion	Yes
Out of Round	No
Settlement	No
Sag / Bow	No
Infiltration	No
Piping	No
Cracking	No

Culvert appears to be in fair to good condition but undersized. When time to be replaced, replace with 500mm Dia. CSP with sloped ends with rip rap.

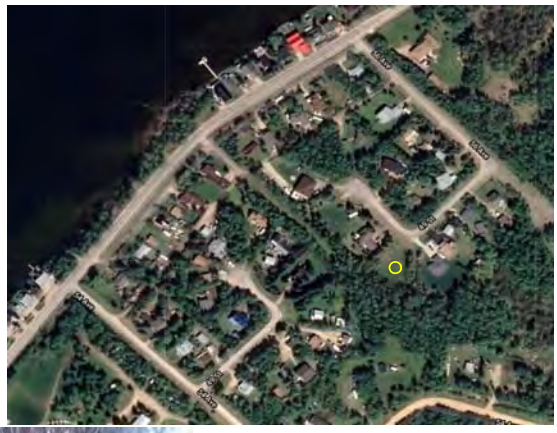
Overall Rating
5

Inlet / Outlet Protection	Rating
Channel scour at Inlet/Outlet	No
Embankment Erosion	No
Sideslopes too Steep	No
Drift - wood, debris around pipe	No
Vegetation - trees, brush etc.	Yes
Silt	Some
Rip Rap	None

Culvert is in good condition. Culvert needs sloped ends. Recommend once this culvert has aged and reached its design life, replace with one 500mm diameter culvert. Ensure more slope in culvert.

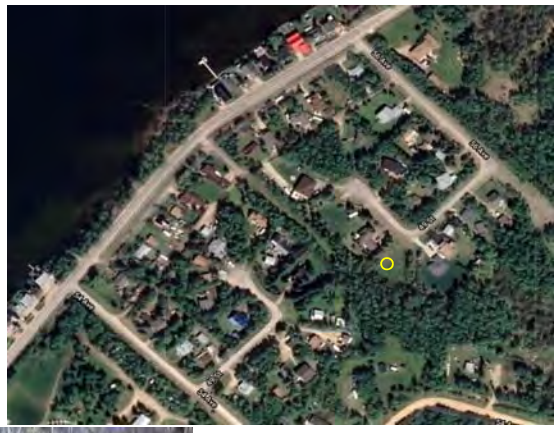
Overall Rating
4

Pipe Barrel	Rating
Blockage	No
Submerged in Water	No
Inlet Damage	Yes
Outlet damage	No
Corrosion / Abrasion	No
Out of Round	No
Settlement	No
Sag / Bow	No
Infiltration	No
Piping	No
Cracking	No

Culvert is in good condition. Culvert needs sloped ends. Recommend once this culvert has aged and reached its design life, replace with one 500mm diameter culvert.

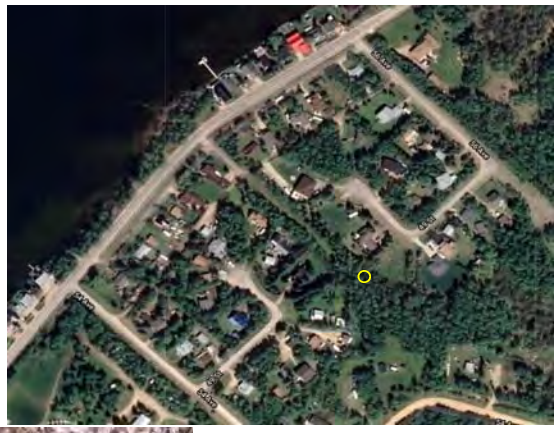
Overall Rating
3

Culvert is in good condition. Homemade opening between culverts should be replaced with proper catchbasin or drop inlet. Culvert needs sloped end on outlet side. Recommend once this culvert has aged and reached its design life, replace with one 500mm diameter culvert.

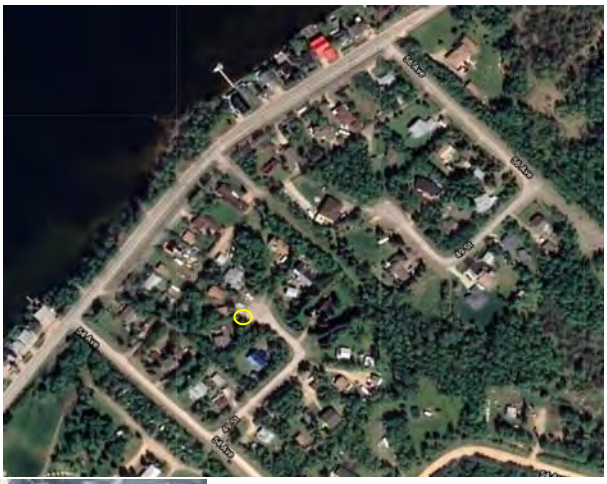
Overall Rating
5

Culvert is in good condition. Inlet is near blocked and needs maintenance. Homemade opening between culverts should be replaced with proper catchbasin or drop inlet. Culvert needs sloped end on inlet side. Recommend once this culvert has aged and reached its design life, replace with one 500mm diameter culvert.

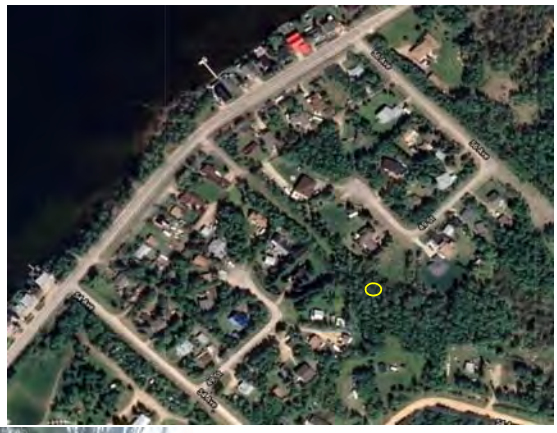
Overall Rating
7

Pipe Barrel	Rating
Blockage	Yes
Submerged in Water	No
Inlet Damage	No
Outlet damage	No
Corrosion / Abrasion	No
Out of Round	No
Settlement	No
Sag / Bow	No
Infiltration	No
Piping	No
Cracking	No

Culvert is in good condition. Inlet and outlet are near blocked and needs maintenance. Culverts need sloped ends. Recommend once this culvert has aged and reached its design life, replace with one 500mm diameter culvert.

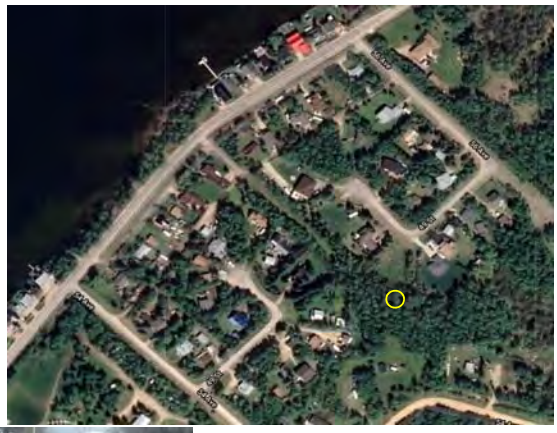
Overall Rating
7

Pipe Barrel	Rating
Blockage	Yes
Submerged in Water	No
Inlet Damage	No
Outlet damage	No
Corrosion / Abrasion	No
Out of Round	No
Settlement	No
Sag / Bow	No
Infiltration	No
Piping	No
Cracking	No

Culvert is in good condition. Inlet is near blocked and needs maintenance. Culverts need sloped ends. Recommend once this culvert has aged and reached its design life, replace with one 500mm diameter culvert.

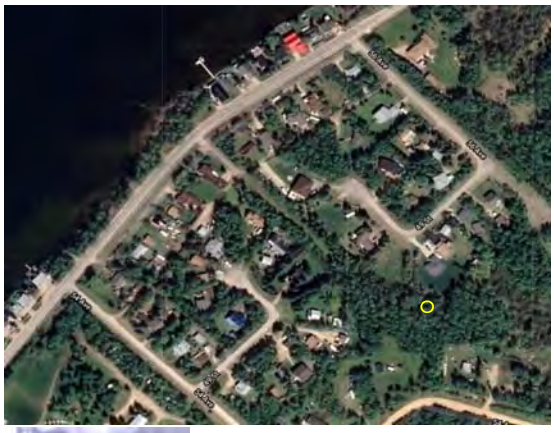
Overall Rating
3

Pipe Barrel	Rating
Blockage	No
Submerged in Water	No
Inlet Damage	Yes
Outlet damage	No
Corrosion / Abrasion	No
Out of Round	No
Settlement	No
Sag / Bow	No
Infiltration	No
Piping	No
Cracking	No

Culvert is in good condition. Culvert needs sloped ends. Recommend once this culvert has aged and reached its design life, replace with one 500mm diameter culvert.

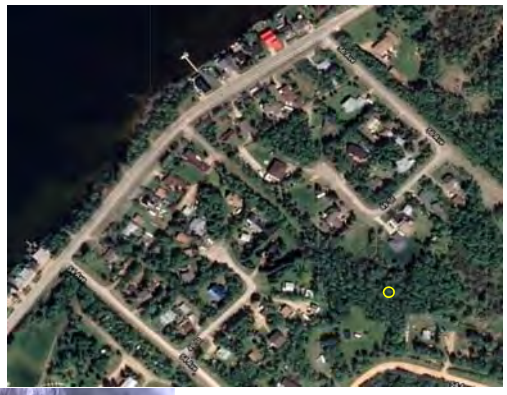
Overall Rating
5

Cannot see through. Maybe be blocked. Culvert is in good condition. Culvert needs sloped end on outlet side. Recommend once this culvert has aged and reached its design life, replace with one 500mm diameter culvert.

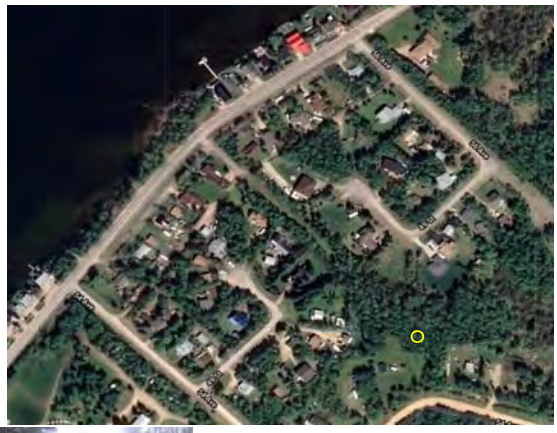
Overall Rating
3

Culvert is in fair condition. Culvert needs sloped end on outlet side. Recommend once this culvert has aged and reached its design life, replace with one 500mm diameter culvert.

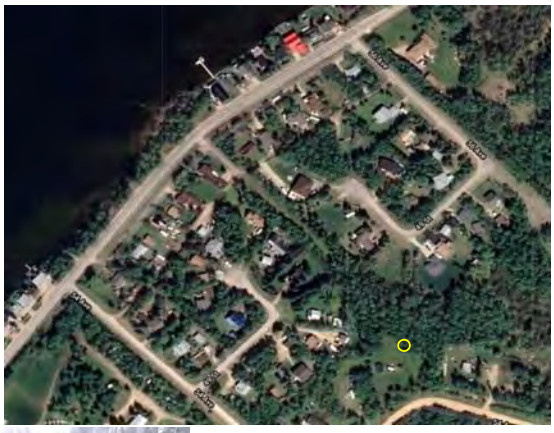
Overall Rating
4

Pipe Barrel	Rating
Blockage	No
Submerged in Water	Partial
Inlet Damage	No
Outlet damage	No
Corrosion / Abrasion	No
Out of Round	No
Settlement	No
Sag / Bow	No
Infiltration	No
Piping	No
Cracking	No

Culvert is in fair condition. Inlet and Outlet areas need to be cleared out so water flows better and does not sit inside culvert. Culvert needs sloped end on outlet side. Recommend once this culvert has aged and reached its design life, replace with one 500mm diameter culvert.

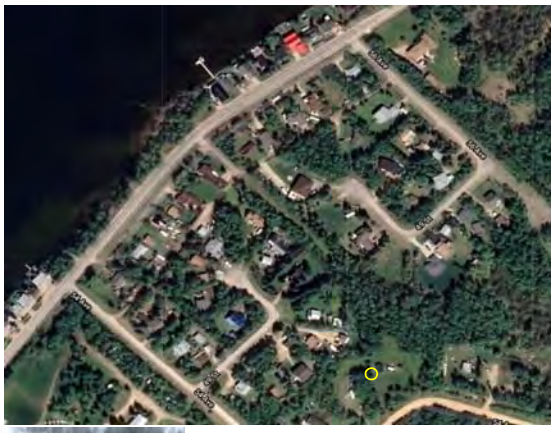
Overall Rating
3

Culvert is in fair to good condition. Culvert needs sloped end on outlet side. Recommend once this culvert has aged and reached its design life, replace with one 500mm diameter culvert.

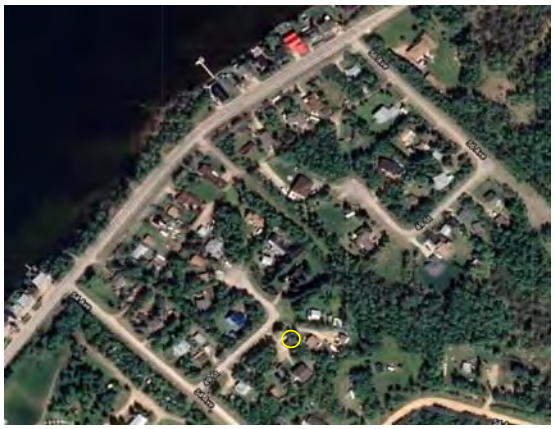
Overall Rating
2

Culvert is in good condition. Culverts need sloped ends. Recommend once this culvert has aged and reached its design life, replace with one 500mm diameter culvert.

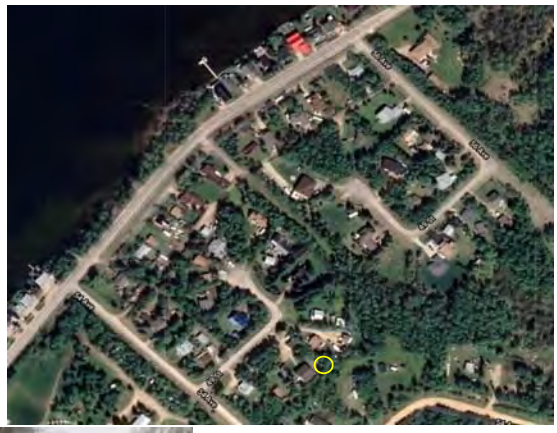
Overall Rating
5

Pipe Barrel	Rating
Blockage	No
Submerged in Water	No
Inlet Damage	No
Outlet damage	Yes
Corrosion / Abrasion	No
Out of Round	No
Settlement	No
Sag / Bow	No
Infiltration	No
Piping	No
Cracking	No

Culvert is in good condition. Culverts need sloped ends. Recommend once this culvert has aged and reached its design life, replace with one 500mm diameter culvert.

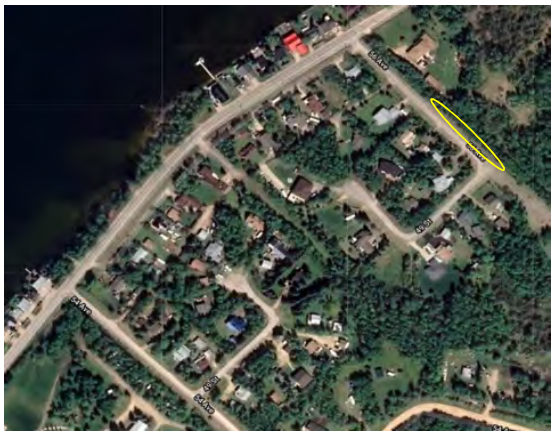
Culvert is in fair condition but small in size. **INCLUDED IN PROJECT #3. Proiect # 3 indicates replacing this culvert with an 800mm Dia. CSP with sloped ends.**

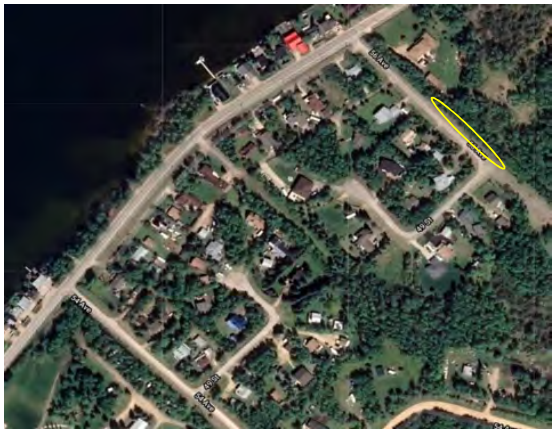
Overall Rating
9

Pipe Barrel	Rating
Blockage	No
Submerged in Water	No
Inlet Damage	Yes
Outlet damage	No
Corrosion / Abrasion	Yes
Out of Round	No
Settlement	No
Sag / Bow	No
Infiltration	No
Piping	No
Cracking	No

Culvert is in fair condition but small in size. **INCLUDED IN PROJECT #3. Proiect # 3 indicates replacing this culvert with an 800mm Dia. CSP with sloped ends.**

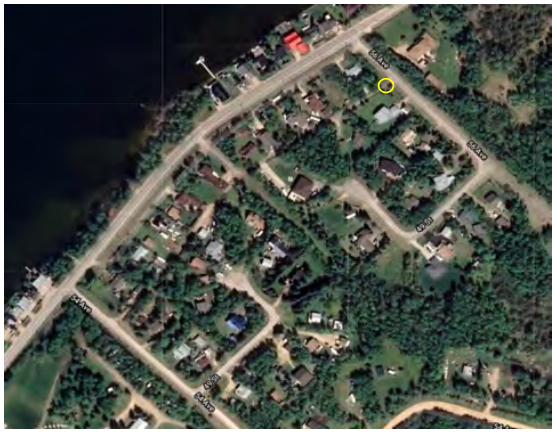
Culvert is in fair to good condition. Culverts need sloped ends. Recommend once this culvert has aged and reached its design life, replace with one 600mm diameter culvert.

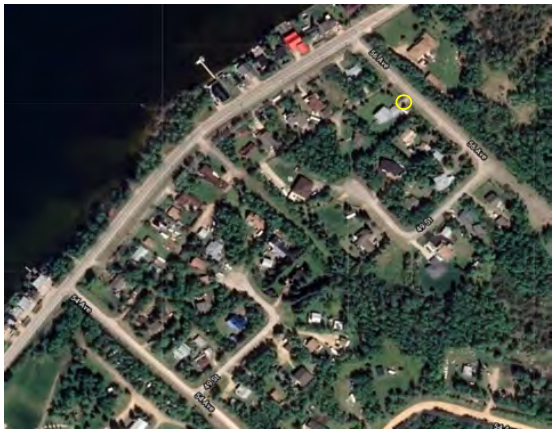
Overall Rating
3

Culvert is in fair to good condition. Culverts need sloped ends. Recommend once this culvert has aged and reached its design life, replace with one 600mm diameter culvert.

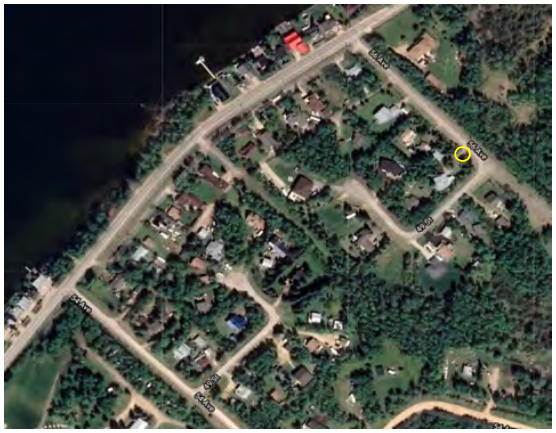
Culvert is in fair to good condition. Culverts need sloped ends. Recommend once this culvert has aged and reached its design life, replace with one 500mm diameter culvert.

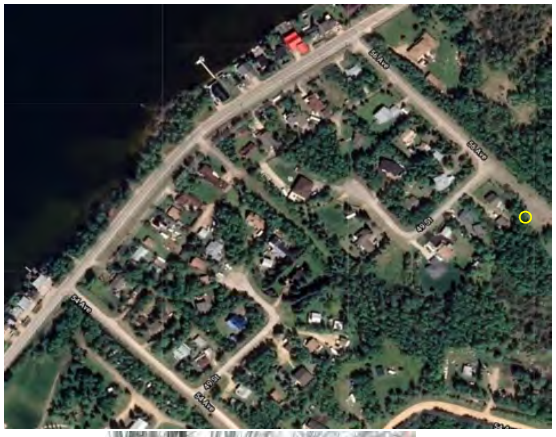
Culvert is in fair to good condition. Water marks inside culvert indicates that flow goes only 1/3 up, so capacity not a large concern. Need to review sizing if development occurs upstream. Culvert needs sloped end on outlet side. **INCLUDED IN PROJECT #3. Proiect # 3 indicates replacing this culvert. Consideration should be to leave in place, just add sloped ends. New culvert to be placed in parallel.**

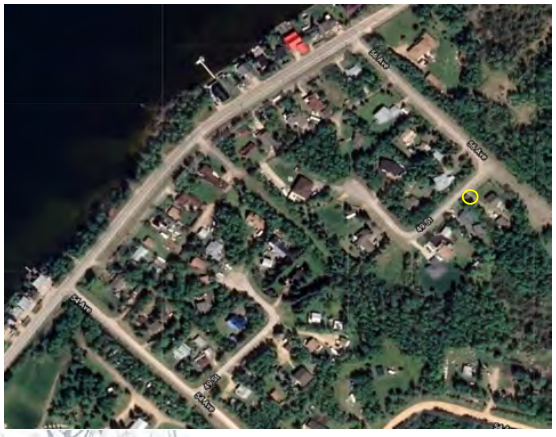
Overall Rating
5

Pipe Barrel	Rating
Blockage	No
Submerged in Water	No
Inlet Damage	Yes
Outlet damage	No
Corrosion / Abrasion	No
Out of Round	No
Settlement	No
Sag / Bow	No
Infiltration	No
Piping	No
Cracking	No

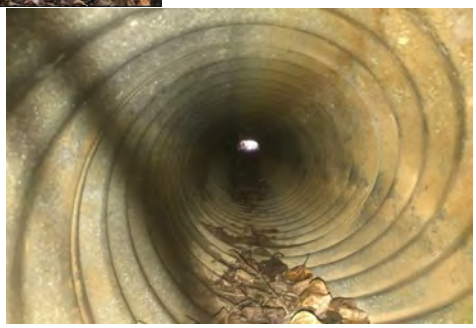
Comments
Culvert is in fair to good condition. Culverts need sloped ends. Recommend once this culvert has aged and reached its design life, replace with one 500mm diameter culvert.

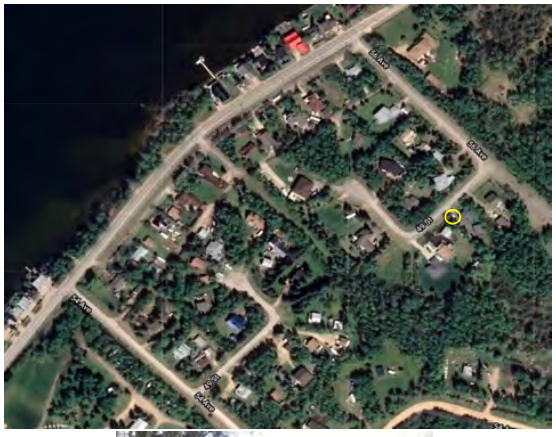
No culvert at this approach to the lot. Drainage appears to flow through and over driveway and head toward buildings. Recommend that a 500mm Dia. CSP with sloped ends be installed under the approach to ensure drainage head down along the ditch to the north.

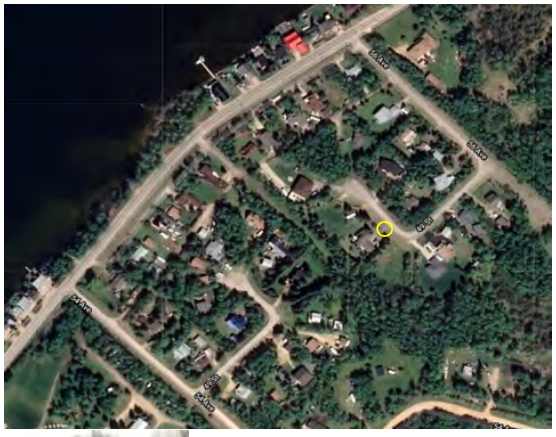
Culvert is in fair to good condition. Culverts need sloped ends. Recommend once this culvert has aged and reached its design life, replace with one 500mm diameter culvert.

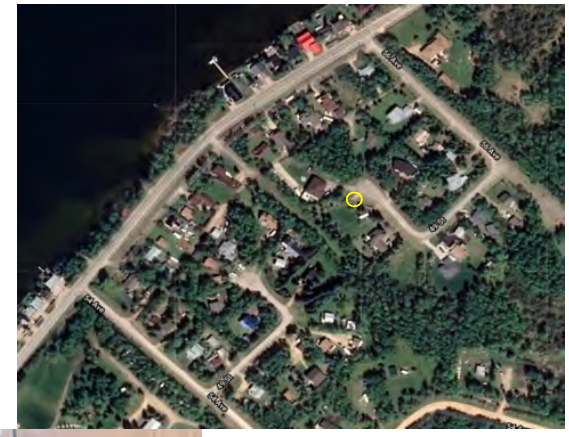
Pipe Barrel	Rating
Blockage	Partial
Submerged in Water	No
Inlet Damage	No
Outlet damage	No
Corrosion / Abrasion	No
Out of Round	No
Settlement	No
Sag / Bow	No
Infiltration	No
Piping	No
Cracking	No

Can't see fully through culvert. Culvert is in fair to good condition. Culverts need sloped ends. Recommend once this culvert has aged and reached its design life, replace with one 500mm diameter culvert.

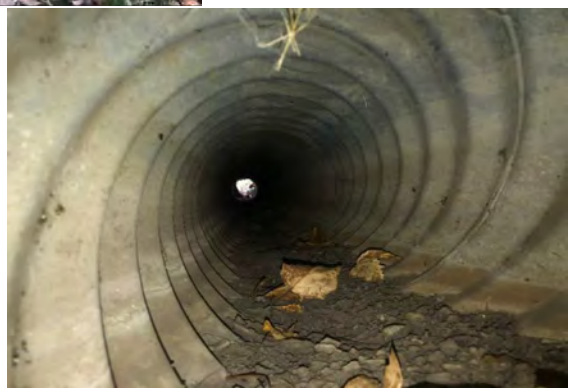
Culvert appears to be in fair to good condition. Small culvert that should be larger just to maintain flow and availability for cleaning out. Recommend when comes time for replacement, replace with 500mm Dia. CSP with sloped ends and rip rap. Check slope in culvert.

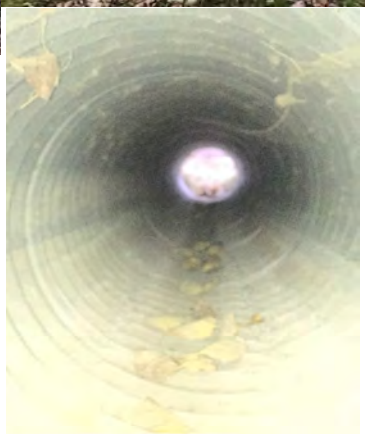
Comments
Culvert appears to be in fair to good condition. Small culvert that should be larger just to maintain flow and availability for cleaning out. Recommend when comes time for replacement, replace with 500mm Dia. CSP with sloped ends and rip rap. Check slope in culvert.
