EXISTING INFRASTRUCTURE REVIEW

1. Drainage & Culvert Review

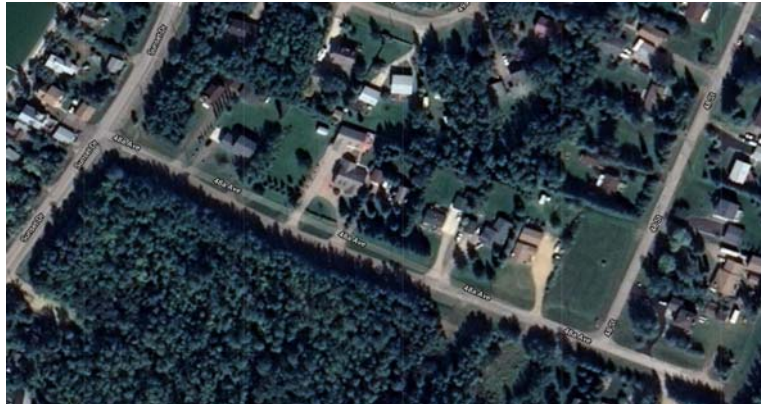
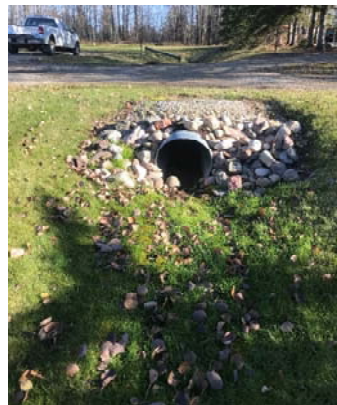
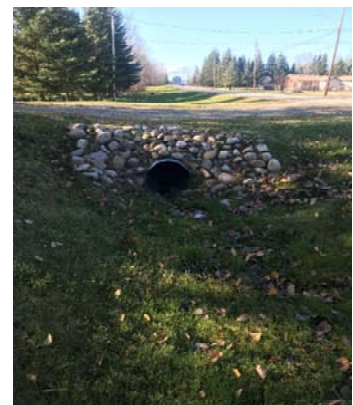
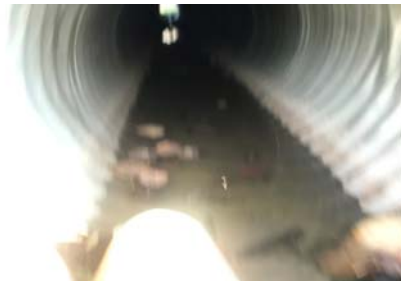
Roadway Over Pipe	Response
Pavement cracks or Patches	Yes
Sag in Roadway	No
Recent signs of high water	No
Amount of Cover (m)	0.3

Inlet / Outlet Protection	Rating
Channel scour at Inlet/Outlet	No
Embankment Erosion	No
Sideslopes too Steep	No
Drift - wood, debris around pipe	No
Vegetation - trees, brush etc.	No
Silt	No
Rip Rap	Needs Apron

Pipe Barrel	Rating
Blockage	No
Submerged in Water	No
Inlet Damage	No
Outlet damage	No
Corrosion / Abrasion	No
Out of Round	No
Settlement	No
Sag / Bow	No
Infiltration	No
Piping	No
Cracking	No

Capacity	Rating
Flow Path Type	Major
Function of size, slope and condition	<5 Year

No Backslope along ditch; risk of flow going into Lot.
Flow will be increased here due to changes upstream.

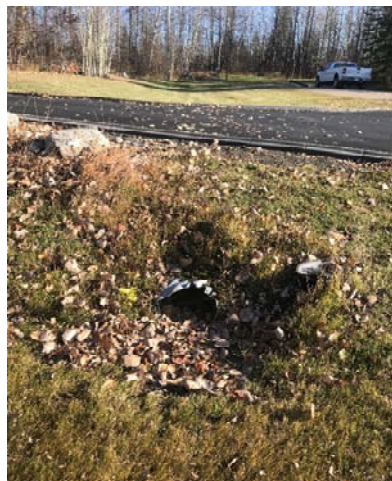
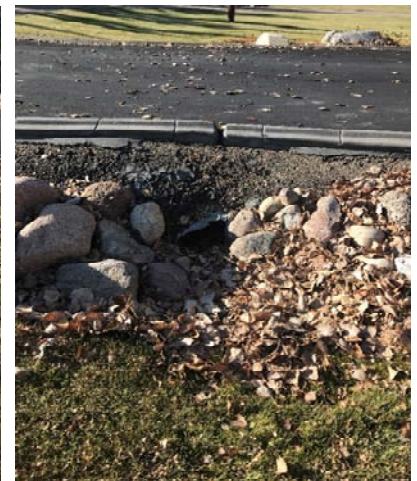
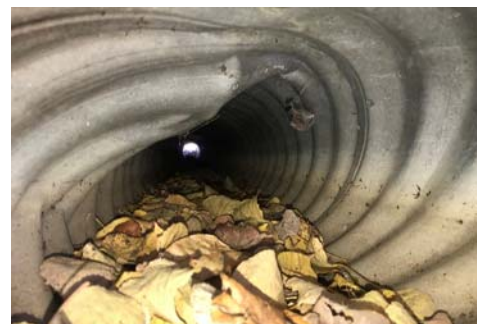
Capacity	Rating
Flow Path Type	Minor
Function of size, slope and condition	Negligible

Comments
Paved Approach. Barrell pushed in on one end.

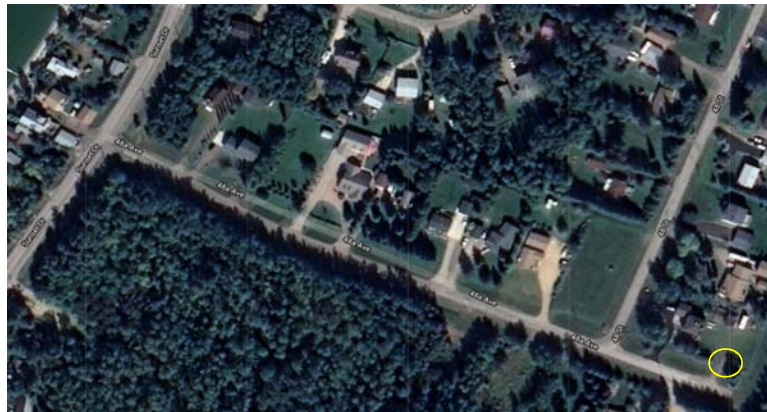
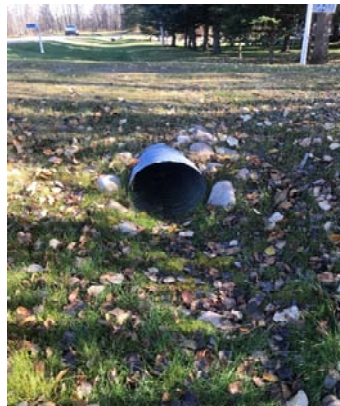
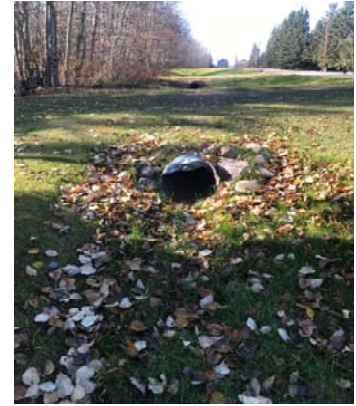
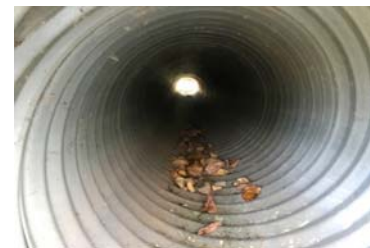
Roadway Over Pipe	Response
Pavement cracks or Patches	No
Sag in Roadway	No
Recent signs of high water	No
Amount of Cover (m)	0.3

Inlet / Outlet Protection	Rating
Channel scour at Inlet/Outlet	No
Embankment Erosion	No
Sideslopes too Steep	No
Drift - wood, debris around pipe	No
Vegetation - trees, brush etc.	Yes
Silt	No
Rip Rap	Needs More

Pipe Barrel	Rating
Blockage	No
Submerged in Water	No
Inlet Damage	No
Outlet damage	No
Corrosion / Abrasion	No
Out of Round	No
Settlement	No
Sag / Bow	No
Infiltration	No
Piping	No
Cracking	No

Capacity	Rating
Flow Path Type	Major
Function of size, slope and condition	<5 Year

Comments
 Very good condition except for bent East end.
 East end bent on top. Straight faced ends.
 Some rip rap. 0.3 cover

Flow will be increased here due to changes upstream.

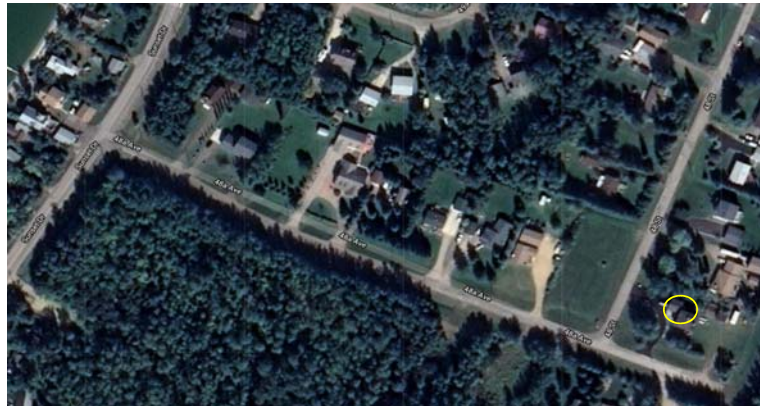
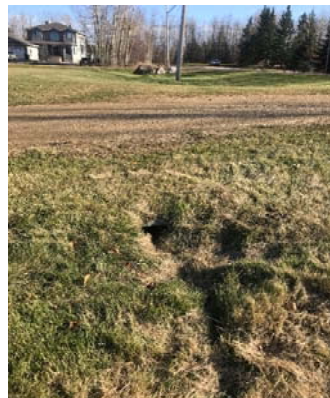
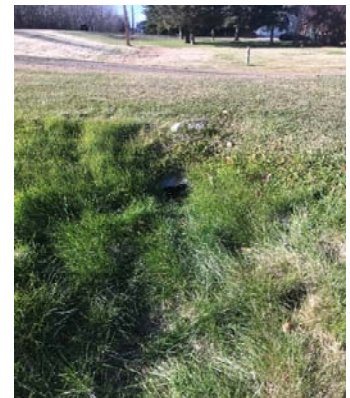
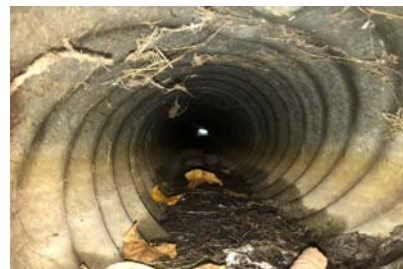
Roadway Over Pipe	Response
Pavement cracks or Patches	No
Sag in Roadway	No
Recent signs of high water	No
Amount of Cover (m)	0.5 - 1.0

Inlet / Outlet Protection	Rating
Channel scour at Inlet/Outlet	No
Embankment Erosion	No
Sideslopes too Steep	No
Drift - wood, debris around pipe	No
Vegetation - trees, brush etc.	Yes
Silt	No
Rip Rap	Needs More

Pipe Barrel	Rating
Blockage	No
Submerged in Water	No
Inlet Damage	No
Outlet damage	No
Corrosion / Abrasion	No
Out of Round	No
Settlement	No
Sag / Bow	No
Infiltration	No
Piping	No
Cracking	No

Capacity	Rating
Flow Path Type	Minor
Function of size, slope and condition	100 yrs

Comments
 Lot 19 vacant. Dual approach. Ends bent.
 Lots of grass. No rip rap.
 0.5 - 1.0 cover

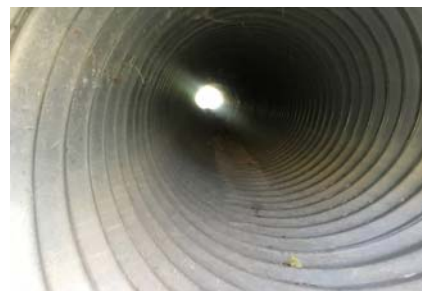
Capacity	Rating
Flow Path Type	Major
Function of size, slope and condition	<5 Year

Comments
Very good condition. 0.3m cover. Rip rap on top. Poor rip rap apron. Grown over with grass Straight face end. Flow will be increased here due to changes upstream.

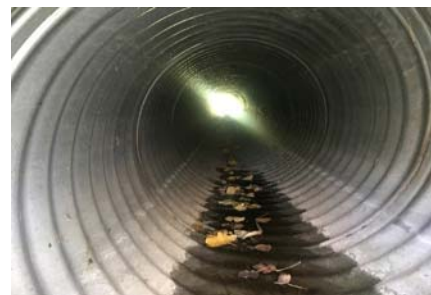
Comments
 Very good condition. Approach to empty bush.
 Rip rap on top of culvert but need on apron
 Straight ends.

Flow will be increased here due to changes upstream.

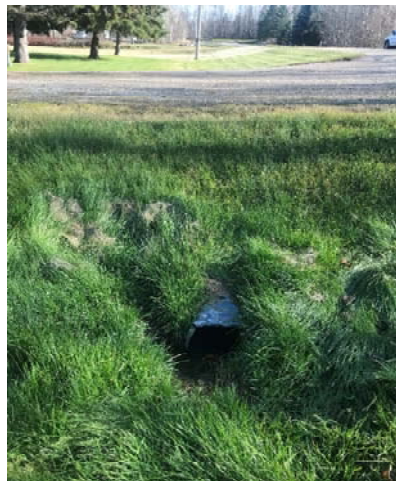
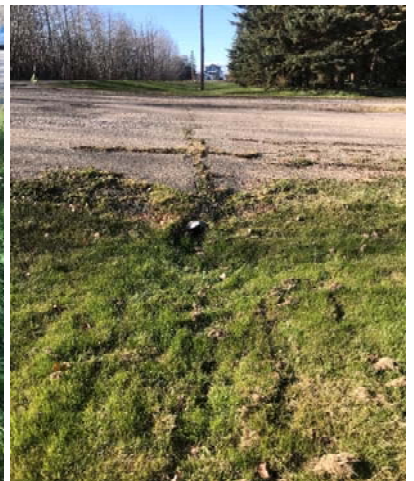
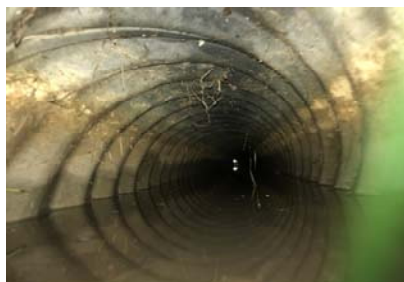
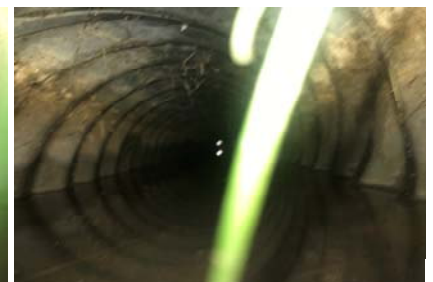
Capacity	Rating
Flow Path Type	Minor
Function of size, slope and condition	100 yrs

Comments
 Good shape. Straight face end - very slightly bent. Pavement failure on approaches, Centerline crac over culvert. Low cover <0.2m on East end. No rip rap, lots of grass Standing water in culvert, no rust. Cover on west end 0.7m .

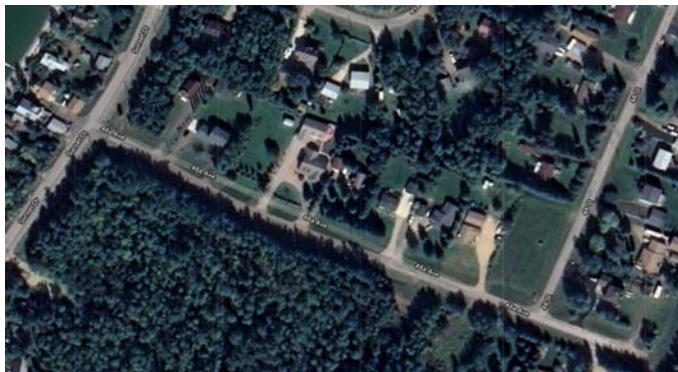
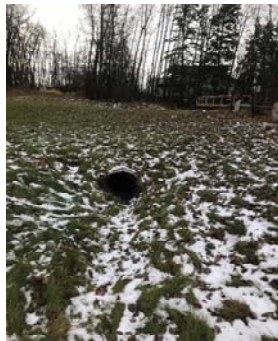
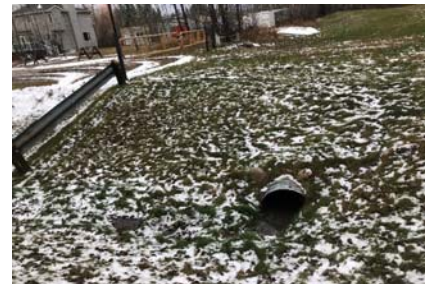
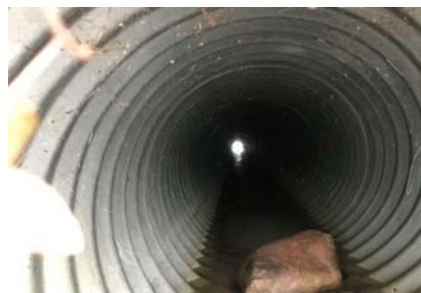
Roadway Over Pipe	Response
Pavement Cracks or Patches	No
Sag in Roadway	No
Recent signs of high water	No
Amount of Cover (m)	<1.0

Inlet / Outlet Protection	Rating
Channel scour at Inlet/Outlet	No
Embankment Erosion	No
Sideslopes too Steep	No
Drift - wood, debris around pipe	No
Vegetation - trees, brush etc.	No
Silt	No
Rip Rap	None

Pipe Barrel	Rating
Blockage	No
Submerged in Water	No
Inlet Damage	No
Outlet damage	No
Corrosion / Abrasion	No
Out of Round	No
Settlement	No
Sag / Bow	No
Infiltration	No
Piping	No
Cracking	No

Capacity	Rating
Flow Path Type	Major
Function of size, slope and condition	<5Yrs.

Comments
Improvements to the flow coming from east of the old railway embankment are anticipated to take most of flow away from this culvert. However, this culvert is expected to drain the west area of the embankment area, taking away runoff from the backyards of the lots. Improvements for this culvert are more in the line of grading upstream to ensure the flow reaches this culvert.

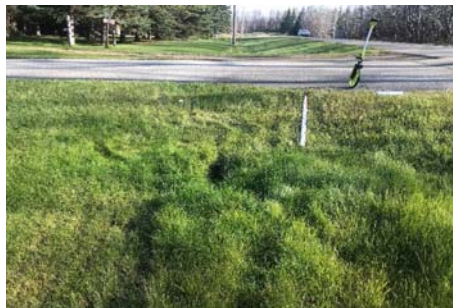
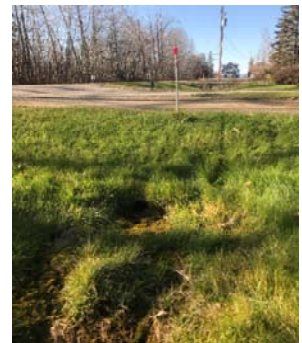
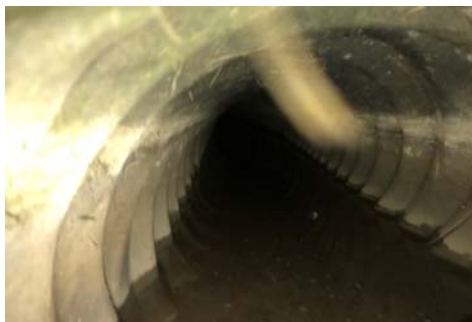
Capacity	Rating
Flow Path Type	Minor
Function of size, slope and condition	5 Yrs.

Comments
Ok shape, Small culvert and grass grown in. Lots of grass grown around ends. Dual approach for lot 24 & 23, being used. No sloped ends, no noticeable rust, no rip rap.

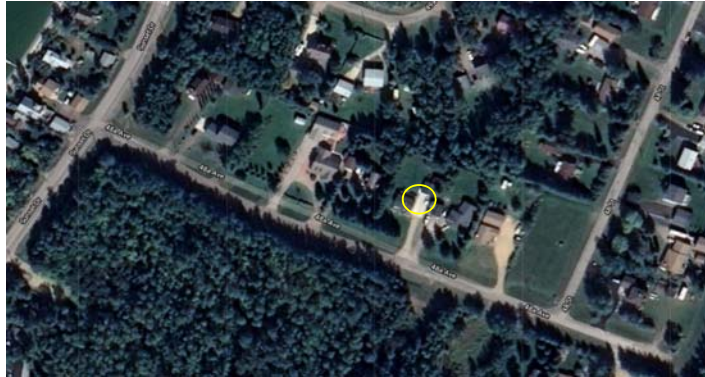
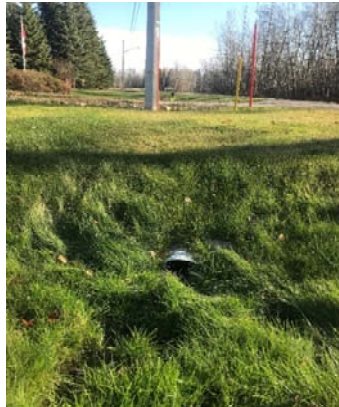
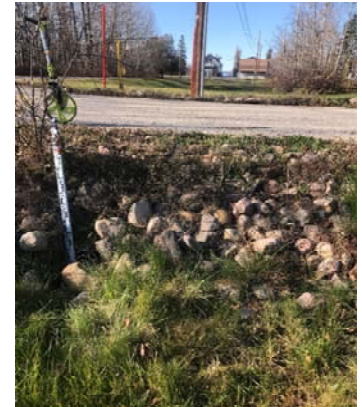
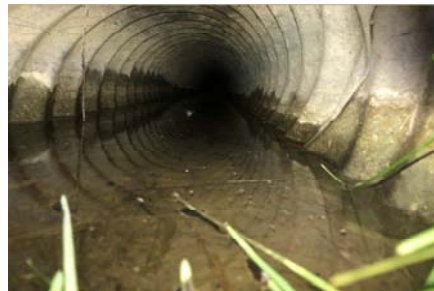
Inlet / Outlet Protection	Rating
Channel scour at Inlet/Outlet	No
Embankment Erosion	No
Sideslopes too Steep	No
Drift - wood, debris around pipe	No
Vegetation - trees, brush etc.	Yes
Silt	No
Rip Rap	Needs More

Comments
Fairly good shape. 1m cover. Outlet (rip rap around pipe but needs more on apron. Dual approach - Lot 25 not being used. No rip rap on inlet side, no slope ends, no noticeable rust or dip. Water in pipe.

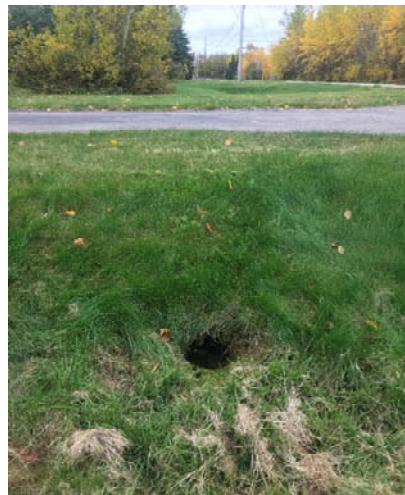
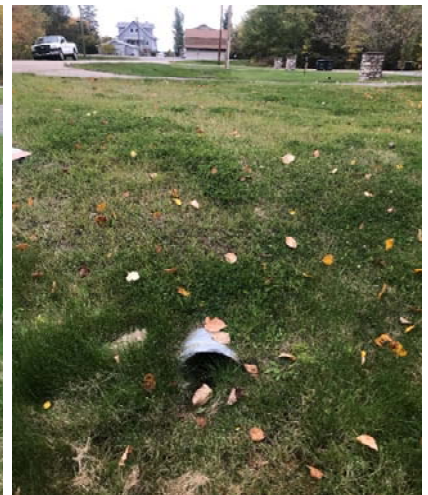
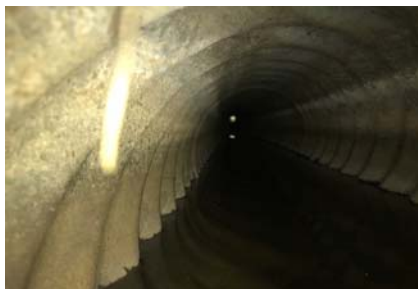
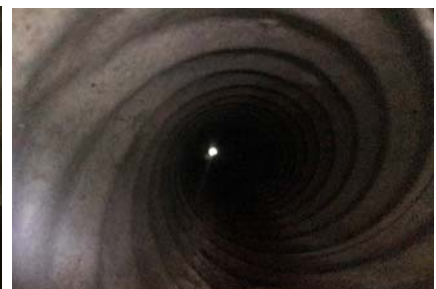
Comments
48 A Ave, North Side, 2nd approach to resident. 1.2 - 1.5 m cover. No rip rap. Clean grass away from culvert ends. Part of culvert is for dual approach but not used to Lot 25 to the East. No one in Lot 25. Water in pipe.

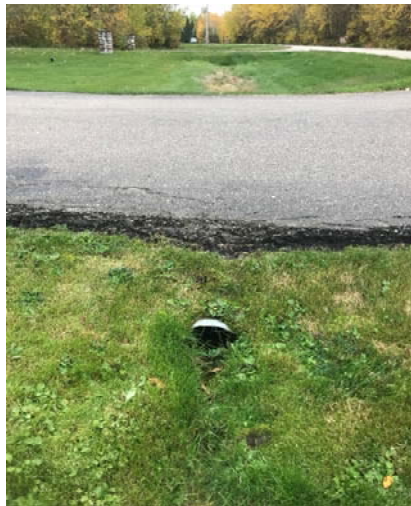
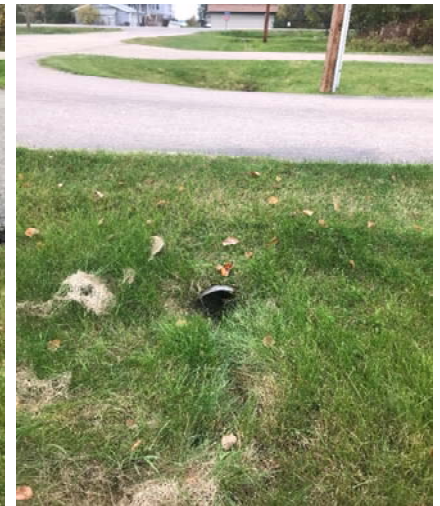
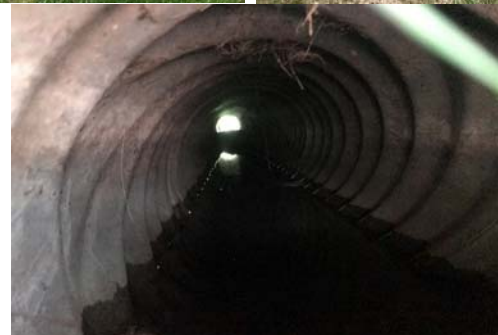
Comments
North side of 48A Ave. 0.3 to 0.5m cover. No rip rap. Clean grass away from culvert ends. Water in pipe.

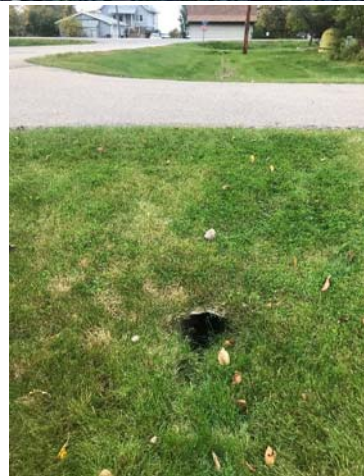
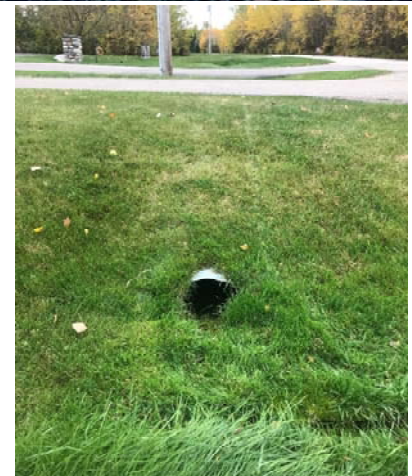
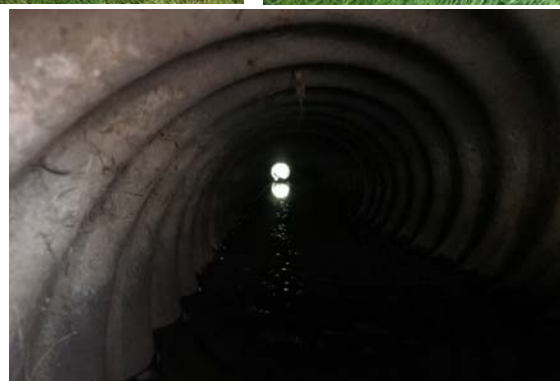
Comments
N. Side 48 A Avenue - Approach to Resident. Lots of grass at ends of culvert that could be cleaned out. No rip rap. Cover 0.6 to 0.9. No dip. Water in pipe.

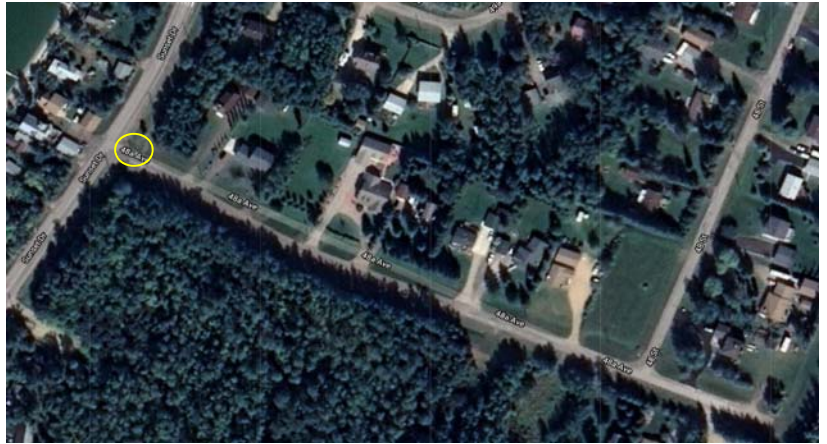
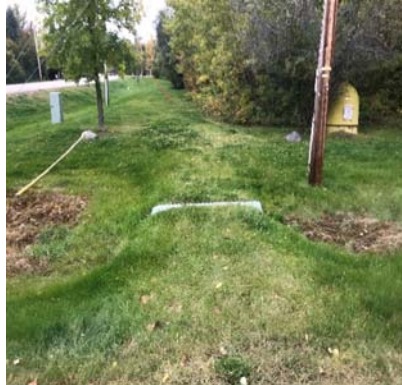
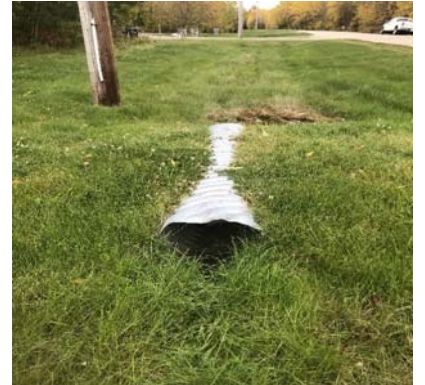
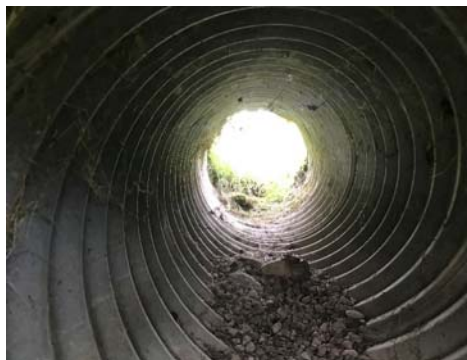
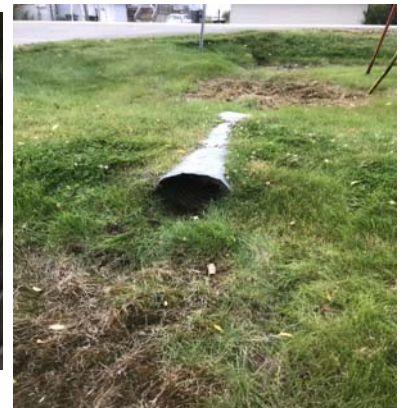
Pipe Barrel	Rating
Blockage	No
Submerged in Water	No
Inlet Damage	Yes
Outlet damage	Yes
Corrosion / Abrasion	No
Out of Round	No
Settlement	No
Sag / Bow	No
Infiltration	No
Piping	No
Cracking	No

Comments
Straight ends, no cover, no rust, no dip, no rip rap, could clean outside ends of grass buildup, scape marks on top with galvanization, could be painted.

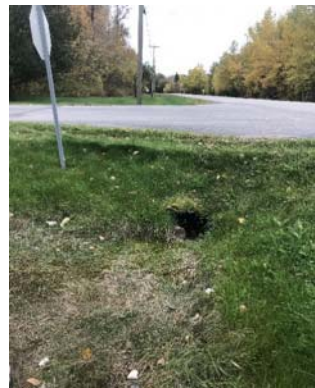
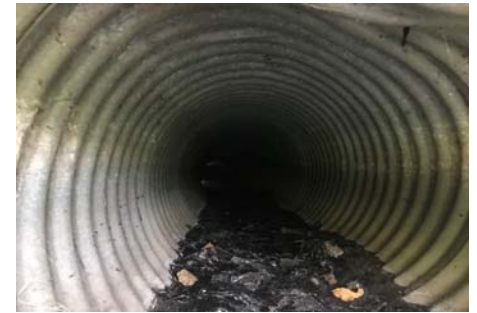
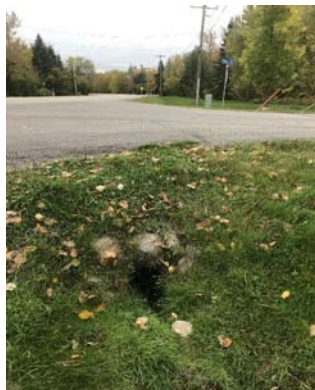
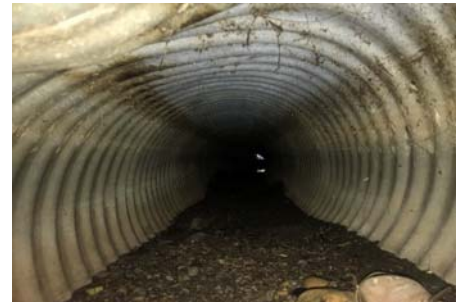
Comments
48A Avenue Culvert to Sunset Drive - East side of Sunset Drive. Damaged North end and South end. No rip rap. Ends need cleaning (very bad), Steep S/S N. end and S. End. Make longer 1m per end. Culvert clogged and can not see thru. Dipping in the center and towards the lake. Area is not draining and this culvert needs to be lowered as a overall area lowering of the ditches and culverts to the lake.

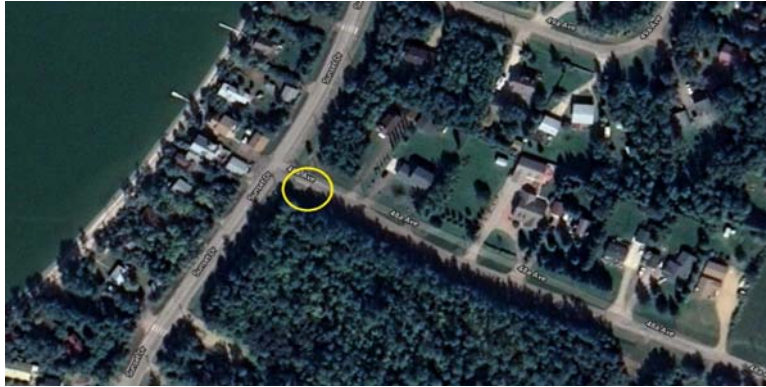
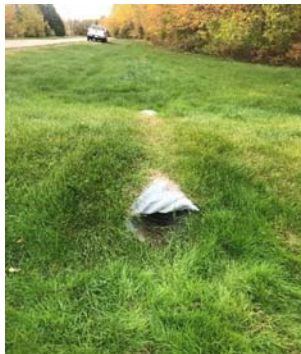
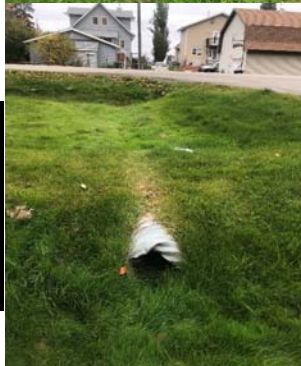
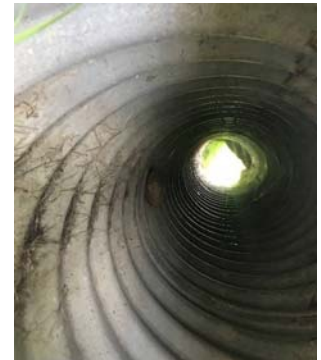
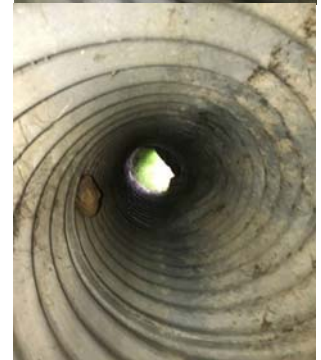
Comments
48A Avenue, South side, East of Sunset Drive. Quad trail over culvert. Straight ends. Ends damaged. No rust, no dip. Grass cover culvert ends. No rip rap. Flow will be increased here due to changes upstream.

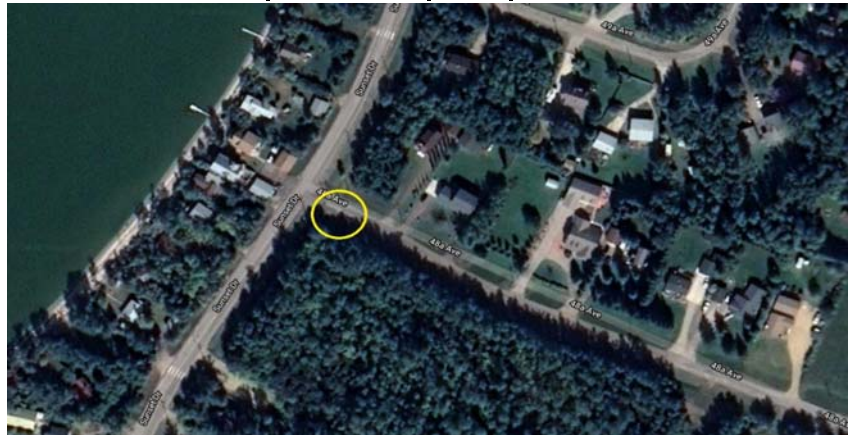
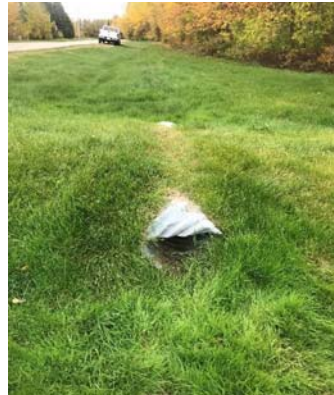
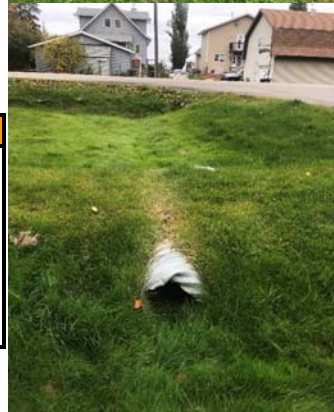
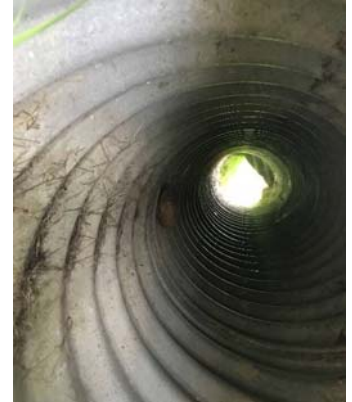
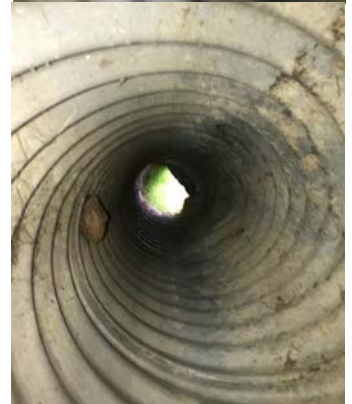
Comments
 48A Avenue, South side, East of Sunset Drive. Quad trail over culvert. Straight ends. Ends damaged. No rust, no dip. Grass cover culvert ends. No rip rap. Flow will be increased here due to changes upstream.

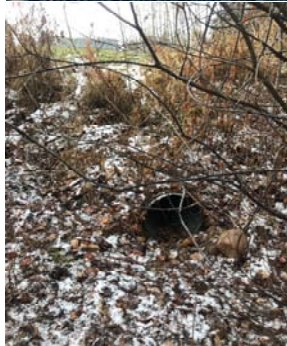
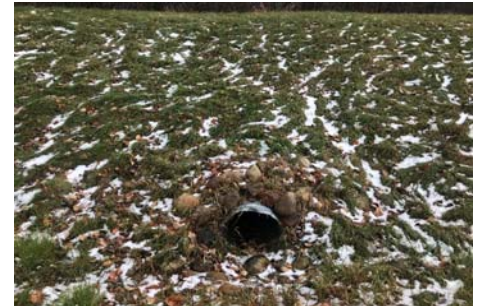
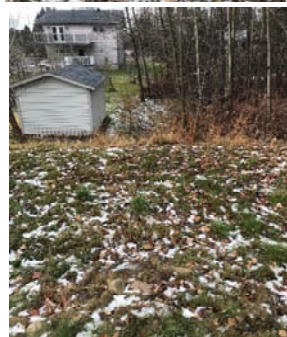
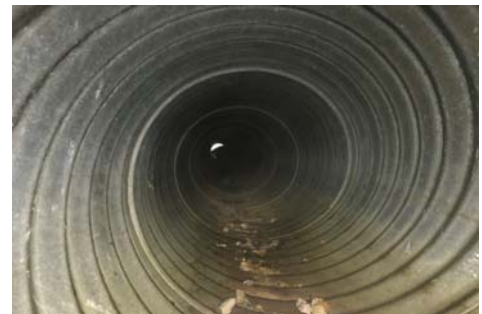
Comments
Flow is very high and flowing to the west and should be draining to the south along old railway embankment. Improvements are recommended to take flow coming from east of the old railway embankment which will take all of the flow away from this culvert. This culvert should be removed as it will become redundant. Improvement work will take flow from the Golf Course and re-direct to south ditch of 48A Avenue via an underground storm sewer.

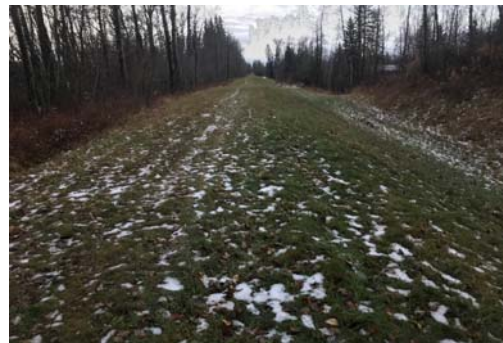
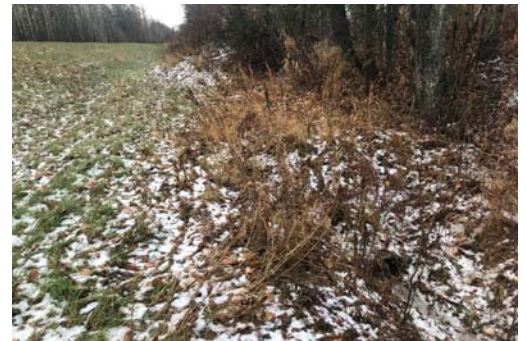
Comments
Could not find this culvert. Records from the old railway embankment construction indicate that a culvert did exist in this area. Flow is high in this area coming from the golf course. Flow should mostly go south along old railway embankment. Improvements are recommended to take this flow mostly to the south to 48A Avenue on both sides of the railway embankment. Some flow is to go to the north where a new drainage course is to be constructed north of the lots. This culvert will be redundant after improvements.

Did Not Find this Culvert

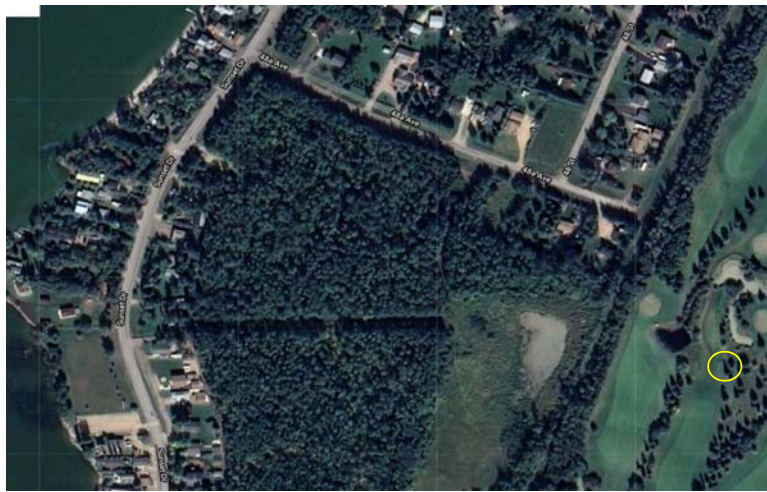
Comments
 Flow is high and is not properly set in elevation as water flow goes from the west and goes east into golf course. All flow should go to the west through vacant land. Improvements are recommended to take flow coming from east of the old railway embankment which will take all of the flow away from this culvert. This culvert should be removed as it will become redundant. Improvement work will take flow from the Golf Course and re-direct to south ditch of 48A Avenue via an underground storm sewer.

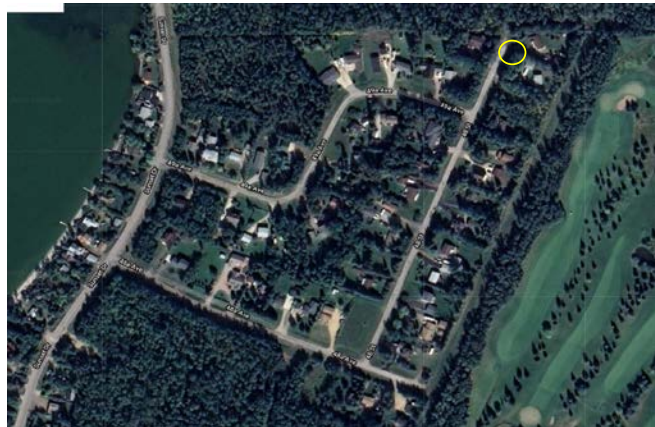
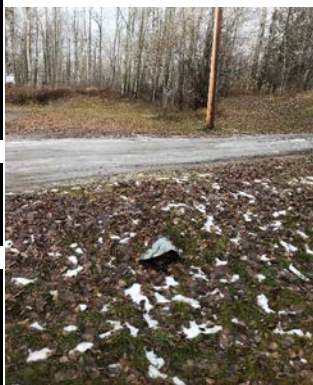
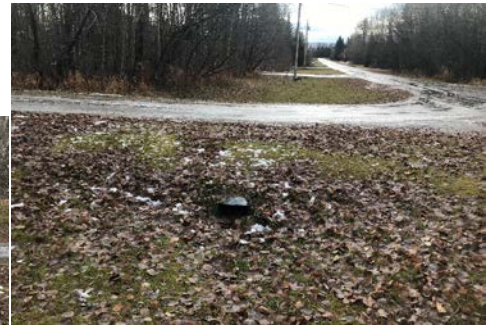
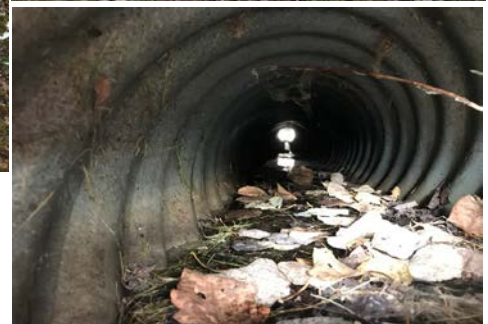
Comments
Culvert in fair condition. Approach is not paved. End treatments poor & damaged; could use sloped ends. Some silt.

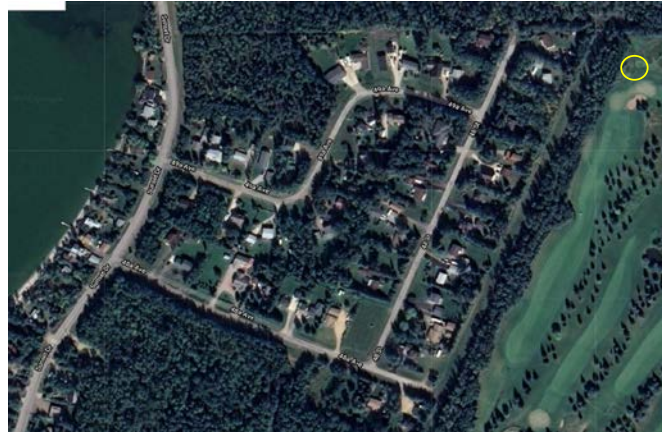
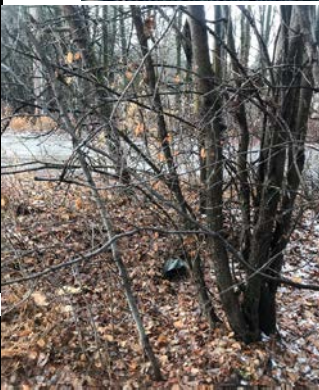
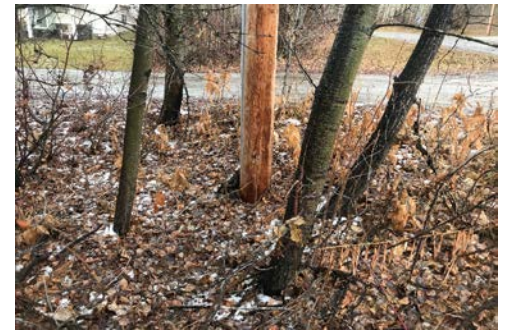
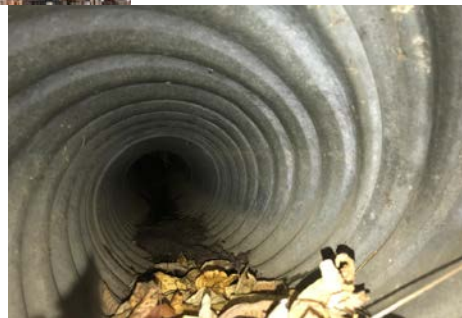
**Culvert Improvement
Cost Estimate**Date: Saturday, February 15, 2020
Culvert: 2654 - F26

Comments
Culvert in fair condition. Approach is not paved. North end is damaged; can't find south end & may be buried; could use sloped ends. Trees on south end make drainage difficult.

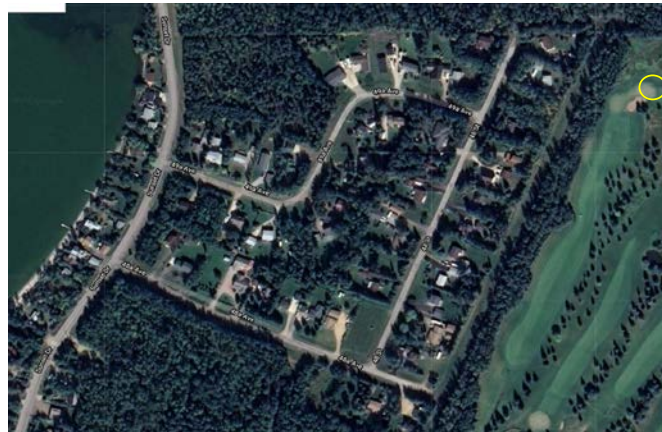
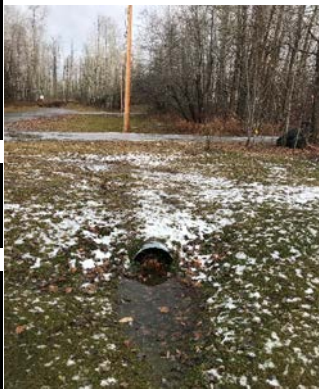
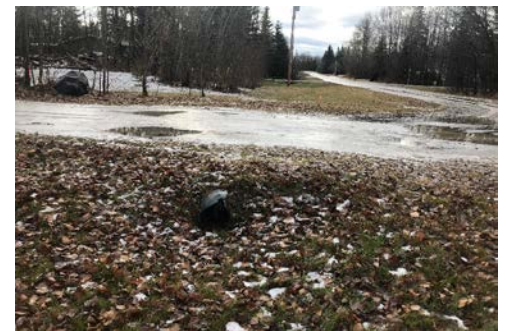
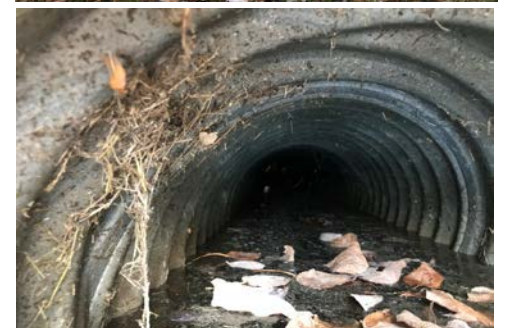
**Culvert Improvement
Cost Estimate**Date: Saturday, February 15, 2020
Culvert: 2655 - F20

Comments
 Culvert in fair condition. Dips on Approach that hold water. Approach is not paved. End treatments poor & damaged; could use sloped ends. Can't see through culvert. 1/3 full of silt.

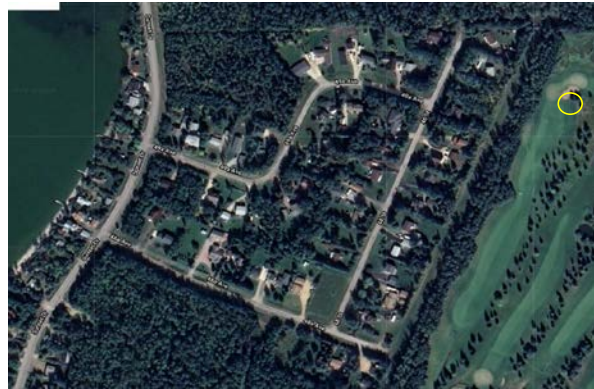
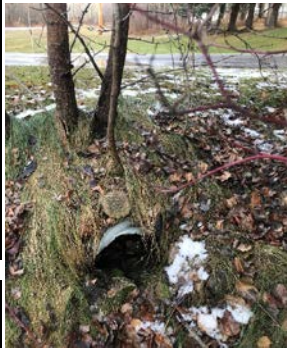
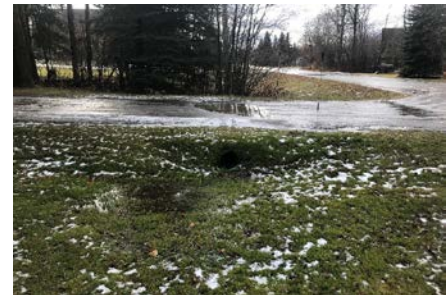
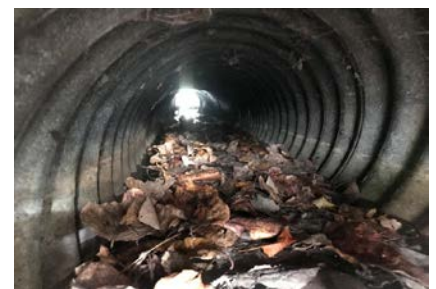
Culvert in fair to good condition. Dip on Approach that holds water. Approach is not paved. End treatments poor; could use sloped ends. Tree/bush at S. End needs to be cleared.

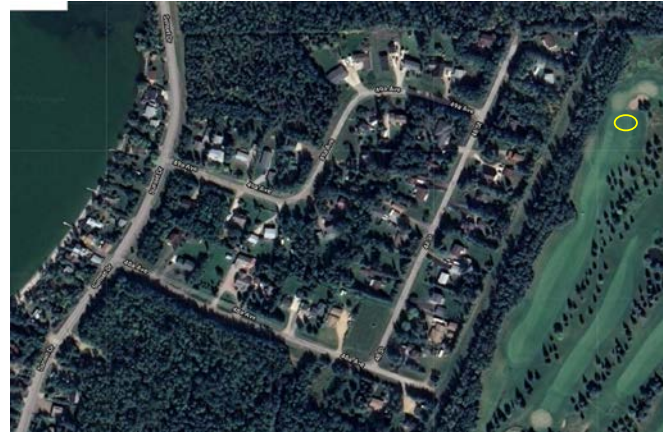
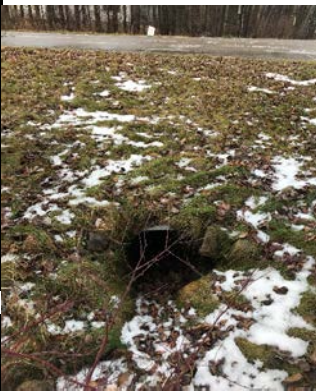
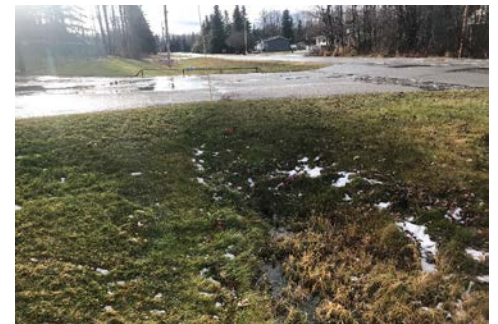
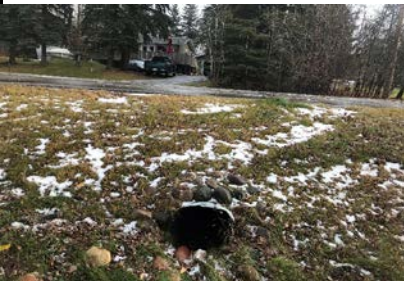
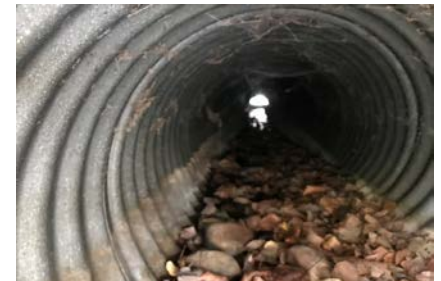
Comments
Culvert interior is in good condition. Culverts need sloped ends. On Major Drainage path from old railway embankment. Recommend once this culvert has aged and reached its design life, replace with one 800mm diameter culvert.

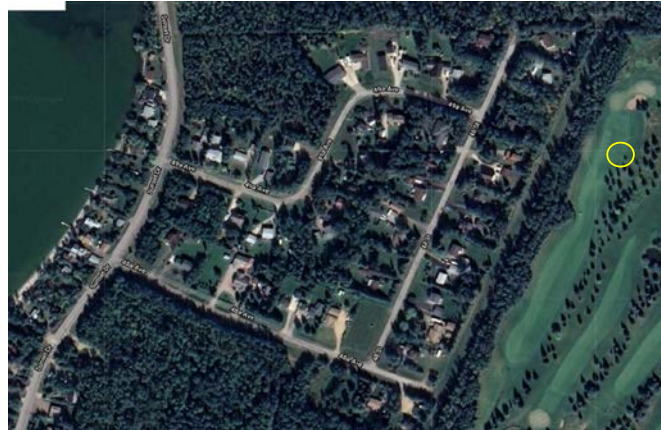
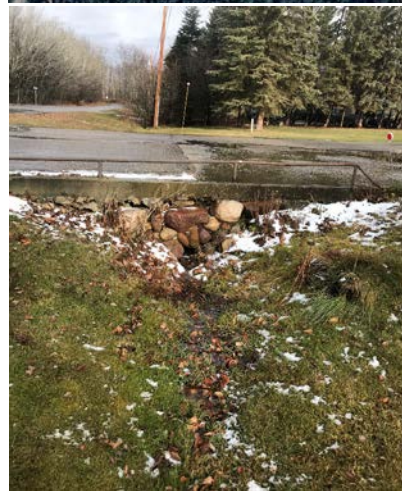
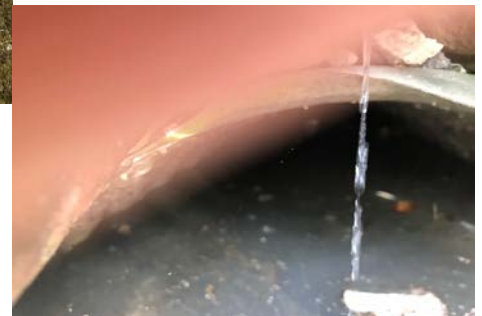
**Culvert Improvement
Cost Estimate**Date: Saturday, February 15, 2020
Culvert: 2671 - F08

Comments
Culvert in fair to good condition. Mostly submerged which is concerning as it provides little capacity for more flow. Low flow area. Expensive driveway replacement. End treatments poor; could use sloped ends.

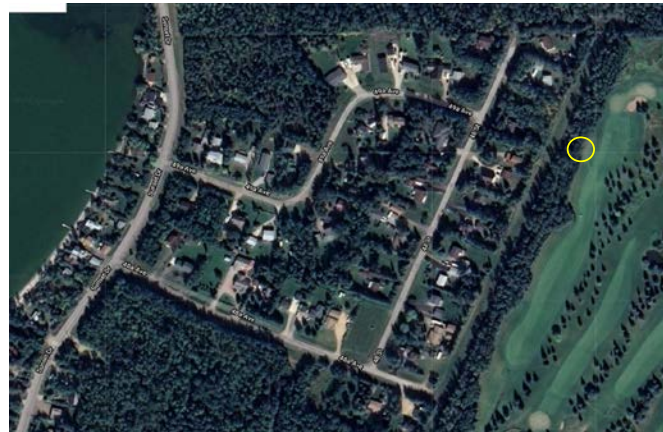
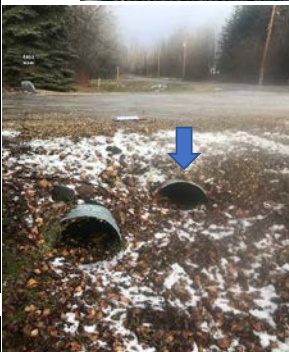
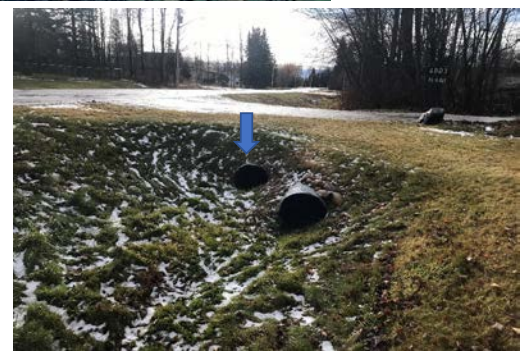
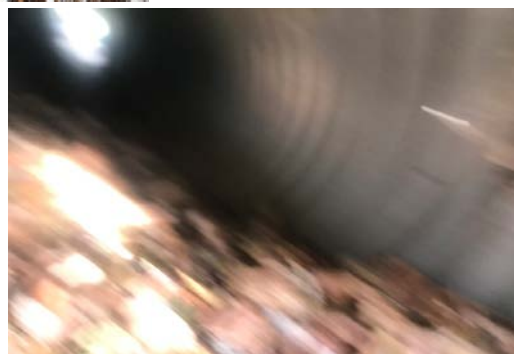
**Culvert Improvement
Cost Estimate**Date: Saturday, February 15, 2020
Culvert: 2672 - F27

Comments
Culvert interior is in very good condition. Some water and little siltation. With future drainage re-direction upstream at the old railway embankment, this flow path will change from a Major Flow path to a Minor Flow path. Recommend once this culvert has aged and reached its design life, remove and will be replaced by 2674/F09.

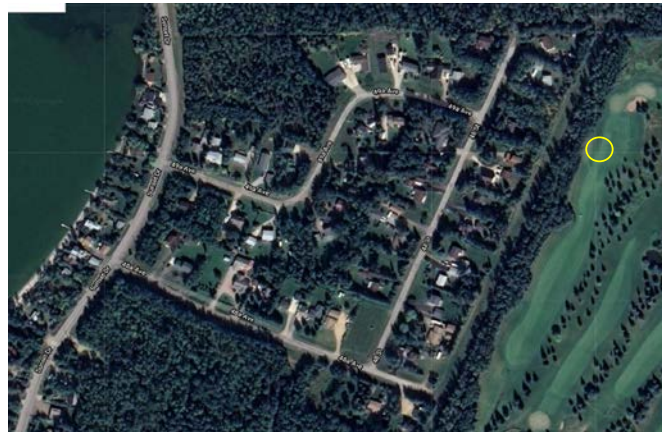
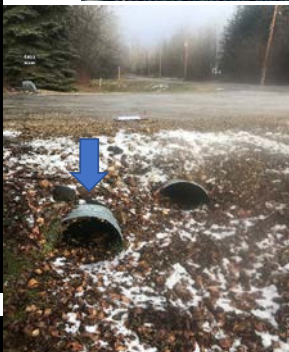
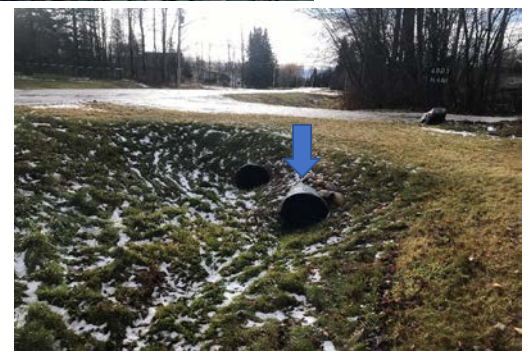
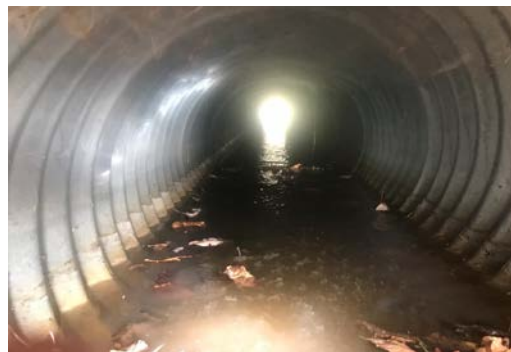
**Culvert Improvement
Cost Estimate**Date: Saturday, February 15, 2020
Culvert: 2673 - F10

Comments
Culvert interior is in very good condition. Some water and little siltation. Flat grade within a major flow path. Culverts stick out too much and need sloped ends. With future drainage re-direction upstream at the old railway embankment, this flow path will change from a Major Flow path to a Minor Flow path. Recommend once this culvert has aged and reached its design life, replace with one 800mm diameter culvert.

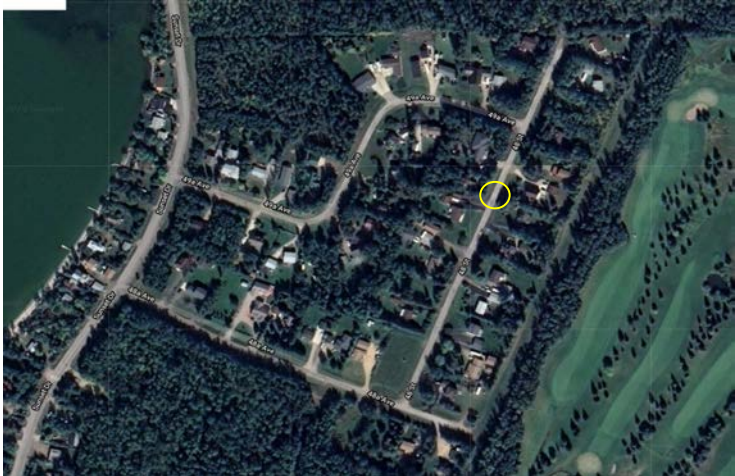
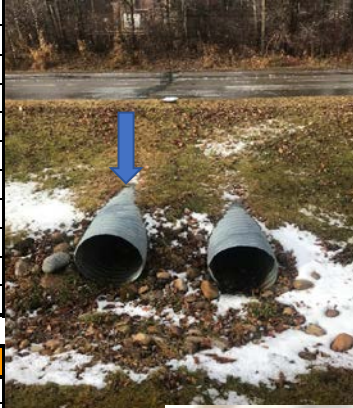
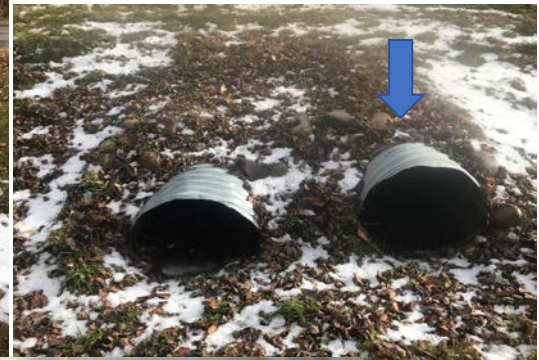
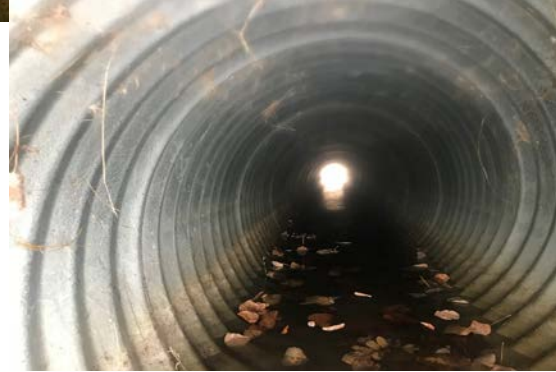
**Culvert Improvement
Cost Estimate**Date: Saturday, February 15, 2020
Culvert: 2674 - F09

Comments
Culvert interior is in very good condition. Culverts stick out too much and need sloped ends. With future drainage re-direction upstream at the old railway embankment, this flow path will change from a Major Flow path to a Minor Flow path. Recommend once this culvert has aged and reached its design life, replace with one 800mm diameter culvert.

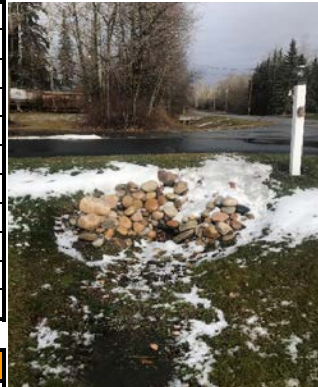
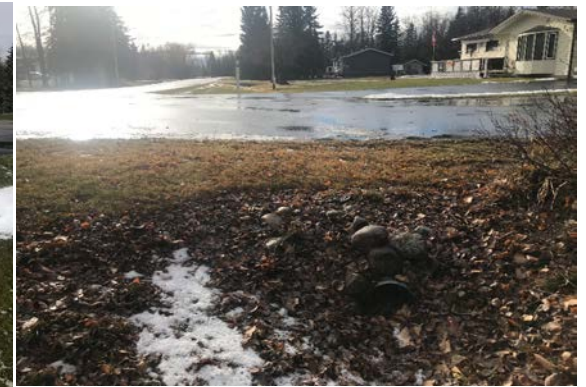
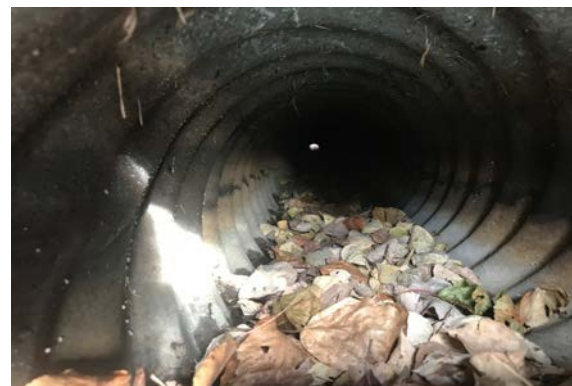
**Culvert Improvement
Cost Estimate**Date: Saturday, February 15, 2020
Culvert: 2675 - F11

Comments
Culvert in fair to good condition. Little siltation. Flat grade but not within a major flow path. Capacity is noted as inadequate from capacity analysis however this is mainly due to pipe slope and not high flow. Recommend not to rate capacity as inadequate but as 25 year capacity.

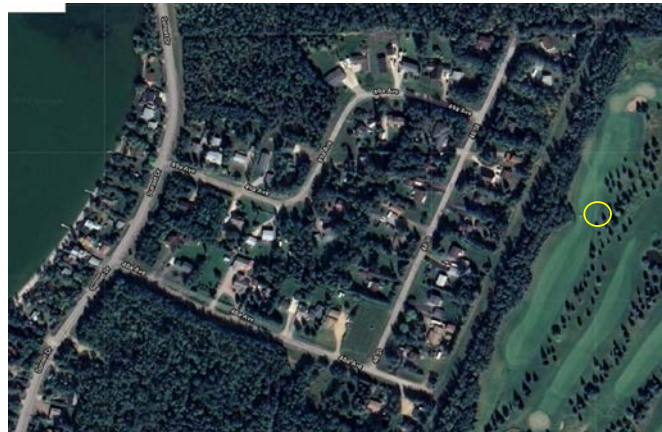
**Culvert Improvement
Cost Estimate**Date: Saturday, February 15, 2020
Culvert: 2676 - F28

Comments
Culvert in very good condition. Little siltation. Flat grade but not within a major flow path. Capacity is noted as 5 Year from capacity analysis however this is mainly due to pipe slope and not high flow. Recommend not to rate capacity as inadequate but as 25 year capacity. End treatments poor; could use sloped ends.

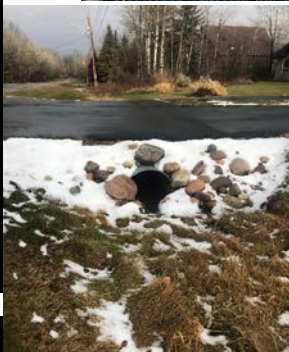
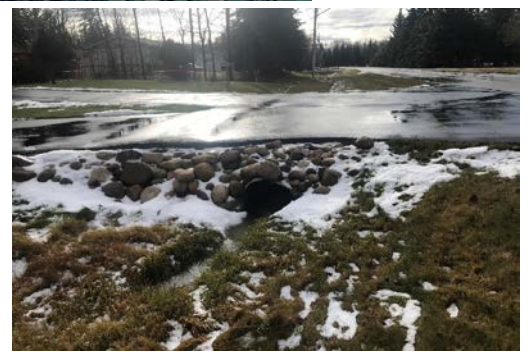
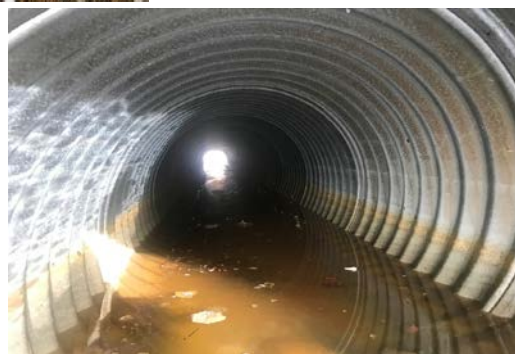
Inlet / Outlet Protection	Rating
Channel scour at Inlet/Outlet	No
Embankment Erosion	No
Sideslopes too Steep	No
Drift - wood, debris around pipe	No
Vegetation - trees, brush etc.	No
Silt	Yes
Rip Rap	None
