EXISTING INFRASTRUCTURE REVIEW

1. Drainage & Culvert Review

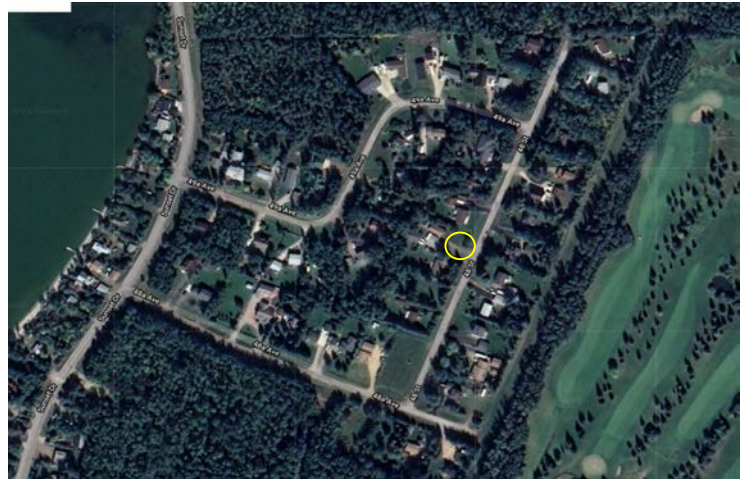
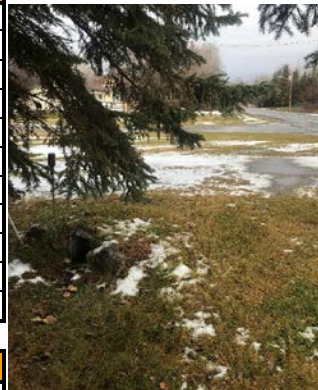
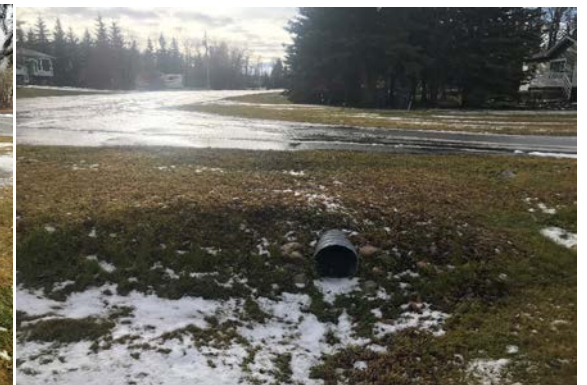
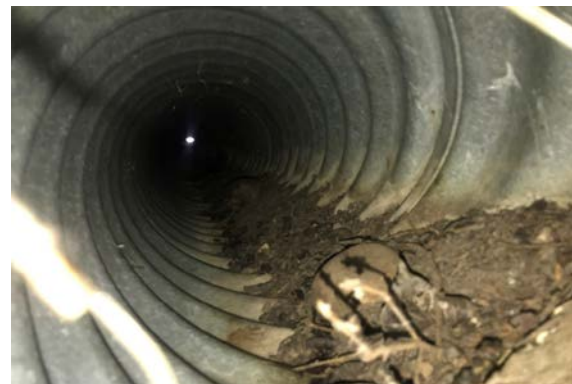
**Culvert Improvement
Cost Estimate**Date: Saturday, February 15, 2020
Culvert: 2677 - F13

Inlet / Outlet Protection	Rating
Channel scour at Inlet/Outlet	No
Embankment Erosion	No
Sideslopes too Steep	No
Drift - wood, debris around pipe	No
Vegetation - trees, brush etc.	No
Silt	Yes
Rip Rap	None

Comments
Culvert in fair to good condition. Little siltation. Flat grade but not within a major flow path. Capacity is noted as inadequate from capacity analysis however this is mainly due to pipe slope and not high flow. Recommend not to rate capacity as inadequate but as 25 year capacity.

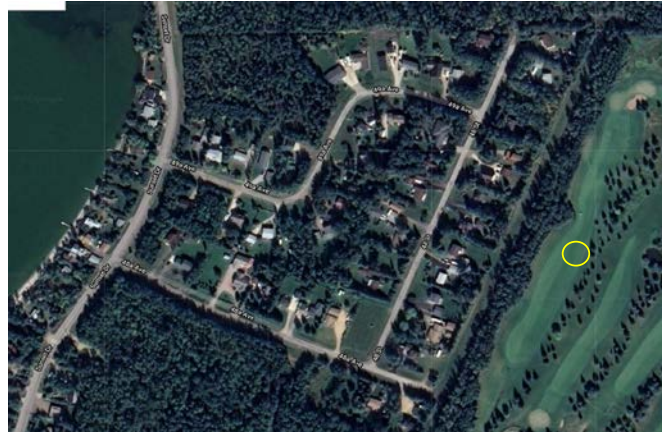
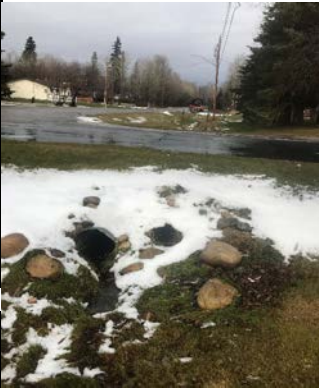
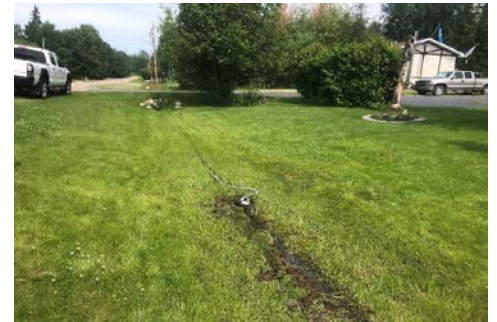
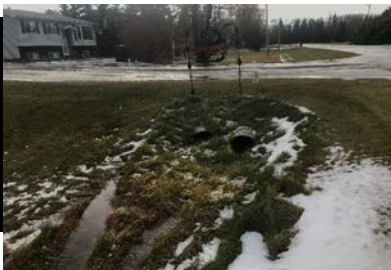
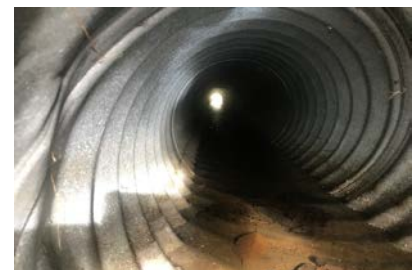
**Culvert Improvement
Cost Estimate**Date: Saturday, February 15, 2020
Culvert: 2678 - F29

Inlet / Outlet Protection	Rating
Channel scour at Inlet/Outlet	No
Embankment Erosion	No
Sideslopes too Steep	Yes
Drift - wood, debris around pipe	No
Vegetation - trees, brush etc.	No
Silt	Yes
Rip Rap	None

Pipe Barrel	Rating
Blockage	Yes
Submerged in Water	No
Inlet Damage	No
Outlet damage	No
Corrosion / Abrasion	No
Out of Round	No
Settlement	No
Sag / Bow	No
Infiltration	No
Piping	No
Cracking	No

Comments
Culvert interior is in very good condition. Lots of issues with end treatments. Flat grade but not within a major flow path. Water ponds in ditch to the south; home owner uses sump pump to pump from ditch to culvert. Ditch re-grading and culvert elevation reset required.

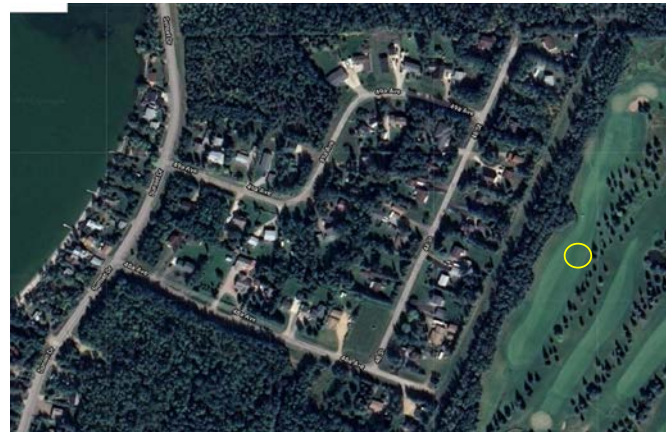
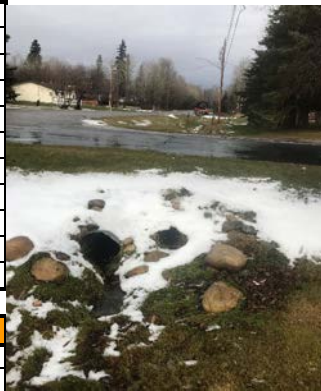
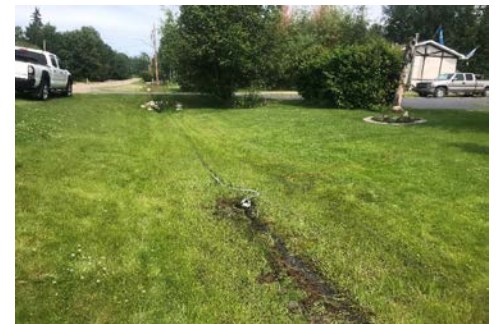
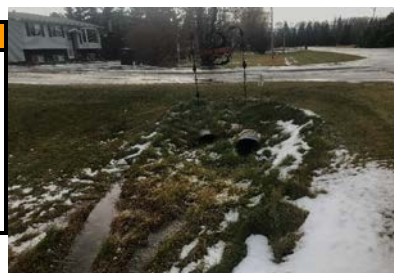
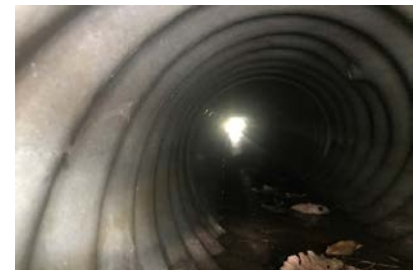
**Culvert Improvement
Cost Estimate**Date: Saturday, February 15, 2020
Culvert: 2679 - F14a

Comments
Culvert interior is in fair to good condition. Lots of issues with end treatments. Flat grade but not within a major flow path. Water ponds in ditch to the south; home owner uses sump pump to pump from ditch to culvert. Ditch re-grading and culvert elevation reset required. This culvert not needed.

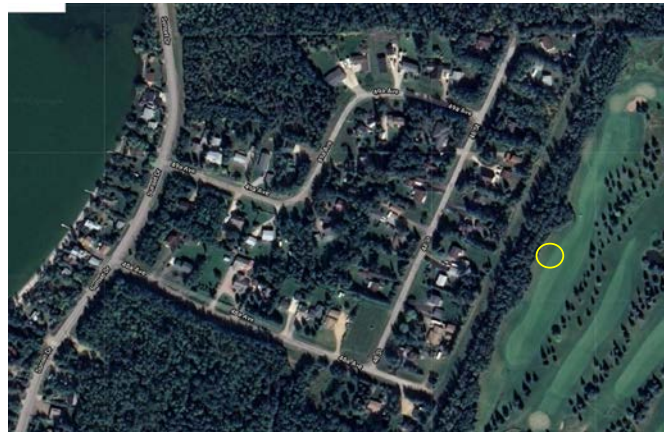
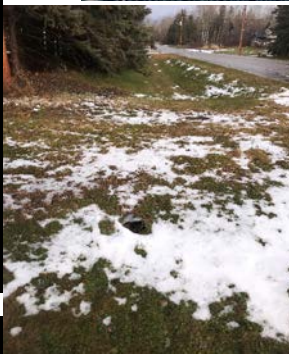
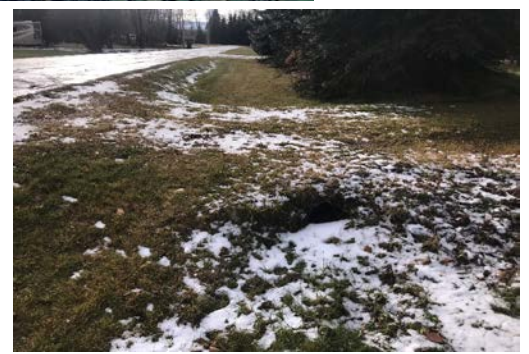
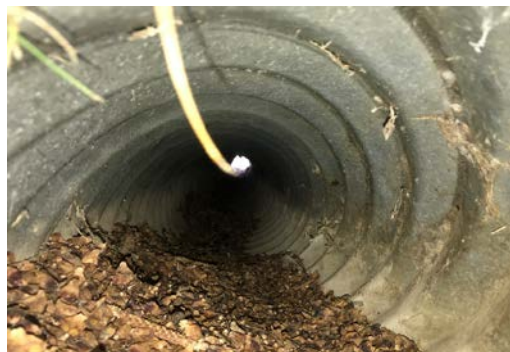
**Culvert Improvement
Cost Estimate**Date: Saturday, February 15, 2020
Culvert: 2679 - F14b

Pipe Barrel	Rating
Blockage	No
Submerged in Water	No
Inlet Damage	No
Outlet damage	No
Corrosion / Abrasion	No
Out of Round	Yes
Settlement	No
Sag / Bow	No
Infiltration	No
Piping	No
Cracking	No

Comments
Culvert in fair to good condition. Some internal staining. Some siltation. Flat grade but not within a major flow path. Capacity is noted as inadequate from capacity analysis however this is mainly due to pipe slope and not high flow. Recommend not to rate capacity as inadequate but as 25 year capacity.

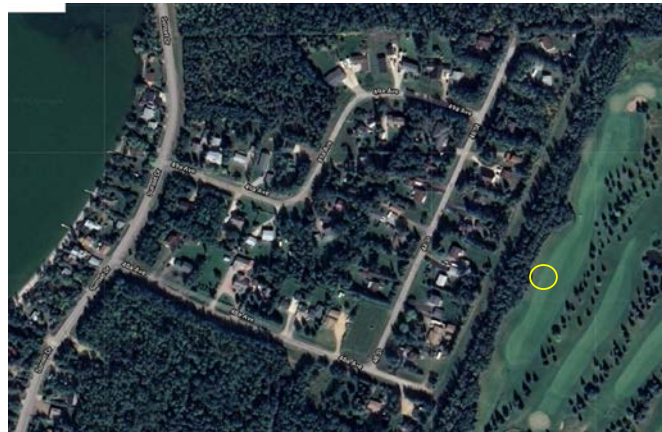
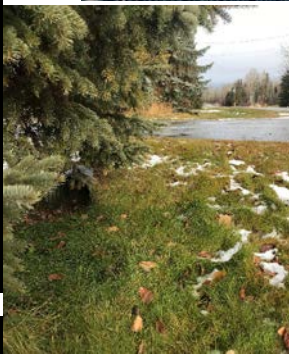
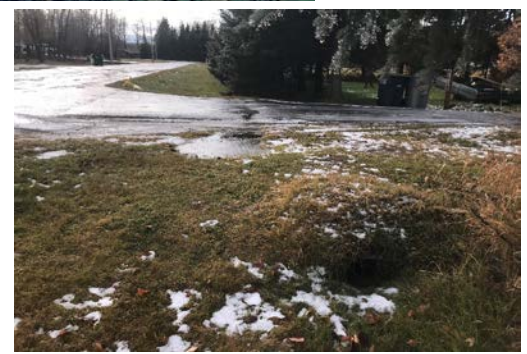
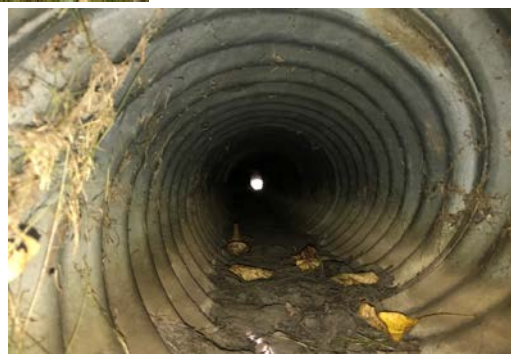
**Culvert Improvement
Cost Estimate**Date: Saturday, February 15, 2020
Culvert: 2680 - F30

Inlet / Outlet Protection	Rating
Channel scour at Inlet/Outlet	No
Embankment Erosion	No
Sideslopes too Steep	No
Drift - wood, debris around pipe	No
Vegetation - trees, brush etc.	No
Silt	No
Rip Rap	Needs More

Comments
Culvert in fair to good condition. Some internal staining with some rust. Flat grade but not within a major flow path. Capacity is noted as inadequate from capacity analysis however this is mainly due to pipe slope and not high flow. Recommend not to rate capacity as inadequate but as 25 year capacity.

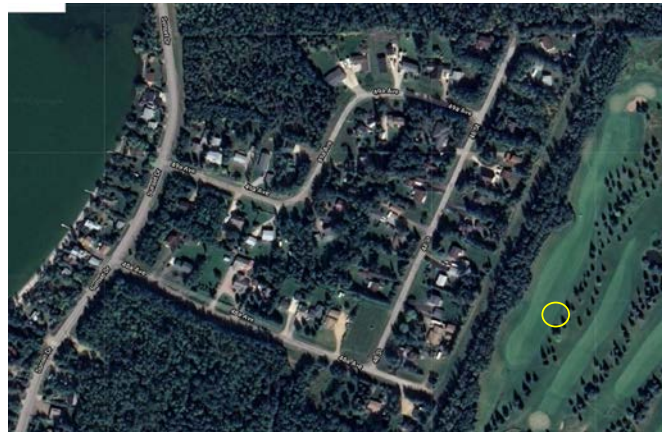
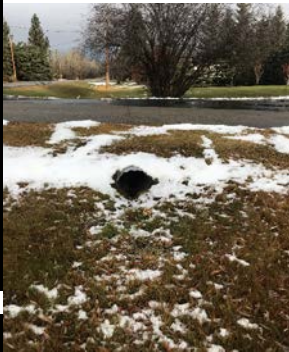
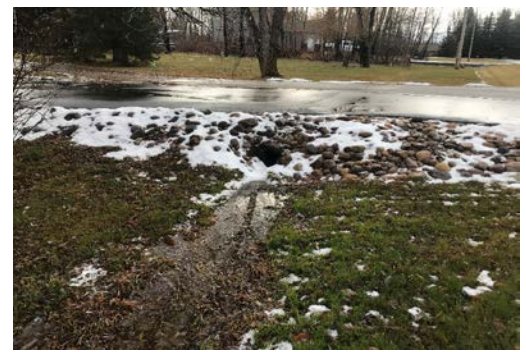
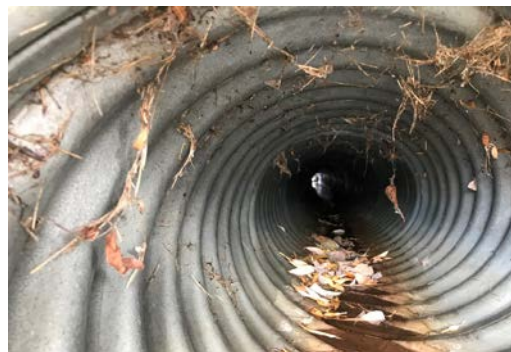
**Culvert Improvement
Cost Estimate**Date: Saturday, February 15, 2020
Culvert: 2681 - F31

Inlet / Outlet Protection	Rating
Channel scour at Inlet/Outlet	No
Embankment Erosion	No
Sideslopes too Steep	No
Drift - wood, debris around pipe	No
Vegetation - trees, brush etc.	No
Silt	No
Rip Rap	Needs More

Comments
Culvert in good condition. Ponding in the ditch due to poor ditch grading. Lots of rock, but very little rock for apron.

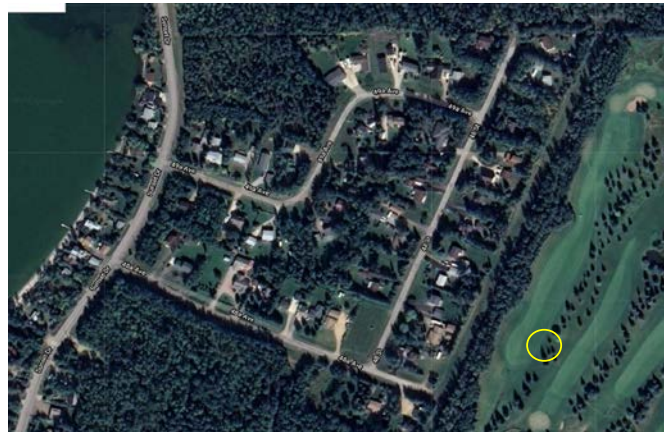
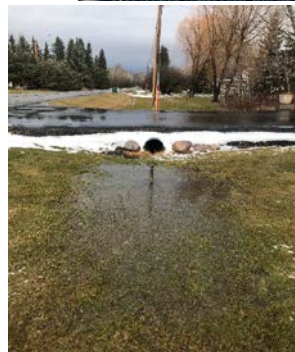
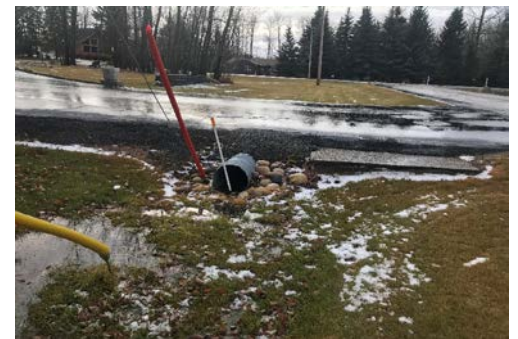
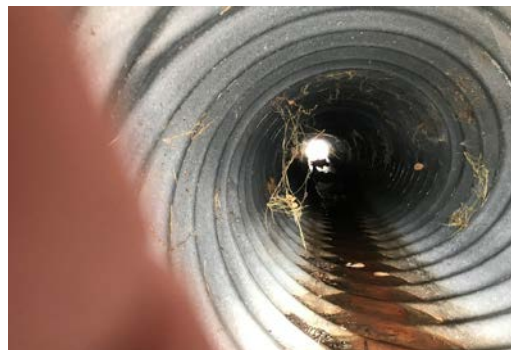
**Culvert Improvement
Cost Estimate**Date: Saturday, February 15, 2020
Culvert: 2682 - F15

Inlet / Outlet Protection	Rating
Channel scour at Inlet/Outlet	No
Embankment Erosion	No
Sideslopes too Steep	No
Drift - wood, debris around pipe	No
Vegetation - trees, brush etc.	No
Silt	No
Rip Rap	Needs More

Comments
Culvert in very good condition. Ponding in the ditch due to poor ditch grading. Culvert is sticking out on one end which is hazardous.

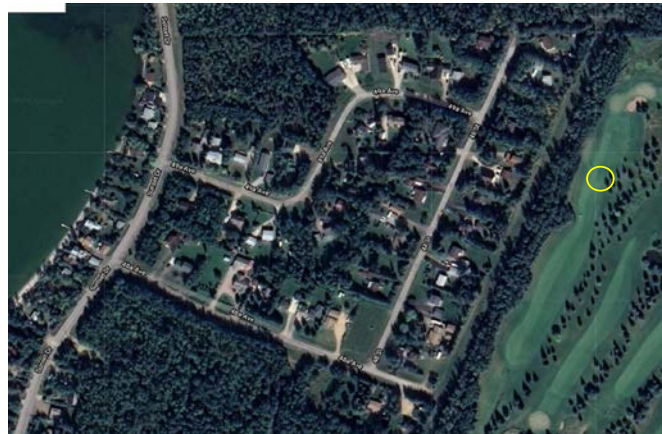
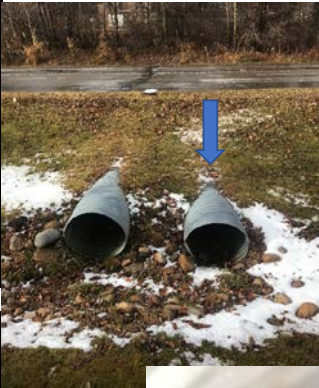
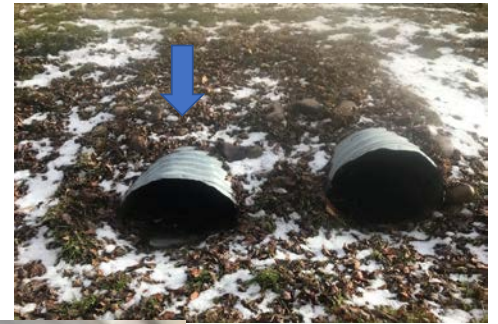
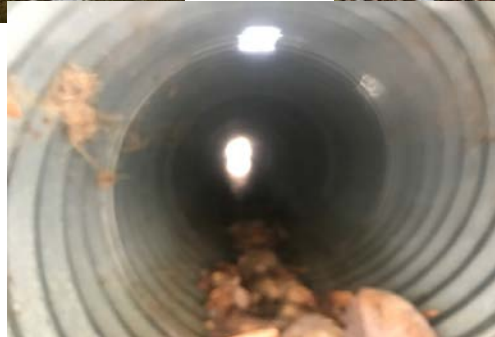
**Culvert Improvement
Cost Estimate**Date: Saturday, February 15, 2020
Culvert: 2683 - F16

Overall Rating
2

Comments
Culvert interior is in very good condition. Culverts stick out too much and need sloped ends. With future drainage re-direction upstream at the old railway embankment, this flow path will change from a Major Flow path to a Minor Flow path. Recommend once this culvert has aged and reached its design life, replace with one 800mm diameter culvert.

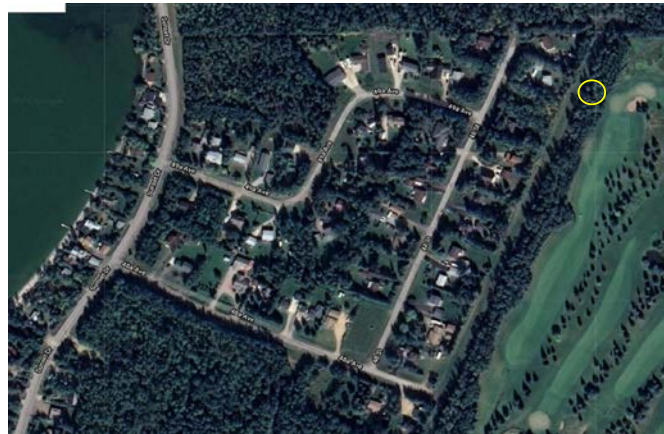
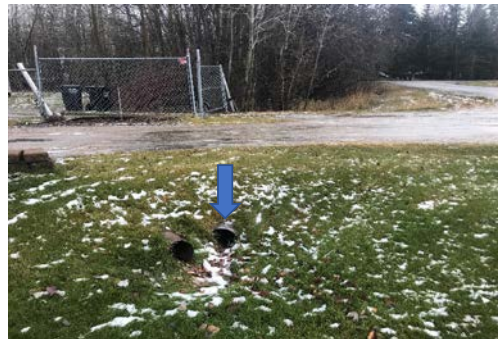
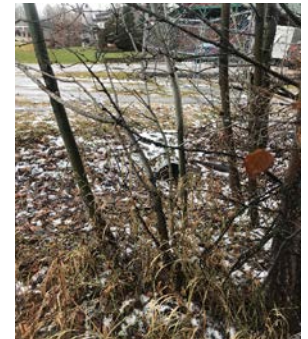
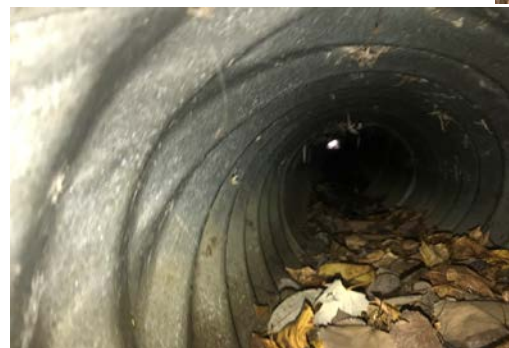
Culvert in fair condition (S. Culvert). Approach is not paved. Bushes near east end will make drainage difficult and should be cleared. When replaced, it is important to re-set slope on culvert to ensure flow is from east to west. Second culvert (smoothwall) is private and drains Lot 12 into ditch. This private culvert makes approach culvert redundant. Lot grading should be reviewed before any replacement work is done. Ideally, this location should be reduced to 1 culvert.

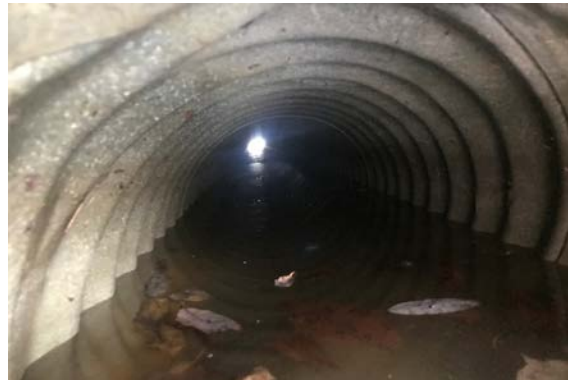
Comments
Culvert in fair condition (S. Culvert). Approach is not paved. Some issues with deformation. Bushes near ends will make drainage difficult and should be cleared. When replaced, it is important to re-set slope on culvert to ensure flow is from east to west.

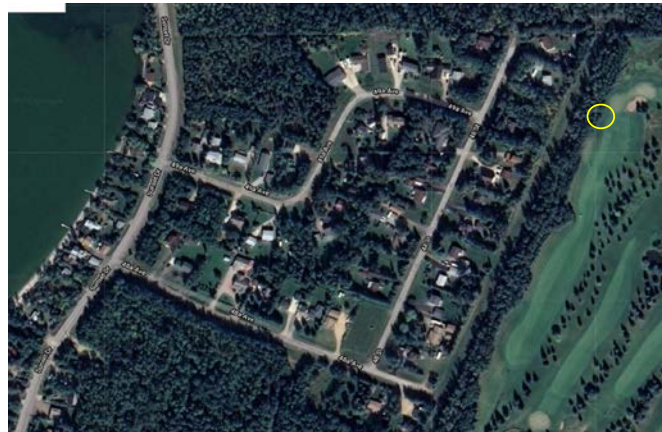
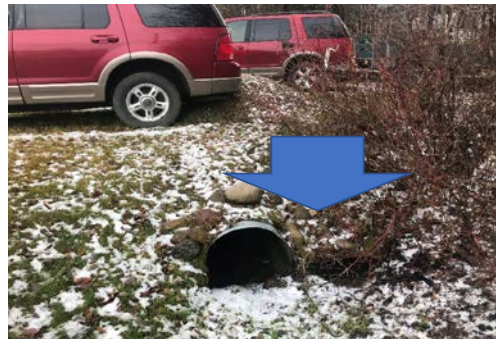
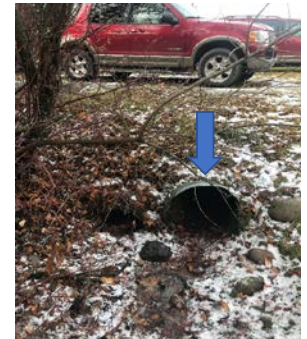
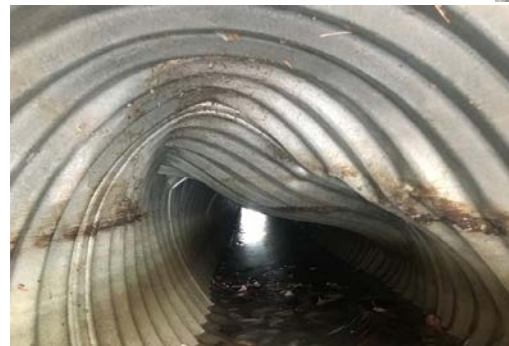
Pipe Barrel	Rating
Blockage	No
Submerged in Water	No
Inlet Damage	No
Outlet damage	No
Corrosion / Abrasion	No
Out of Round	Yes
Settlement	No
Sag / Bow	No
Infiltration	No
Piping	No
Cracking	No

Comments
Culvert in poor condition (N. Culvert) and has reduced capacity. Approach is not paved. Bushes near ends will make drainage difficult and should be cleared. When replaced, it is important to re-set slope on culvert to ensure flow is from east to west.

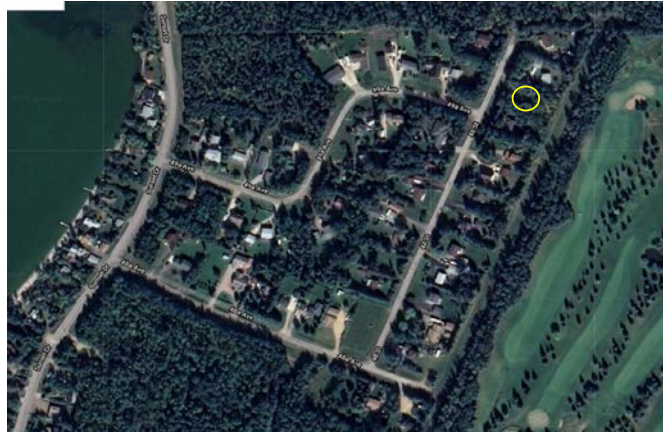
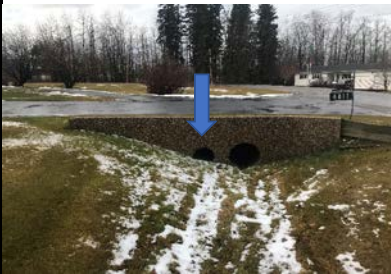
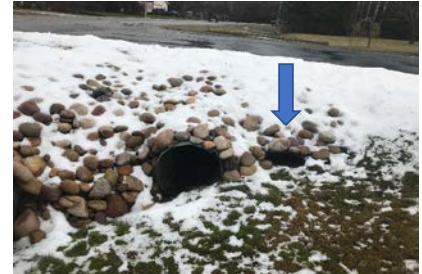
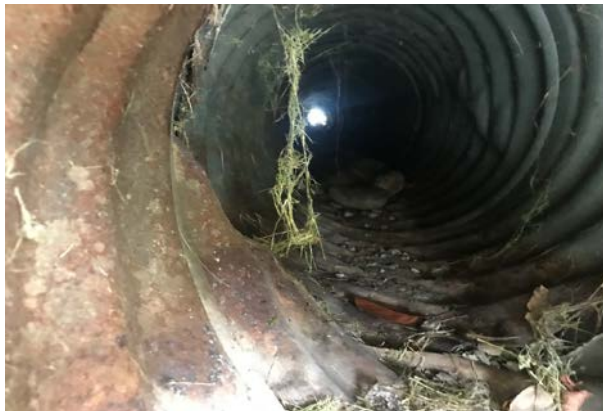
Pipe Barrel	Rating
Blockage	No
Submerged in Water	No
Inlet Damage	No
Outlet damage	No
Corrosion / Abrasion	Yes
Out of Round	No
Settlement	No
Sag / Bow	No
Infiltration	No
Piping	No
Cracking	No

Comments
Culvert in fair condition. Rusting should be monitored. Approach is paved with a headwall on the east side.

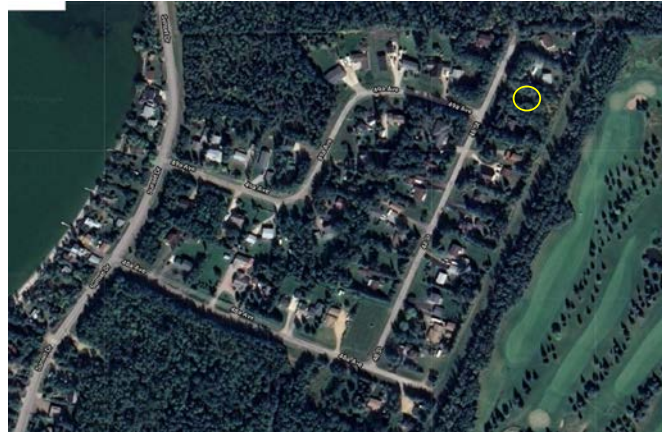
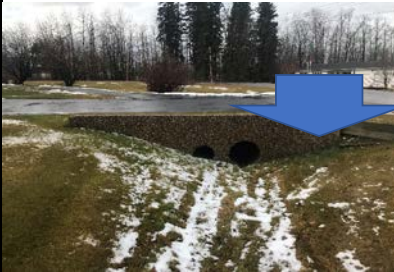
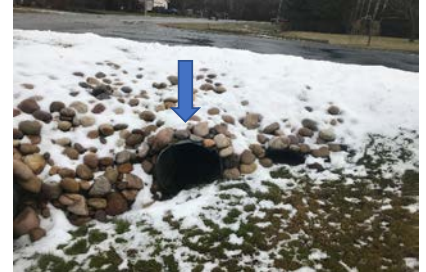
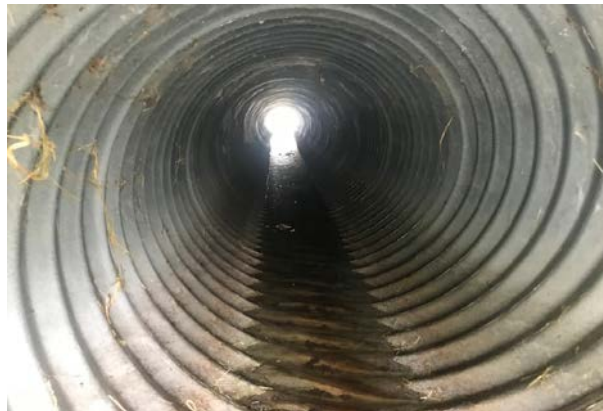
Comments
Culvert in very good condition. Approach is paved with a headwall on the east side.

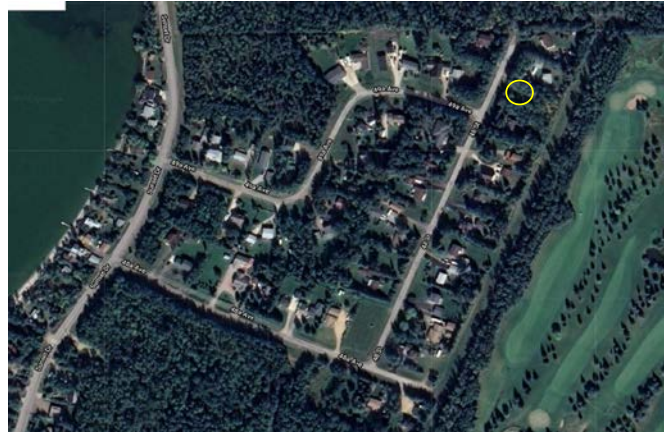
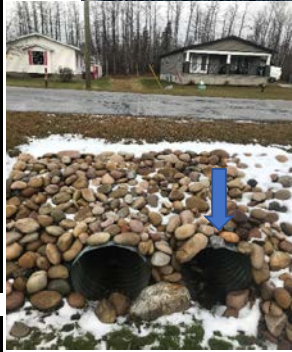
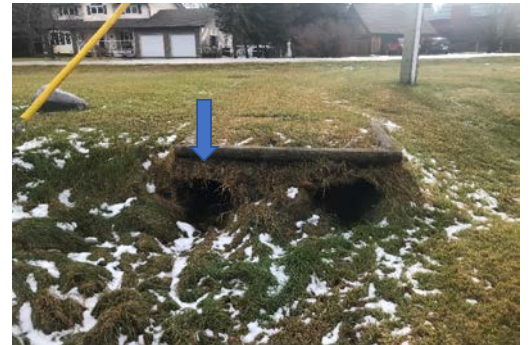
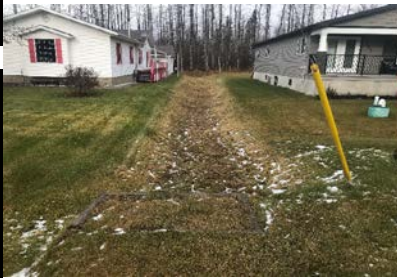
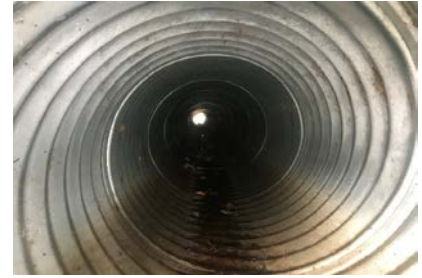
Comments
Culvert in very good condition. Steep sideslope on south side; grassed headwall north side. When replacing, ensure to provide some slope from south the north.

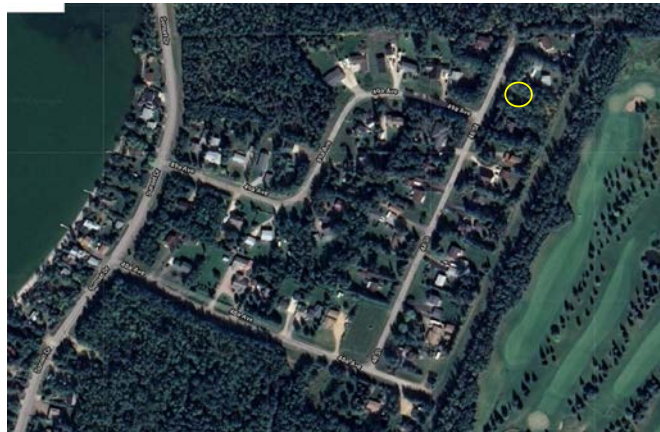
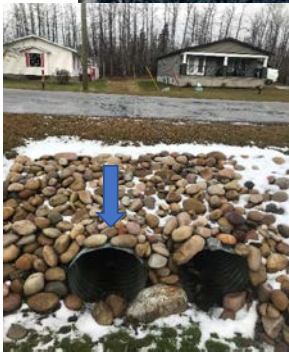
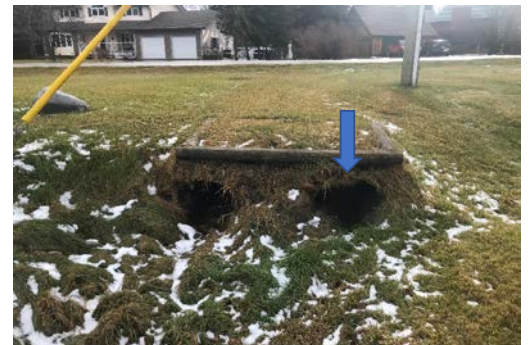
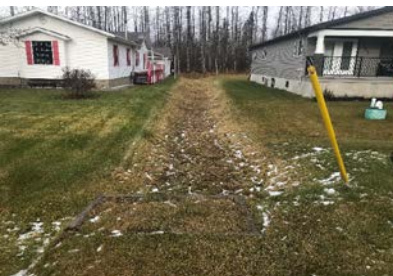
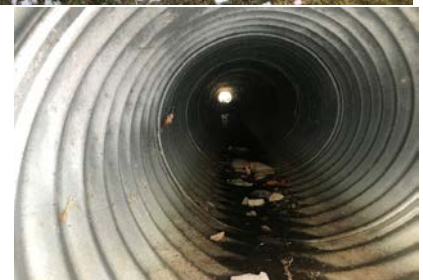
Comments
Culvert in very good condition. Steep sideslope on south side; grassed headwall north side. When replacing, ensure to provide some slope from south the north.

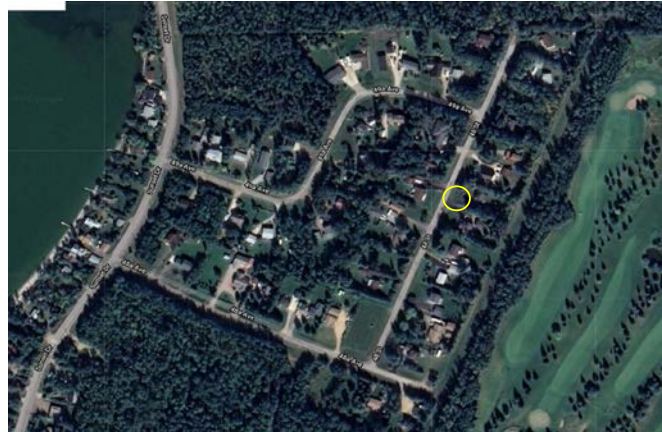
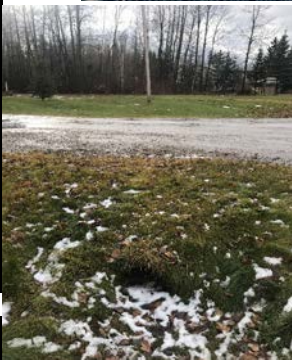
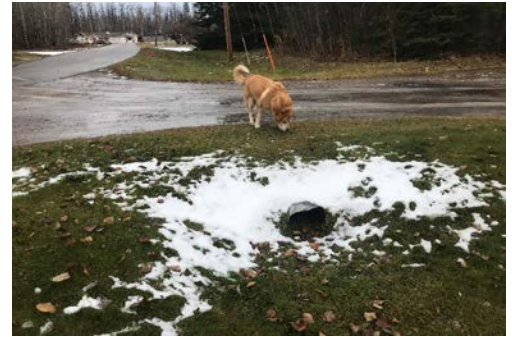
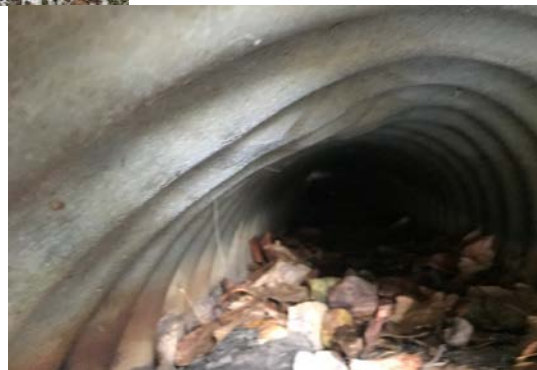
Pipe Barrel	Rating
Blockage	No
Submerged in Water	No
Inlet Damage	No
Outlet damage	No
Corrosion / Abrasion	No
Out of Round	Yes
Settlement	No
Sag / Bow	No
Infiltration	No
Piping	No
Cracking	No

Comments
Culvert in poor condition. Approach is paved. Culvert end is deformed as dog is pointing out.

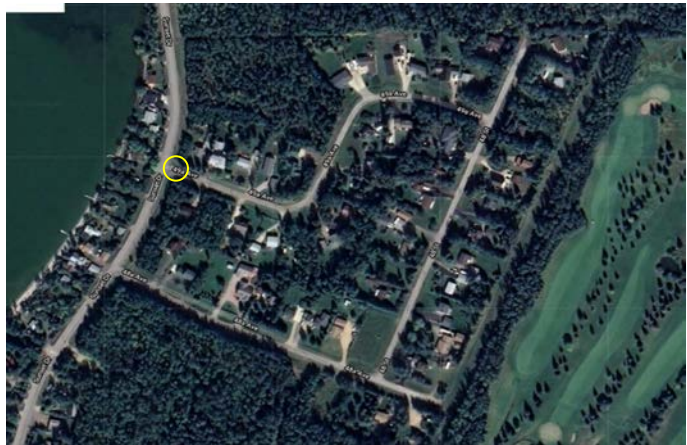
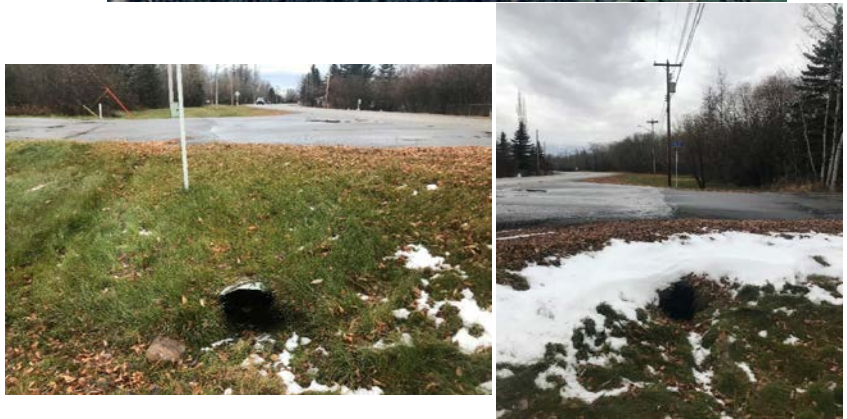
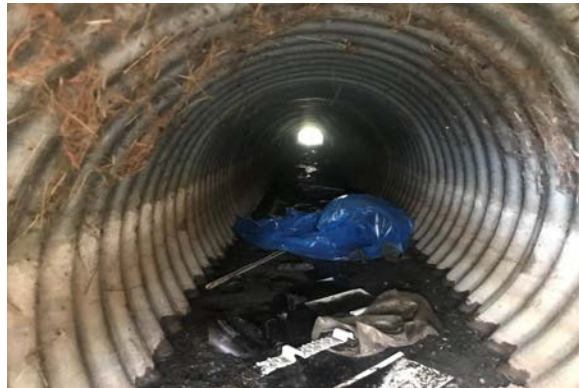
Inlet / Outlet Protection	Rating
Channel scour at Inlet/Outlet	No
Embankment Erosion	No
Sideslopes too Steep	Yes
Drift - wood, debris around pipe	No
Vegetation - trees, brush etc.	No
Silt	No
Rip Rap	None

Comments
Needs sloped ends with rip rap. Make longer 1m per end. No signs of capacity issues such as flowing over road. No ponding evident.

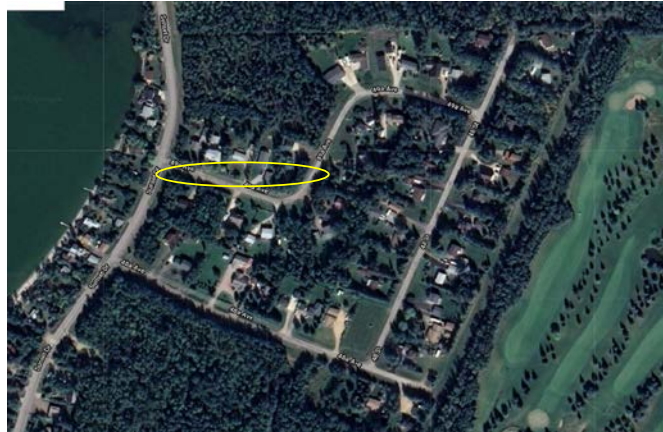
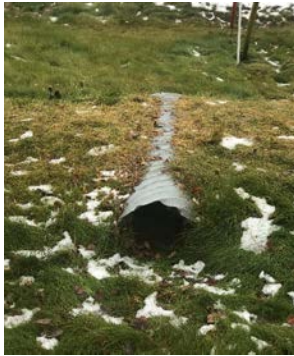
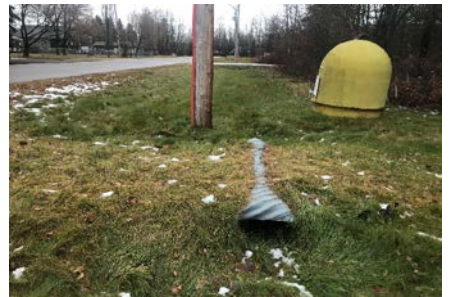
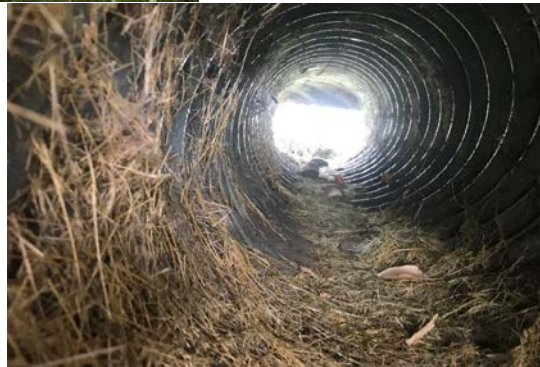
Pipe Barrel	Rating
Blockage	No
Submerged in Water	No
Inlet Damage	No
Outlet damage	Yes
Corrosion / Abrasion	No
Out of Round	No
Settlement	No
Sag / Bow	No
Infiltration	No
Piping	No
Cracking	No

Comments
Culvert in fair to good condition. Culvert alignment is poor to flow with ditch to the east.

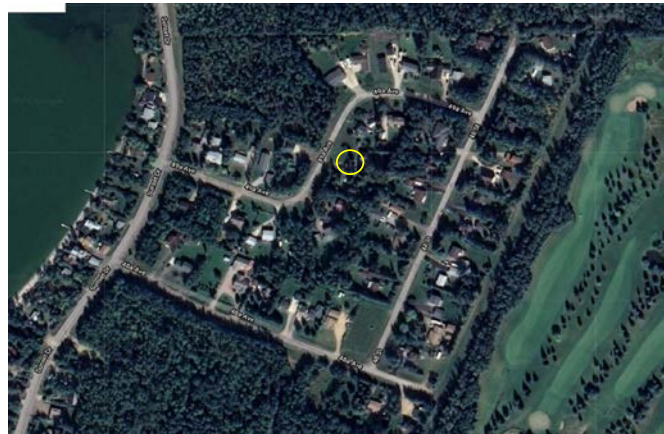
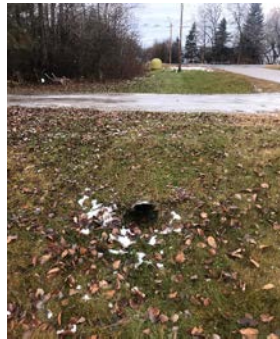
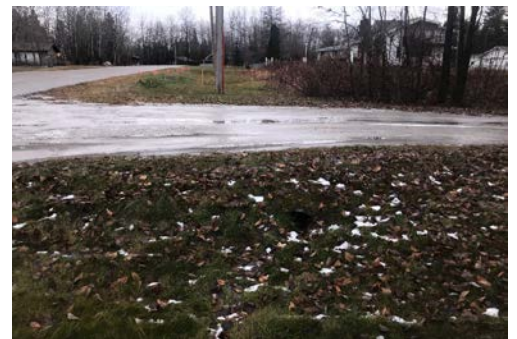
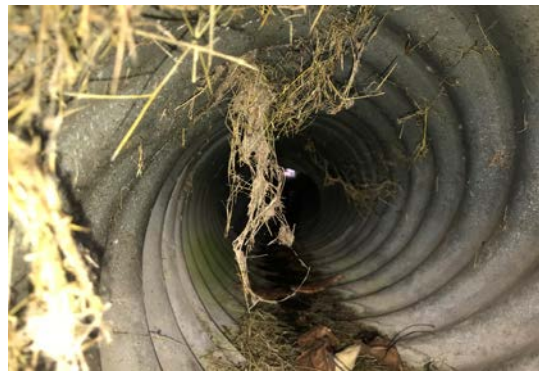
Comments
Culvert in fair to poor condition. Approach is paved. Bent on the end.

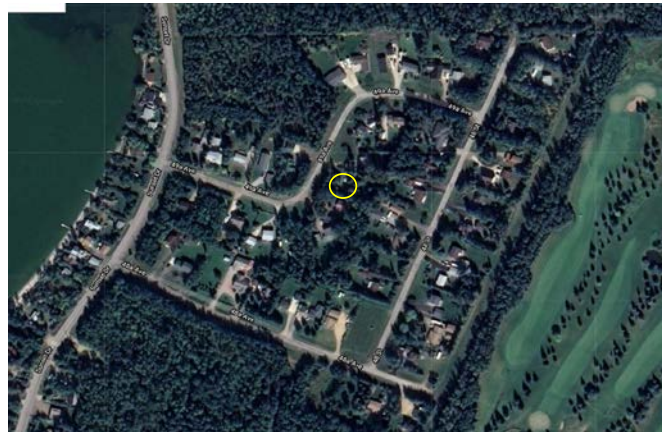
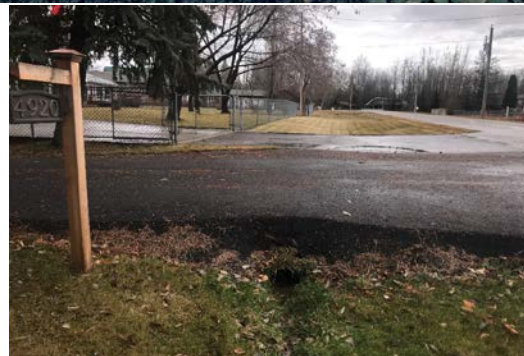
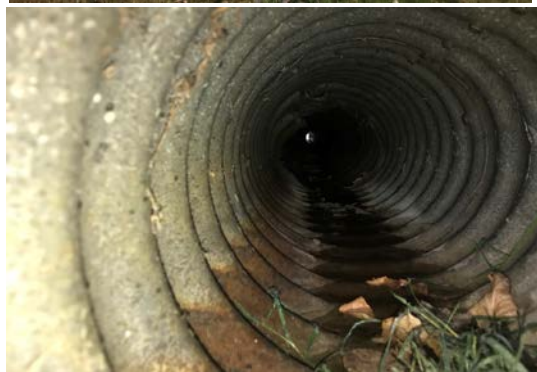
Comments
Culvert in fair to poor condition. Approach is paved. Barely could see through.

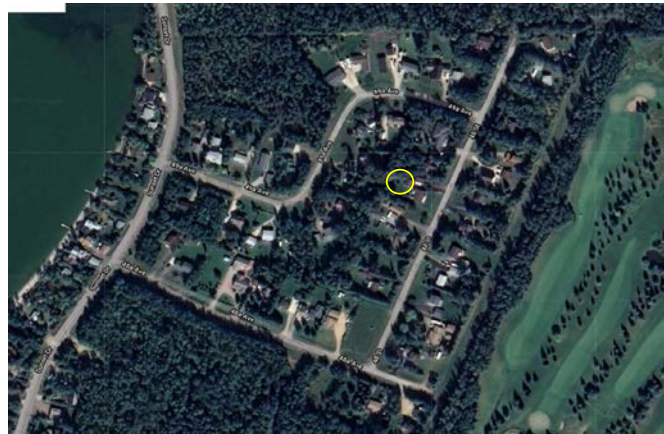
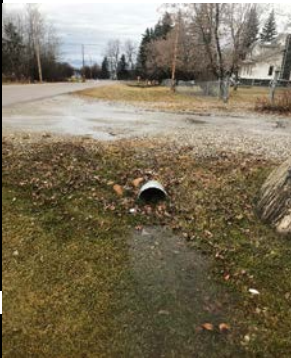
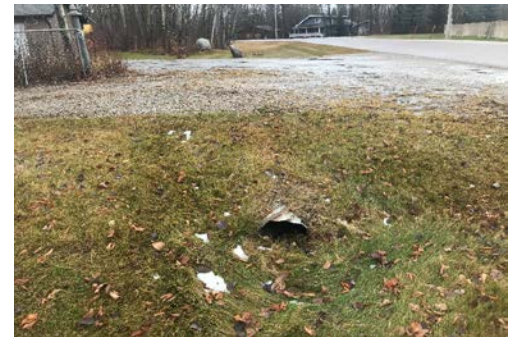
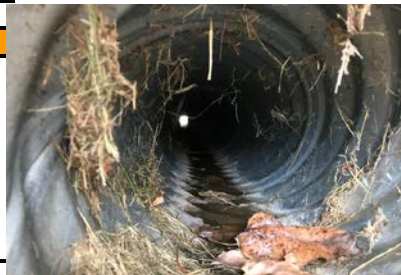
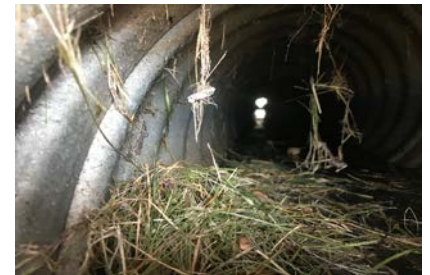
Comments
Culvert in good to fair condition. Approach is not paved. Culvert end on the east was recently extended by 4m. Still old original culvert in the ground from the west.

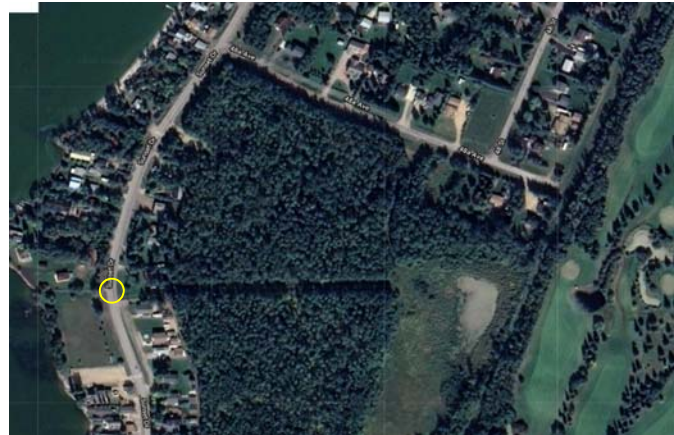
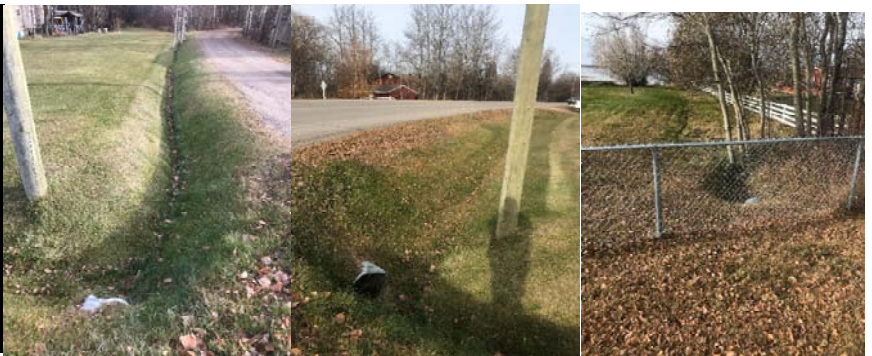
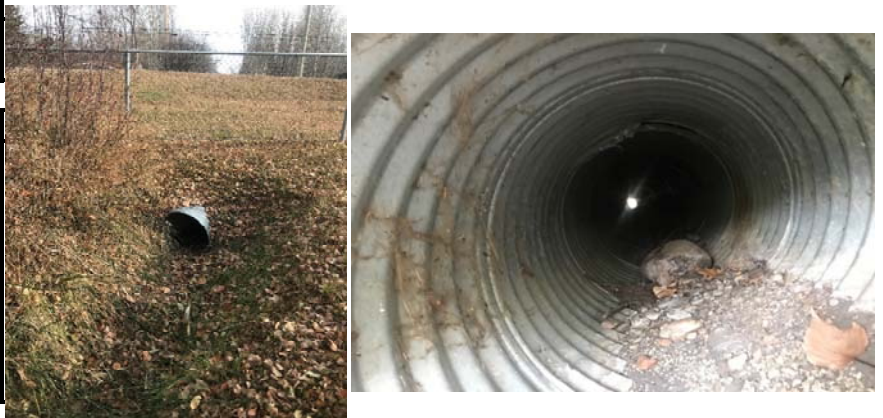
Inlet / Outlet Protection	Rating
Channel scour at Inlet/Outlet	No
Embankment Erosion	No
Sideslopes too Steep	Yes
Drift - wood, debris around pipe	No
Vegetation - trees, brush etc.	Yes
Silt	No
Rip Rap	None

Comments
 This crossing is for a Major Flow Path for an undeveloped area. The existing 600mm Dia. culvert maybe too small for future flow upstream. Needs sloped ends with rip rap. Make longer 1m per end. Potentially included **IN PROJECT #4. Could consider just adding 1 - 800mm Dia. CSP and leaving the existing 600mm Dia. CSP. Down drain open channel may require additional berm on the north side to ensure flow does not enter lot.**

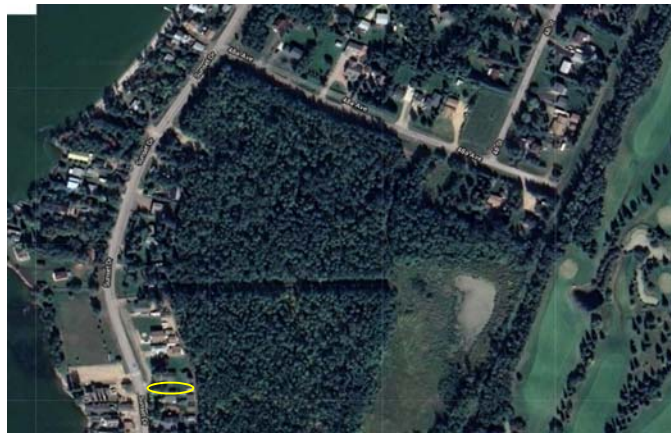
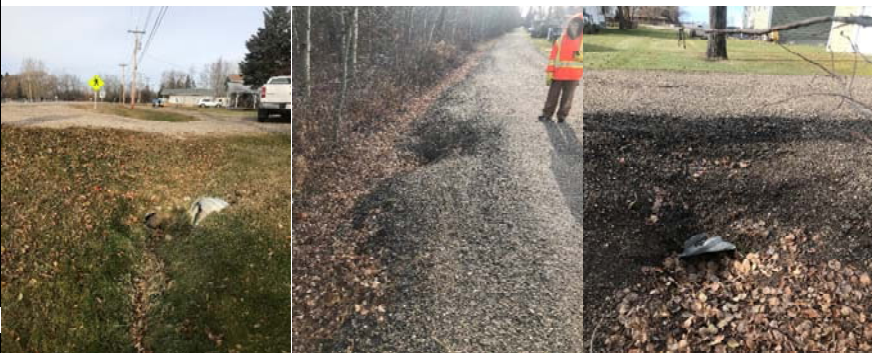
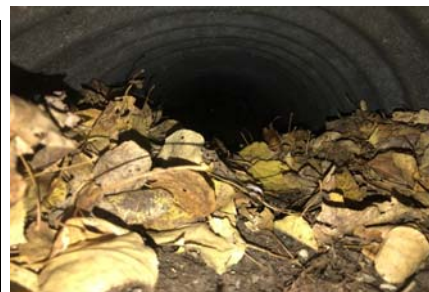
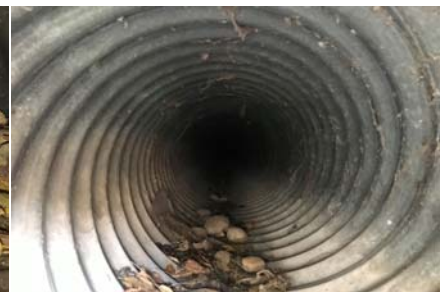
Comments
 This culvert is very long with several issues. The inlet is within the road surface and presents a safety concern. Cannot verify if this culvert is plugged due to the length. There is significant siltation at the inlet end. The outlet end appears to be in good condition. Overall, it is appears that this culvert is not functioning as there is little evidence of flow from the outlet. Culvert should be unplugged immediately and lengthened on the inlet end. Needs rip rap. Recommend to replace with an 1 - 800mm Dia. CSP. or open channel. **PROJECT #4.**

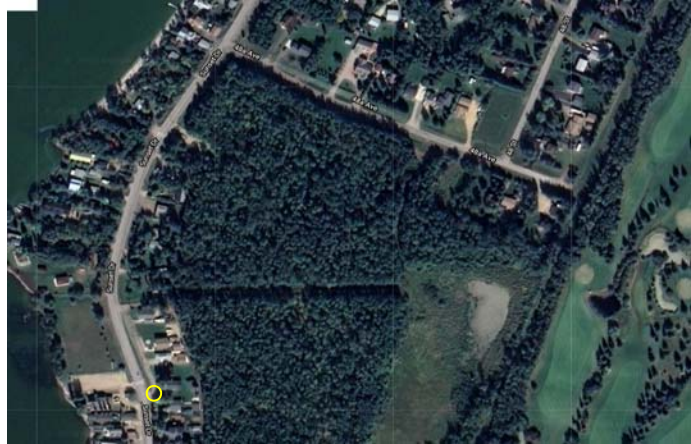
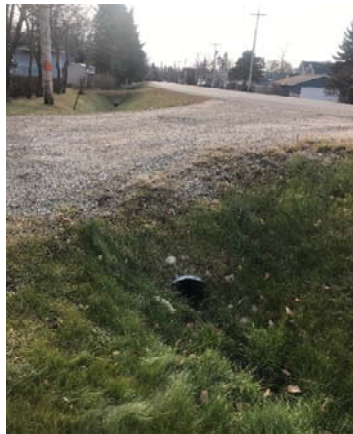
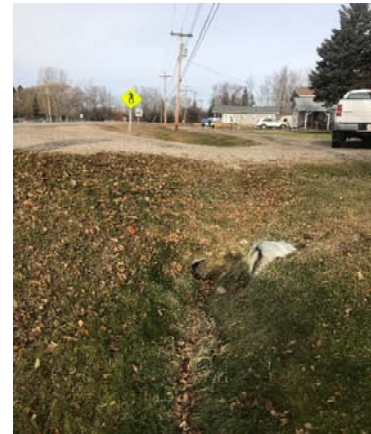
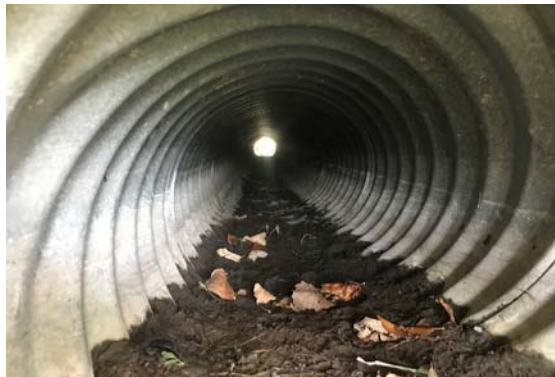
**Culvert Improvement
Cost Estimate**Date: February 15, 2020
Culvert: 2203-B05

Inlet / Outlet Protection	Rating
Channel scour at Inlet/Outlet	No
Embankment Erosion	No
Sideslopes too Steep	Yes
Drift - wood, debris around pipe	No
Vegetation - trees, brush etc.	No
Silt	Yes
Rip Rap	None

Comments
Culvert appears to be in fair to good condition but undersized. Capacity is of concern now. When time to be replaced, replace with 800mm Dia. CSP with sloped ends with rip rap. **PROJECT #4.**

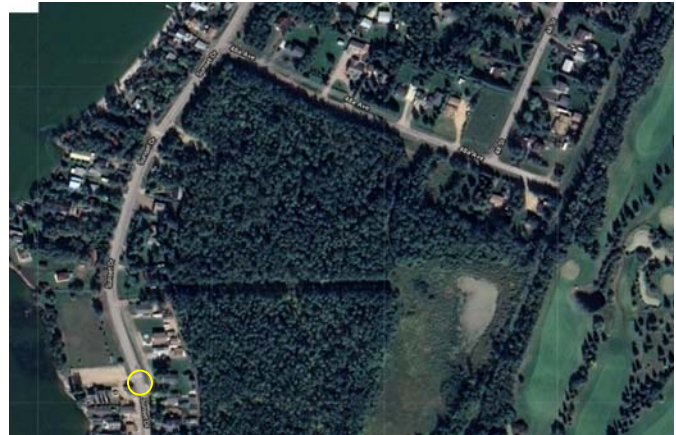
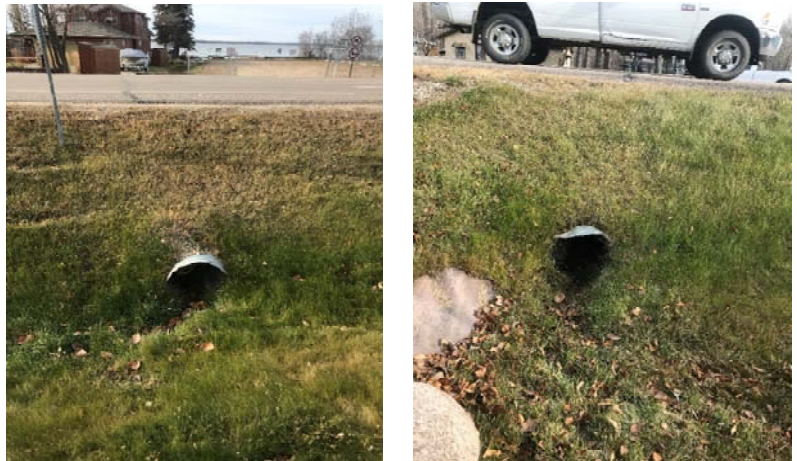
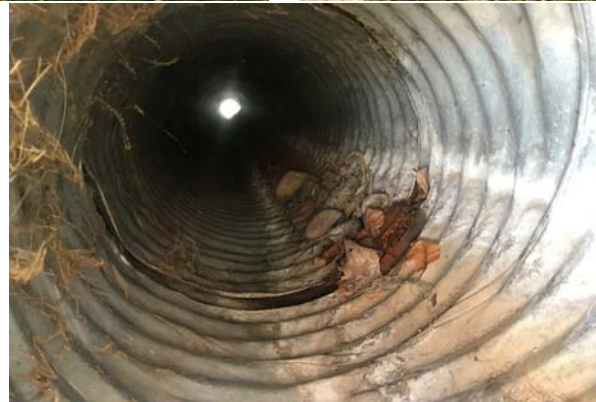
Pipe Barrel	Rating
Blockage	No
Submerged in Water	No
Inlet Damage	Yes
Outlet damage	No
Corrosion / Abrasion	Yes
Out of Round	No
Settlement	No
Sag / Bow	No
Infiltration	No
Piping	No
Cracking, Separation	Yes

Comments
This culvert is in fair to good condition. The existing 600mm Dia. culvert maybe too small for future flow upstream. Needs sloped ends with rip rap. Make longer 1m per end. Replace when aged out with an 1 - 800mm Dia. CSP. PROJECT #4.

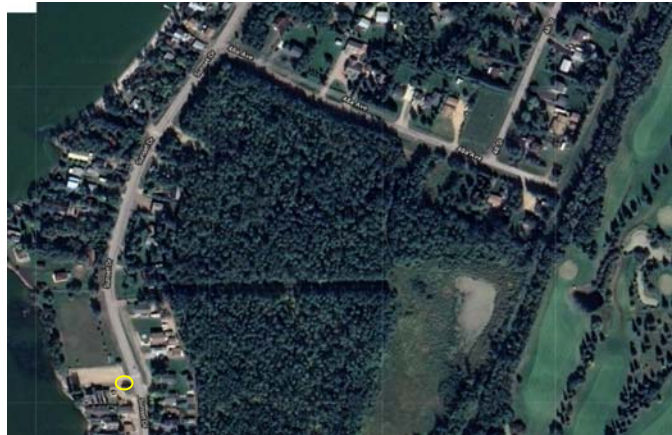
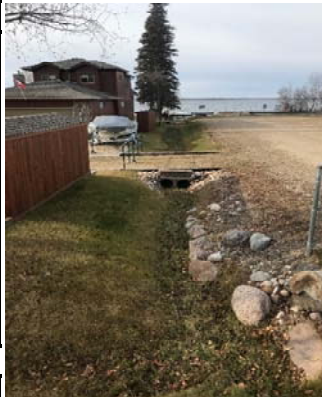
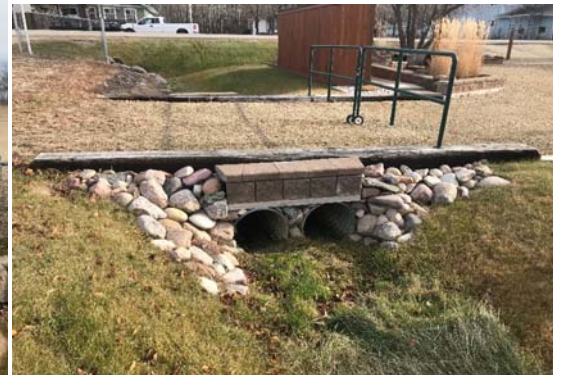
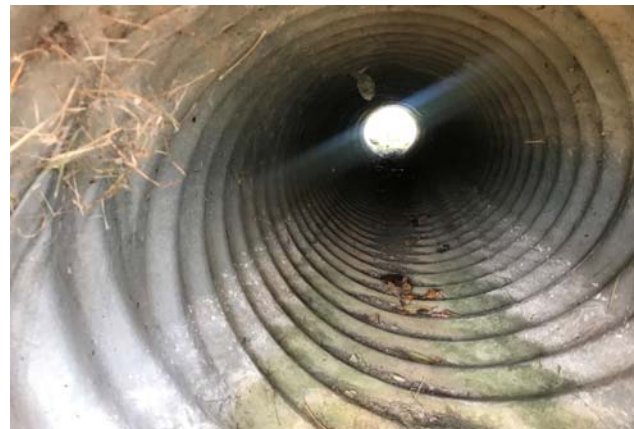
Inlet / Outlet Protection	Rating
Channel scour at Inlet/Outlet	No
Embankment Erosion	No
Sideslopes too Steep	No
Drift - wood, debris around pipe	No
Vegetation - trees, brush etc.	No
Silt	No
Rip Rap	Needs Apron

Comments
 This culvert is in good condition. The existing 400mm Dia. culvert maybe too small for future flow upstream. Needs sloped ends with rip rap. Replace when aged out with an 1 - 600mm Dia. CSP.
PROJECT #4.
