EXISTING INFRASTRUCTURE REVIEW

1. Drainage & Culvert Review

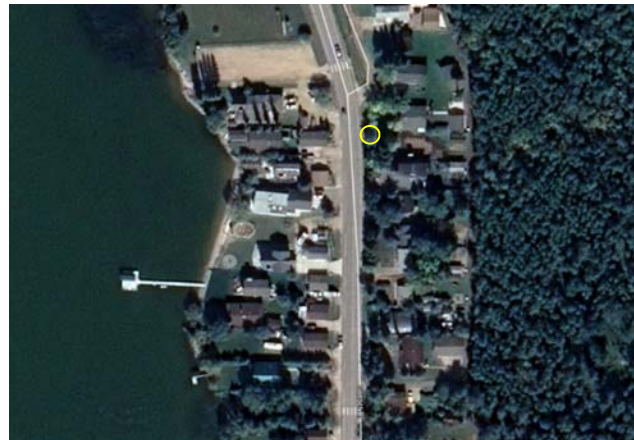
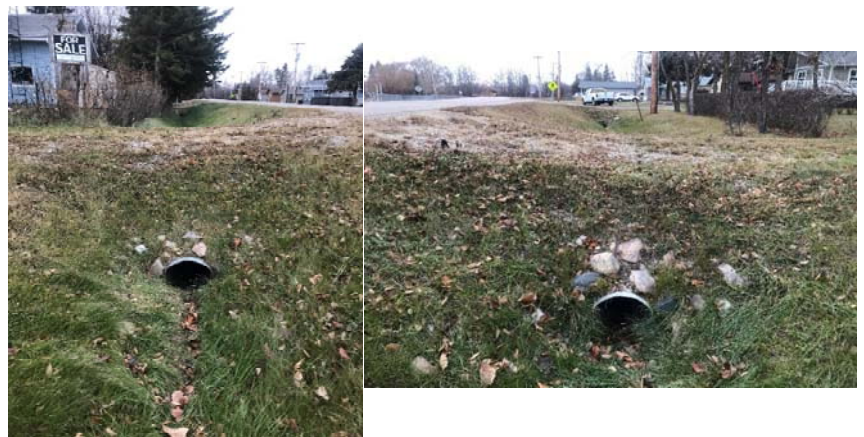
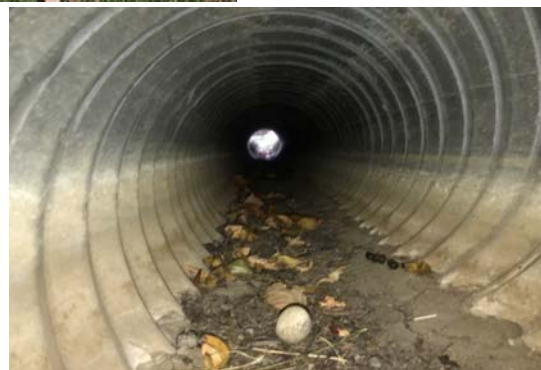
Inlet / Outlet Protection	Rating
Channel scour at Inlet/Outlet	No
Embankment Erosion	No
Sideslopes too Steep	No
Drift - wood, debris around pipe	No
Vegetation - trees, brush etc.	No
Silt	Yes
Rip Rap	Needs Aprons

Comments
Culvert appears to be in fair to good condition. Small culvert that should be larger just to maintain flow and availability for cleaning out. Recommend when comes time for replacement, replace with 500mm Dia. CSP with sloped ends and rip rap.

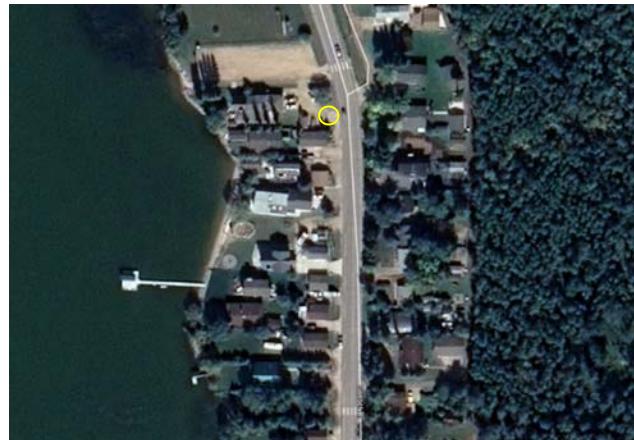
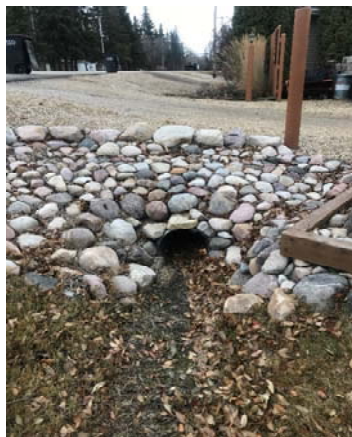
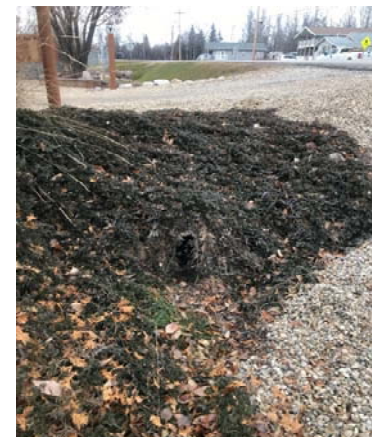
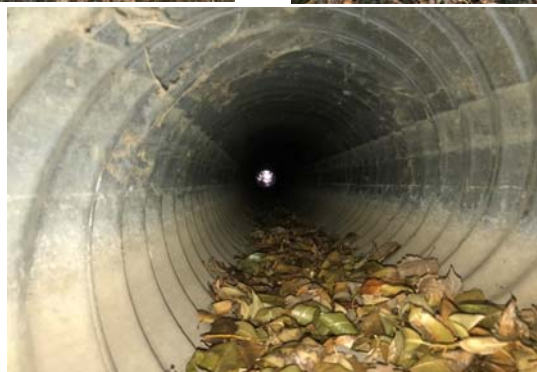
Inlet / Outlet Protection	Rating
Channel scour at Inlet/Outlet	No
Embankment Erosion	No
Sideslopes too Steep	No
Drift - wood, debris around pipe	No
Vegetation - trees, brush etc.	No
Silt	No
Rip Rap	Needs Aprons

Comments
Culvert appears to be in fair to good condition. Small culvert that should be larger just to maintain flow and availability for cleaning out. Recommend when comes time for replacement, replace with 500mm Dia. CSP with sloped ends and rip rap.

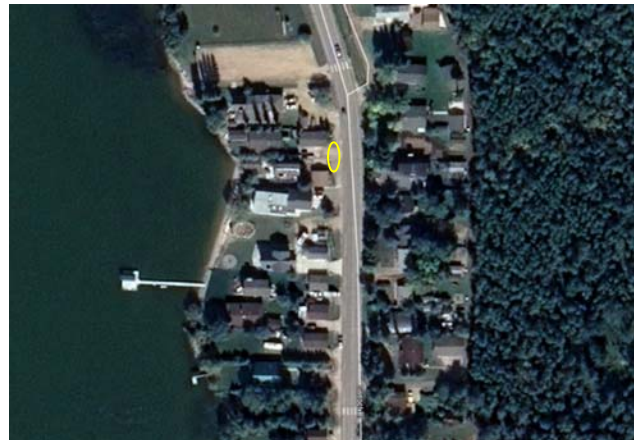
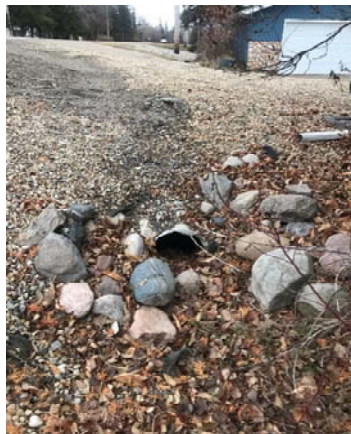
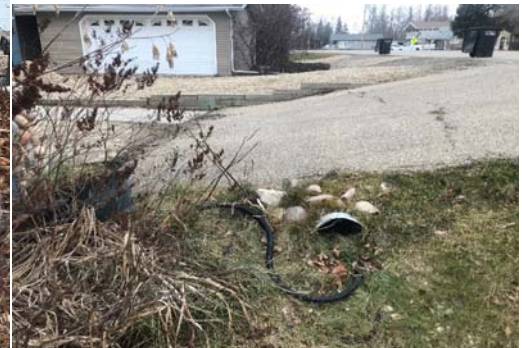
Inlet / Outlet Protection	Rating
Channel scour at Inlet/Outlet	No
Embankment Erosion	No
Sideslopes too Steep	No
Drift - wood, debris around pipe	No
Vegetation - trees, brush etc.	Yes
Silt	Yes
Rip Rap	Needs Aprons

Comments
Culvert appears to be in fair condition. Small culvert that should be larger just to maintain flow and availability for cleaning out. Recommend when comes time for replacement, replace with 500mm Dia. CSP with sloped ends and rip rap. **Review slope of culvert as water is sitting within culvert. Also, the ditch could use some reshaping as there is very little backslope and this could allow flow to go into the lot.**

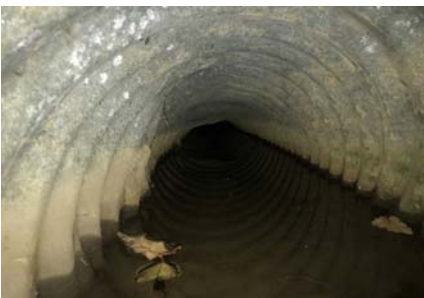
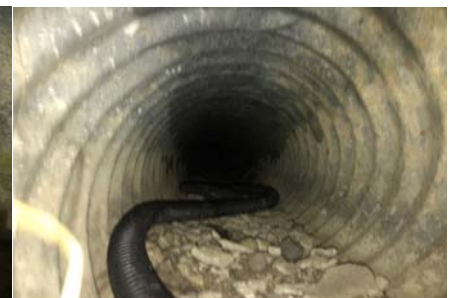
Pipe Barrel	Rating
Blockage	No
Submerged in Water	No
Inlet Damage	No
Outlet damage	No
Corrosion / Abrasion	Yes
Out of Round	No
Settlement	No
Sag / Bow	No
Infiltration	No
Piping	No
Cracking	No

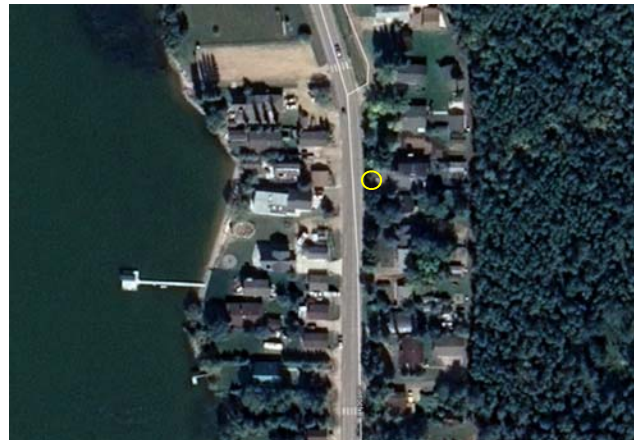
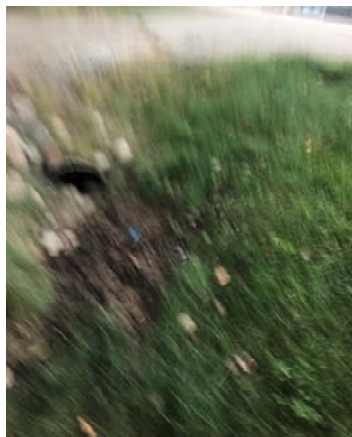
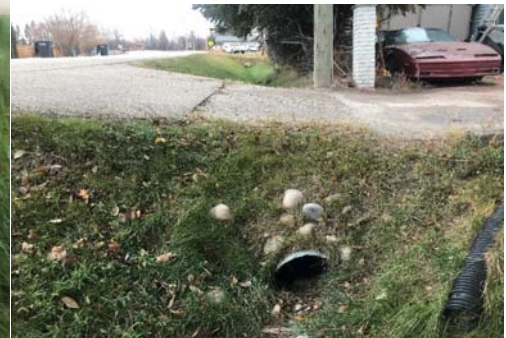
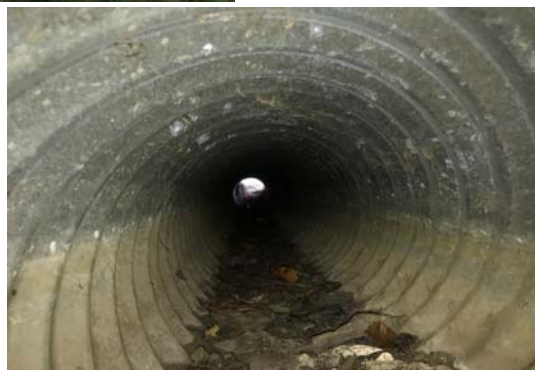
Comments
Culvert appears to be in fair to good condition. Small culvert that should be larger just to maintain flow and availability for cleaning out. Recommend when comes time for replacement, replace with 500mm Dia. CSP with sloped ends and rip rap.

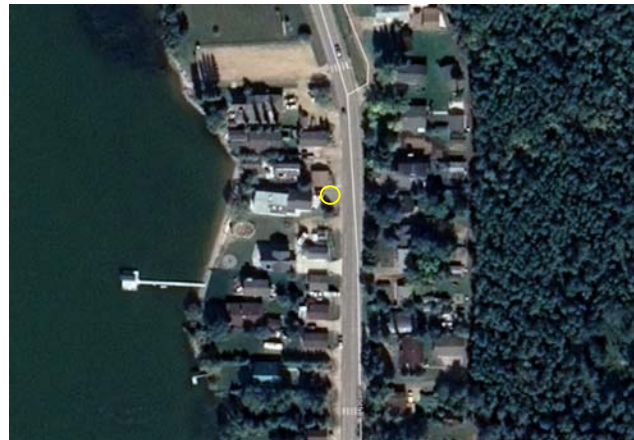
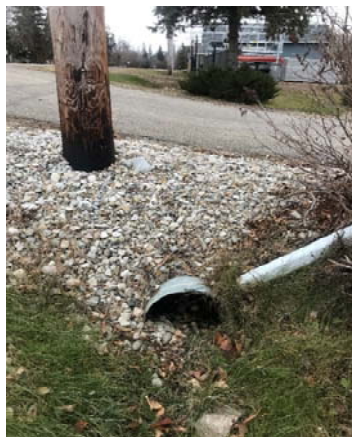
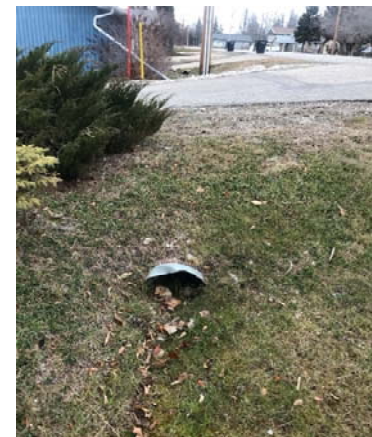
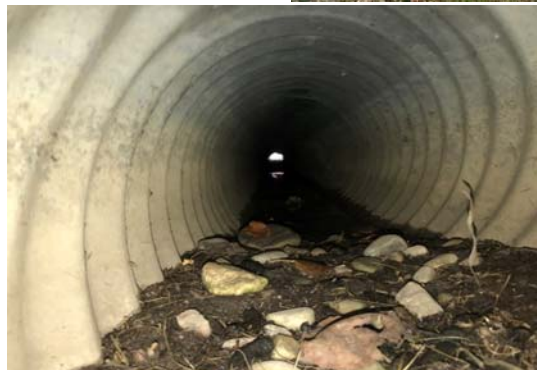
**Culvert Improvement
Cost Estimate**Date: February 15, 2020
Culvert: 2211- B14

Inlet / Outlet Protection	Rating
Channel scour at Inlet/Outlet	No
Embankment Erosion	No
Sideslopes too Steep	No
Drift - wood, debris around pipe	No
Vegetation - trees, brush etc.	No
Silt	Yes
Rip Rap	Needs Aprons

Comments
Culvert appears to be in fair to good condition. Small culvert that should be larger just to maintain flow and availability for cleaning out. Recommend when comes time for replacement, replace with 500mm Dia. CSP with sloped ends and rip rap.

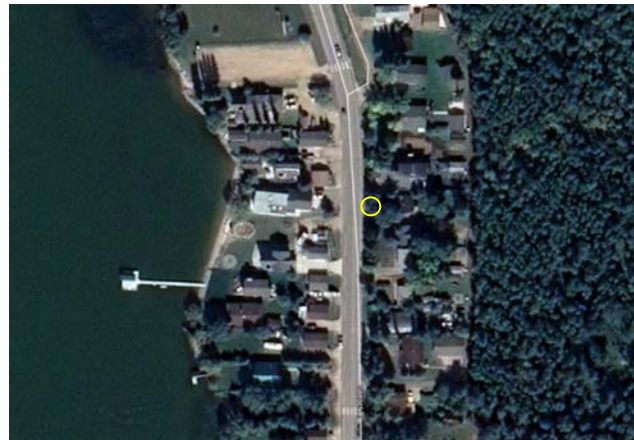
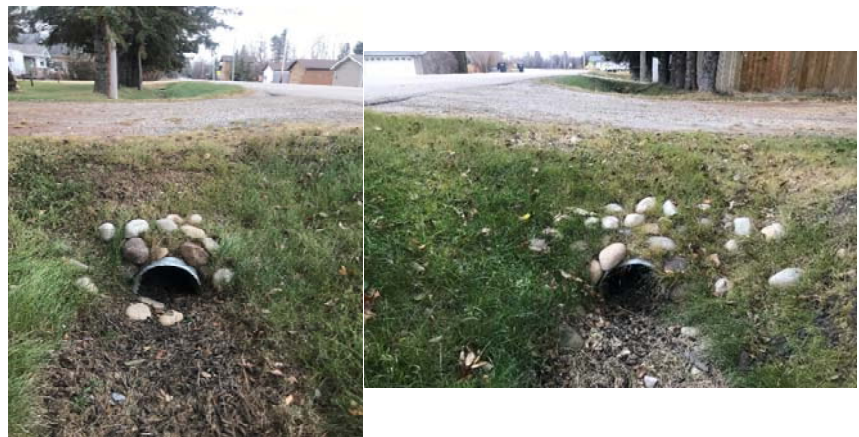
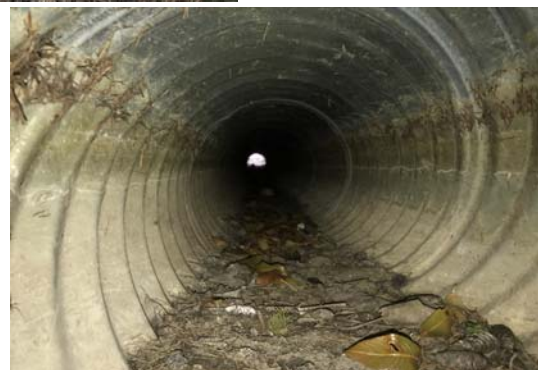
**Culvert Improvement
Cost Estimate**Date: February 15, 2020
Culvert: 2212 - B08

Inlet / Outlet Protection	Rating
Channel scour at Inlet/Outlet	No
Embankment Erosion	No
Sideslopes too Steep	No
Drift - wood, debris around pipe	No
Vegetation - trees, brush etc.	No
Silt	Yes
Rip Rap	Needs Aprons

Comments
Culvert appears to be in fair to good condition. Small culvert that should be larger just to maintain flow and availability for cleaning out. Recommend when comes time for replacement, replace with 500mm Dia. CSP with sloped ends and rip rap.

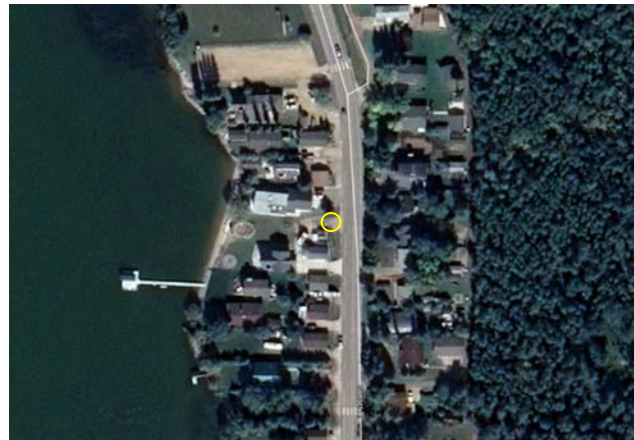
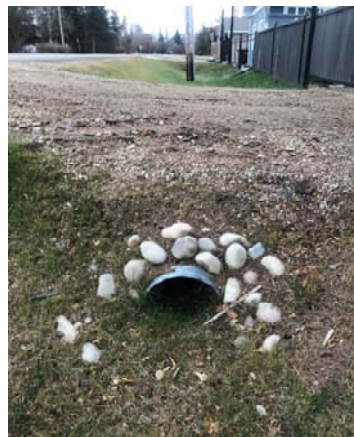
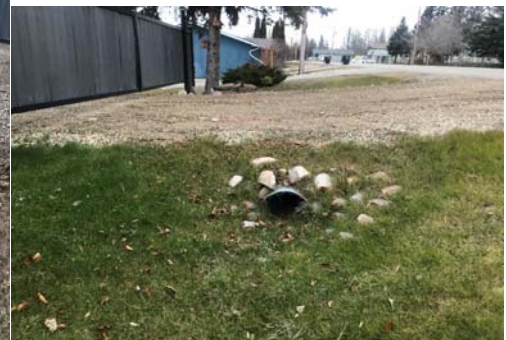
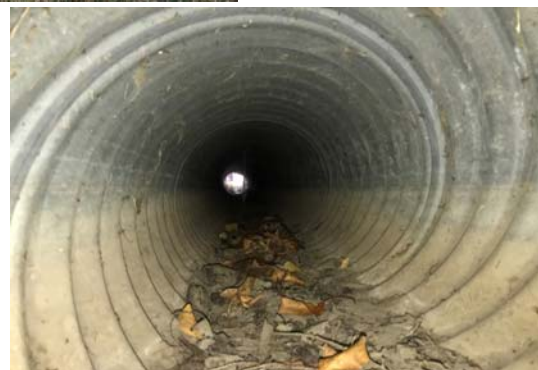
**Culvert Improvement
Cost Estimate**Date: February 15, 2020
Culvert: 2213- B15

Inlet / Outlet Protection	Rating
Channel scour at Inlet/Outlet	No
Embankment Erosion	No
Sideslopes too Steep	No
Drift - wood, debris around pipe	No
Vegetation - trees, brush etc.	No
Silt	No
Rip Rap	Needs Aprons

Comments
Culvert appears to be in fair to good condition. Small culvert that should be larger just to maintain flow and availability for cleaning out. Recommend when comes time for replacement, replace with 500mm Dia. CSP with sloped ends and rip rap.

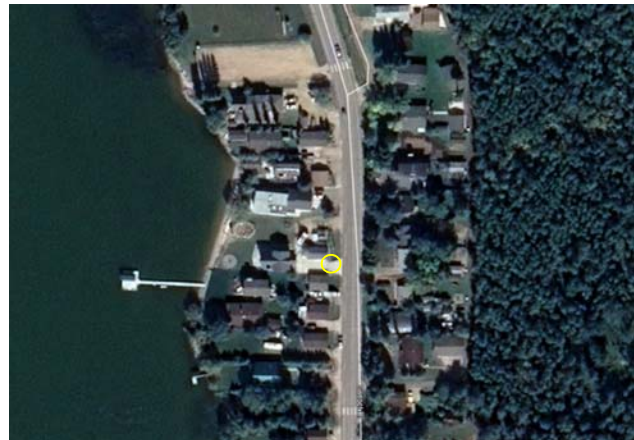
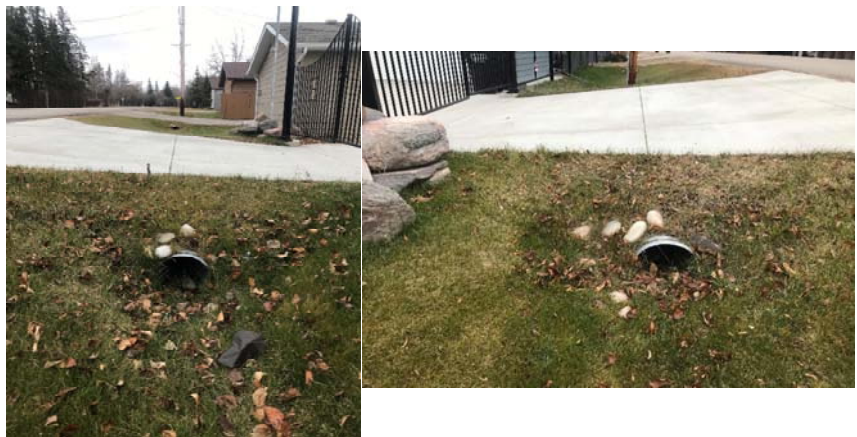
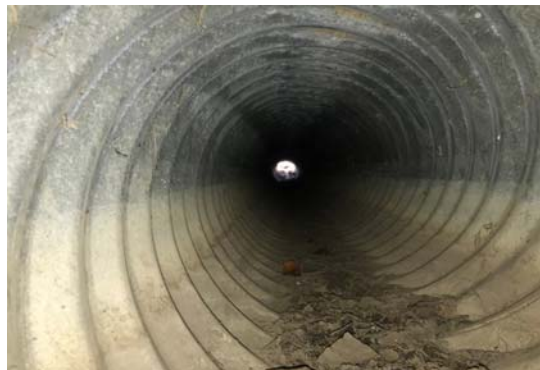
**Culvert Improvement
Cost Estimate**Date: February 15, 2020
Culvert: 2214 - B09

Inlet / Outlet Protection	Rating
Channel scour at Inlet/Outlet	No
Embankment Erosion	No
Sideslopes too Steep	No
Drift - wood, debris around pipe	No
Vegetation - trees, brush etc.	No
Silt	No
Rip Rap	Needs Aprons

Comments
Culvert appears to be in fair to good condition. Small culvert that should be larger just to maintain flow and availability for cleaning out. Recommend when comes time for replacement, replace with 500mm Dia. CSP with sloped ends and rip rap.

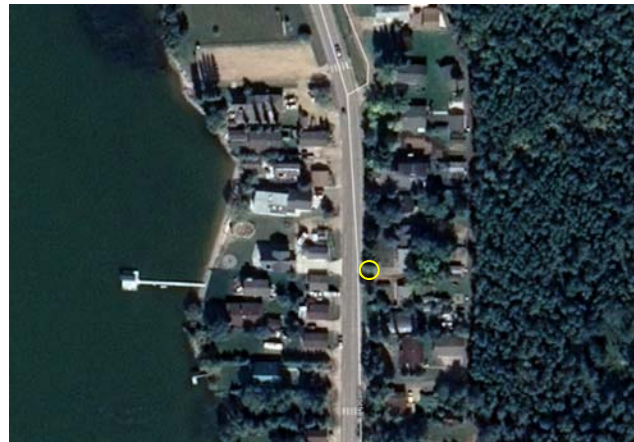
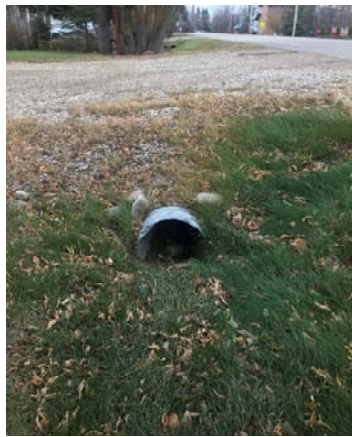
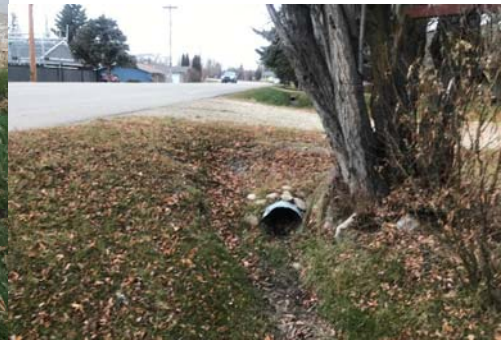
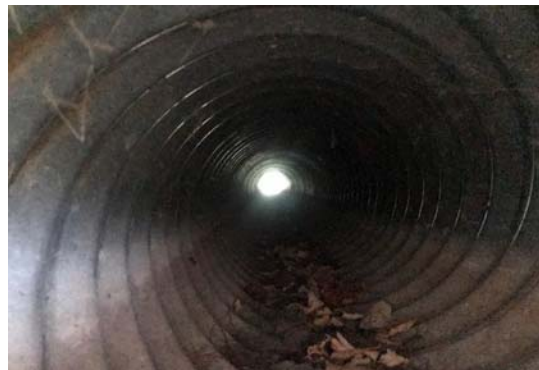
**Culvert Improvement
Cost Estimate**Date: February 15, 2020
Culvert: 2215 - B10

Comments
Culvert appears to be in fair to good condition. Small culvert that should be larger just to maintain flow and availability for cleaning out. Recommend when comes time for replacement, replace with 500mm Dia. CSP with sloped ends and rip rap.

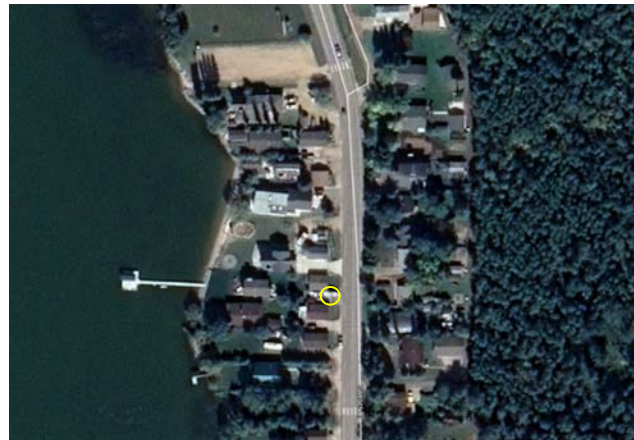
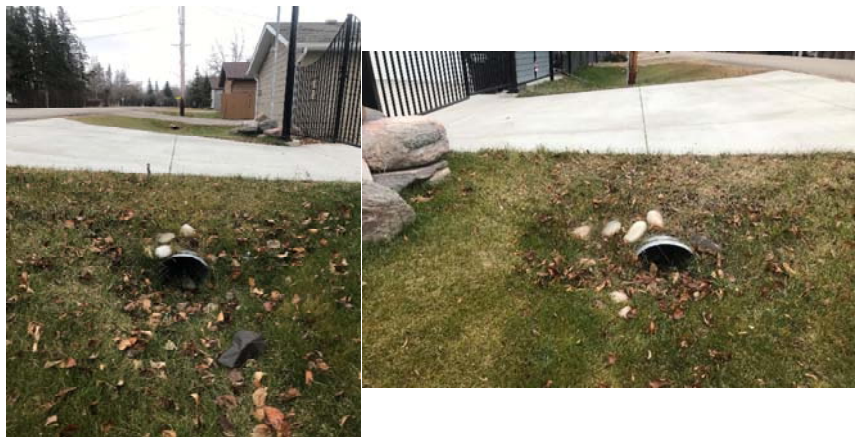
**Culvert Improvement
Cost Estimate**Date: February 15, 2020
Culvert: 2216- B16

Comments
Culvert appears to be in fair to good condition. Small culvert that should be larger just to maintain flow and availability for cleaning out. Recommend when comes time for replacement, replace with 500mm Dia. CSP with sloped ends and rip rap.

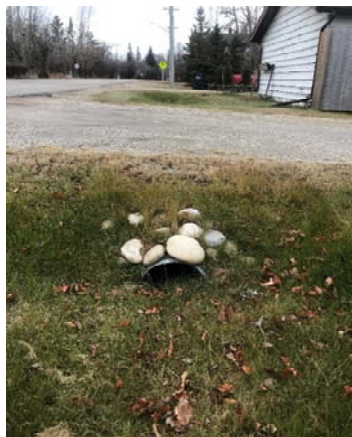
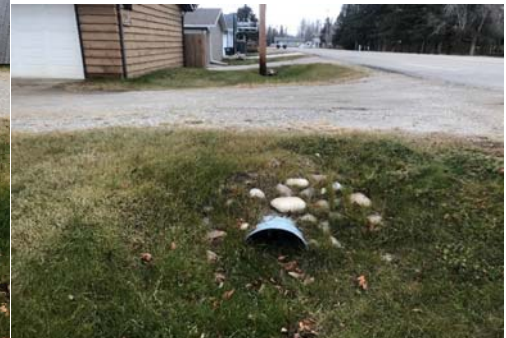
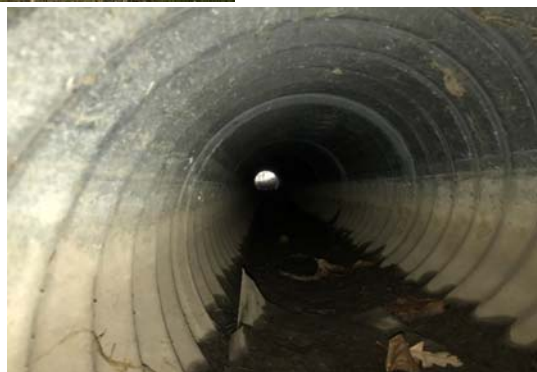
**Culvert Improvement
Cost Estimate**Date: February 15, 2020
Culvert: 2217 - B11

Comments
Culvert appears to be in fair to good condition. Small culvert that should be larger just to maintain flow and availability for cleaning out. Recommend when comes time for replacement, replace with 500mm Dia. CSP with sloped ends and rip rap.

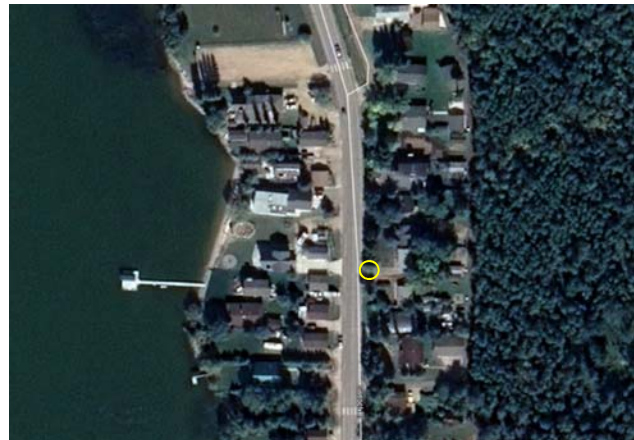
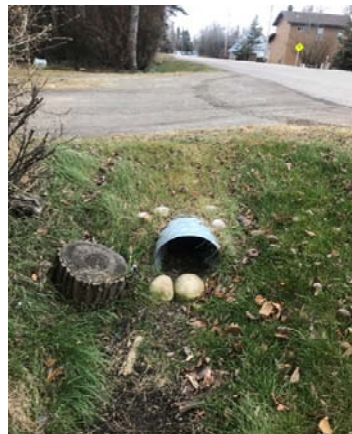
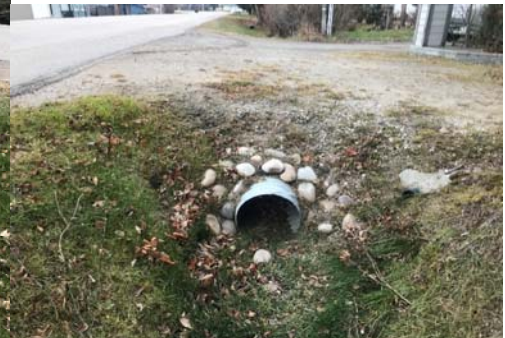
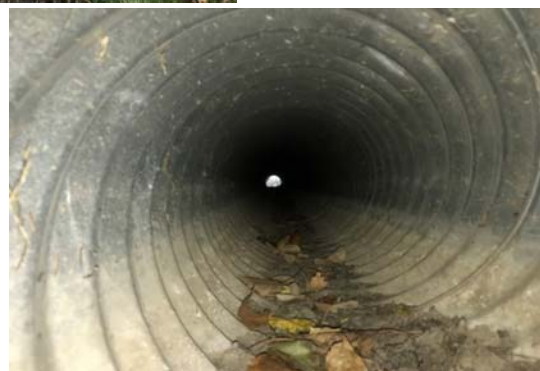
**Culvert Improvement
Cost Estimate**Date: February 15, 2020
Culvert: 2218- B12

Comments
Culvert appears to be in fair to good condition. Small culvert that should be larger just to maintain flow and availability for cleaning out. Recommend when comes time for replacement, replace with 500mm Dia. CSP with sloped ends and rip rap.

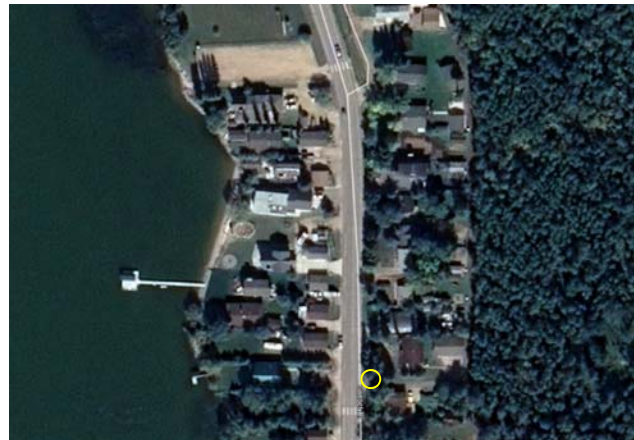
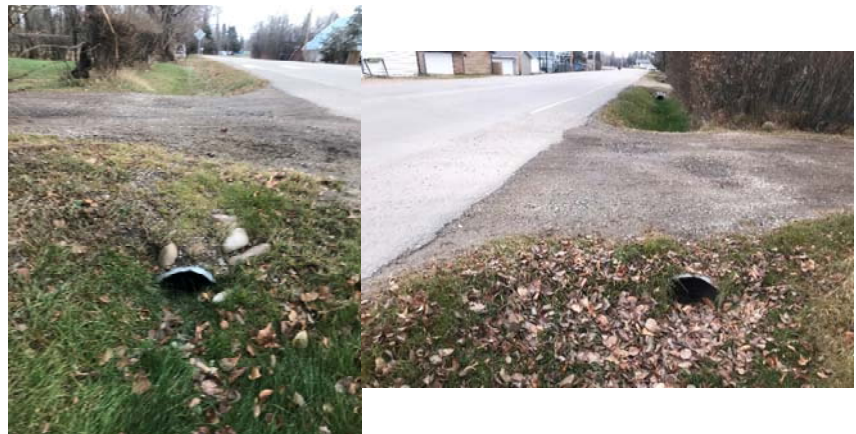
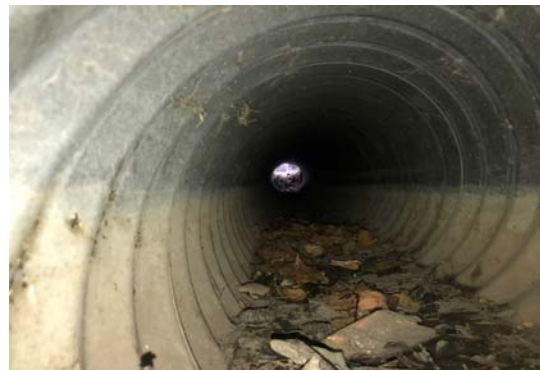
**Culvert Improvement
Cost Estimate**Date: February 15, 2020
Culvert: 2219- B17

Comments
Culvert appears to be in fair to good condition. Small culvert that should be larger just to maintain flow and availability for cleaning out. Recommend when comes time for replacement, replace with 500mm Dia. CSP with sloped ends and rip rap.

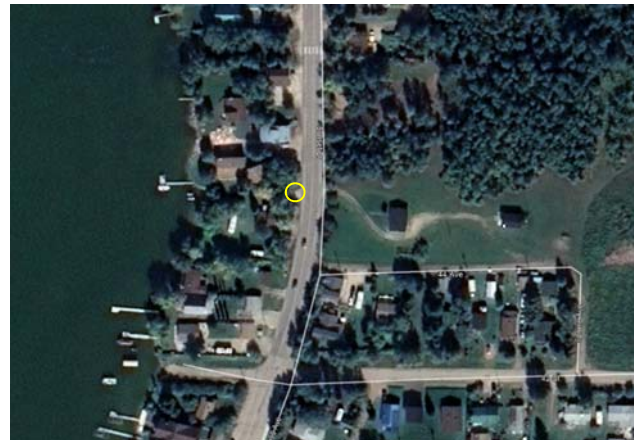
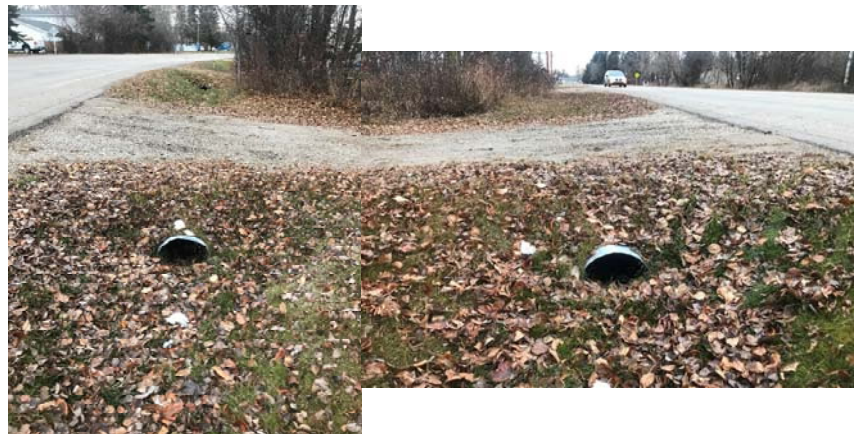
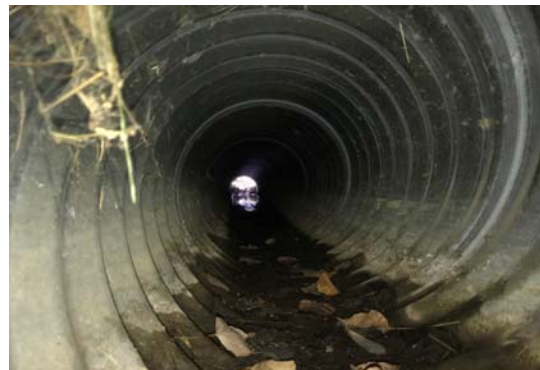
**Culvert Improvement
Cost Estimate**Date: February 15, 2020
Culvert: 2220- B18

Comments
Culvert appears to be in fair to good condition. Small culvert that should be larger just to maintain flow and availability for cleaning out. Recommend when comes time for replacement, replace with 500mm Dia. CSP with sloped ends and rip rap.

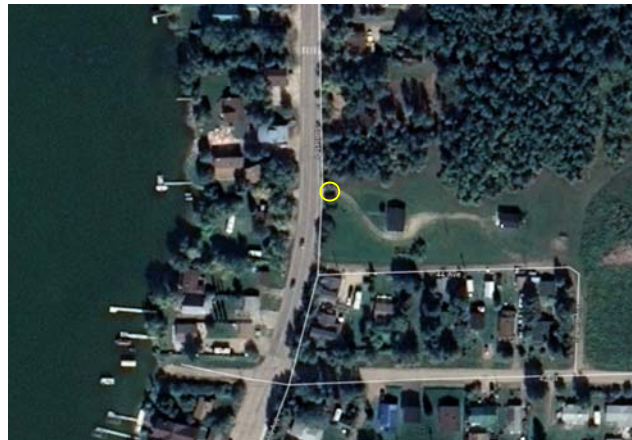
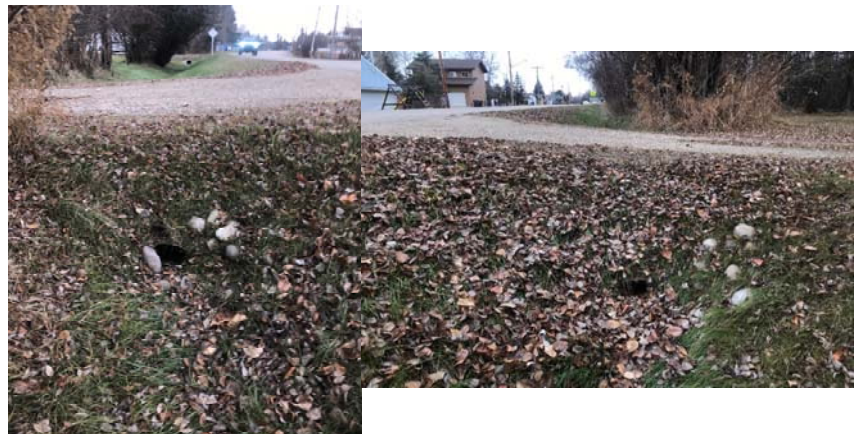
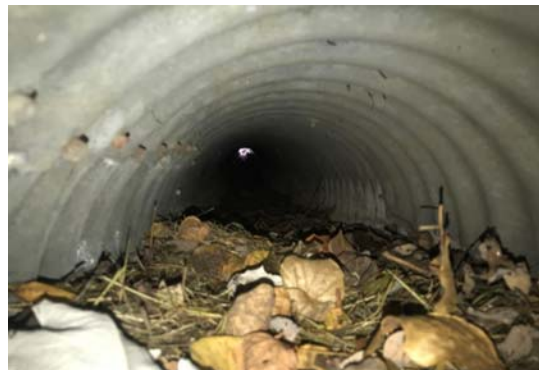
Comments
Culvert appears to be in fair to good condition. Small culvert that should be larger just to maintain flow and availability for cleaning out. Recommend when comes time for replacement, replace with 500mm Dia. CSP with sloped ends and rip rap.

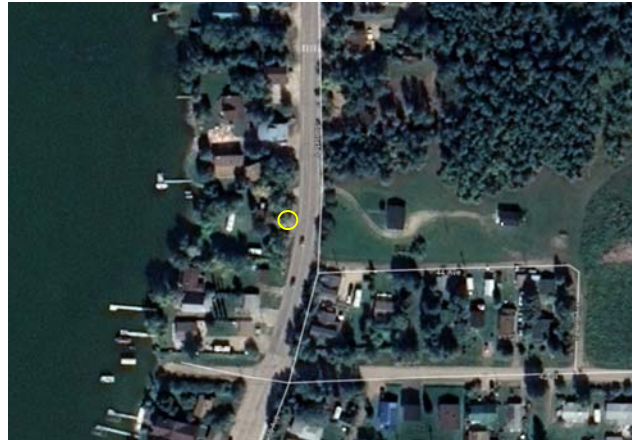
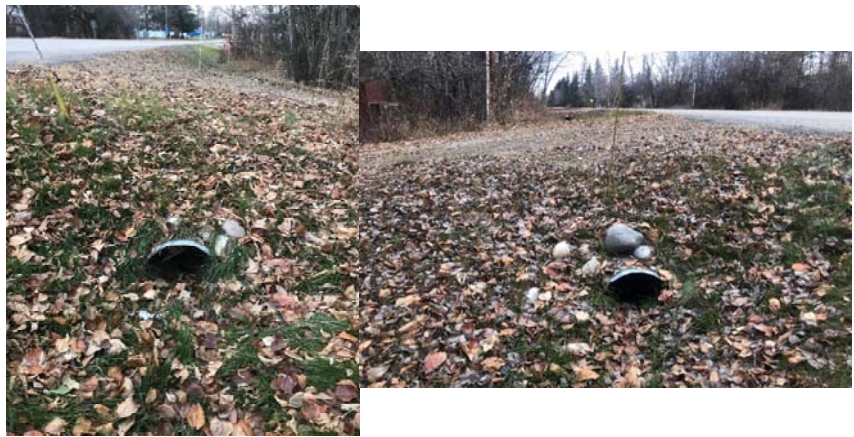
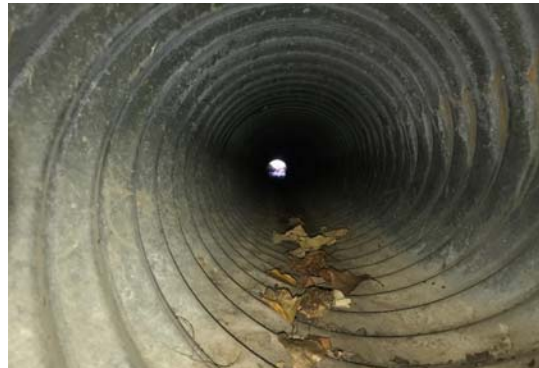
**Culvert Improvement
Cost Estimate**Date: February 15, 2020
Culvert: 2222 - A26

Comments
Culvert appears to be in fair to good condition. Small culvert that should be larger just to maintain flow and availability for cleaning out. Recommend when comes time for replacement, replace with 500mm Dia. CSP with sloped ends and rip rap.

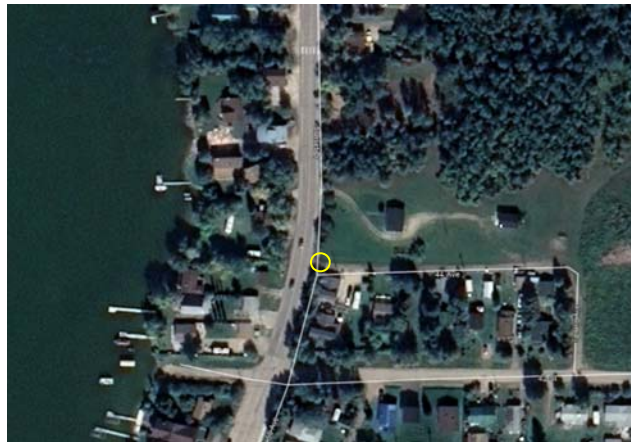
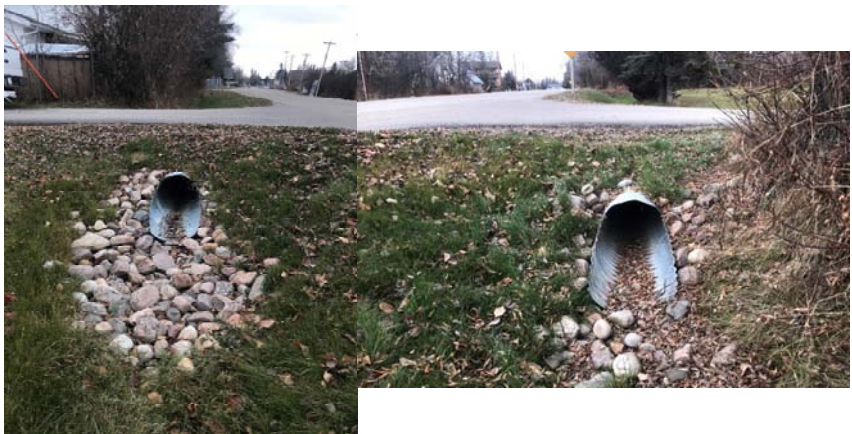
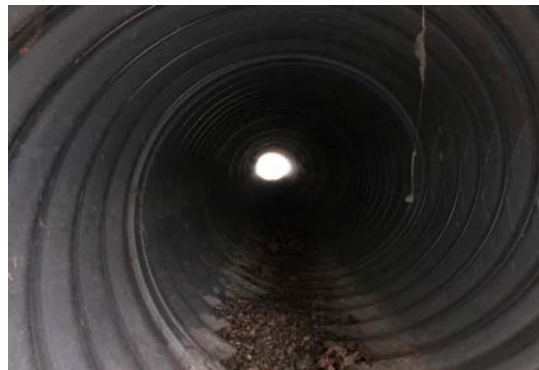
**Culvert Improvement
Cost Estimate**Date: February 15, 2020
Culvert: 2223 - A23

Comments
Culvert appears to be in very good condition. Culvert is too small for 25-Year target capacity and should be replaced with an 800mm Dia. CSP with sloped ends and rip rap. Since the watermark in the culvert reveals a very low level, the need for improvement is not high priority and should be reviewed if there is new development upstream. Better slope within the culvert should also be improved.

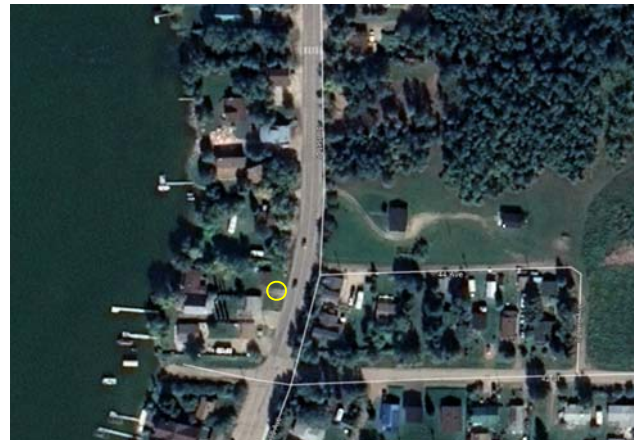
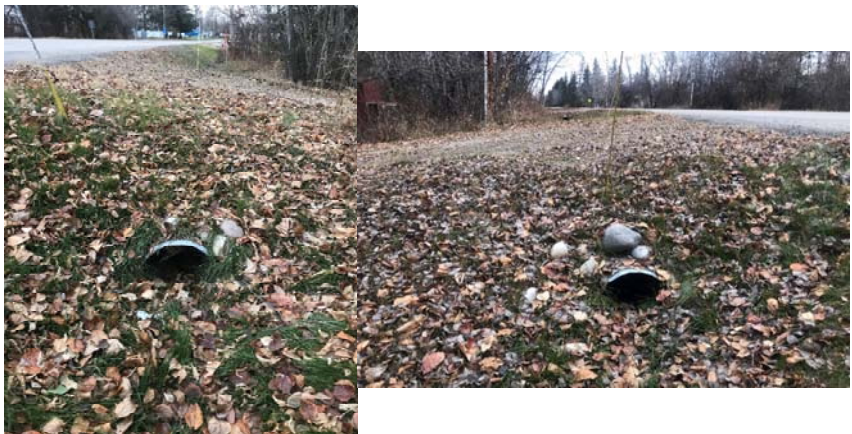
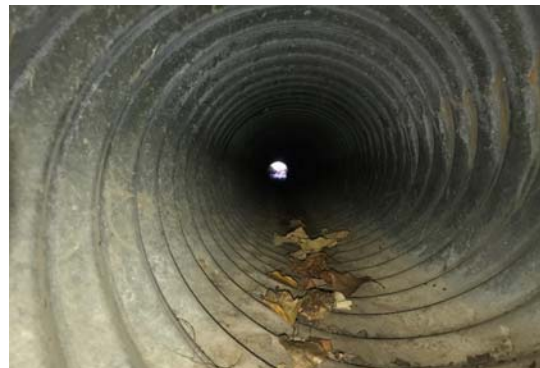
**Culvert Improvement
Cost Estimate**Date: February 15, 2020
Culvert: 2224 - A25

Comments
Culvert appears to be in fair to good condition. Small culvert that should be larger just to maintain flow and availability for cleaning out. Recommend when comes time for replacement, replace with 500mm Dia. CSP with sloped ends and rip rap.

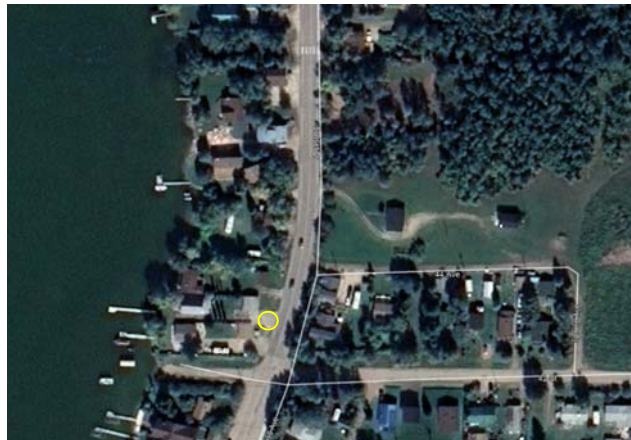
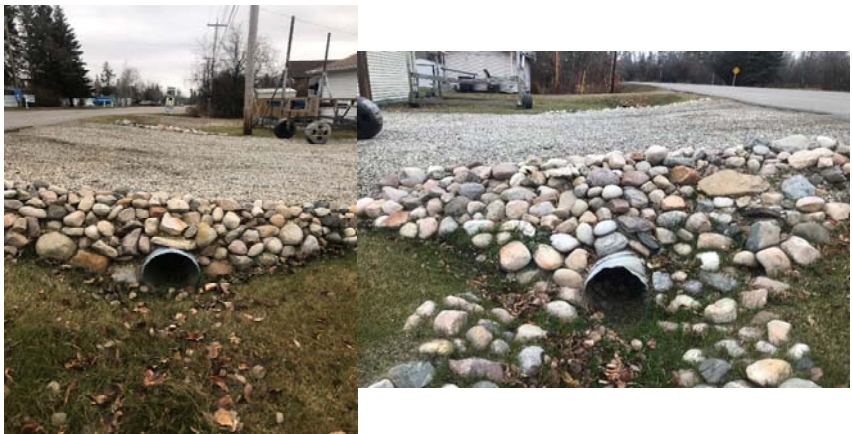
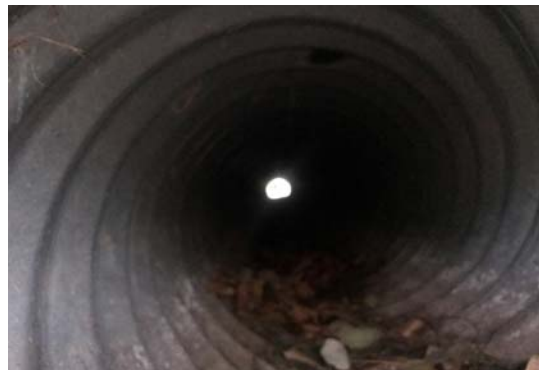
**Culvert Improvement
Cost Estimate**Date: February 15, 2020
Culvert: 2235 - A22

Comments
Culvert appears to be in fair to good condition. Small culvert that should be larger just to maintain flow and availability for cleaning out. Recommend when comes time for replacement, replace with 500mm Dia. CSP with sloped ends and rip rap. Check slope in culvert.

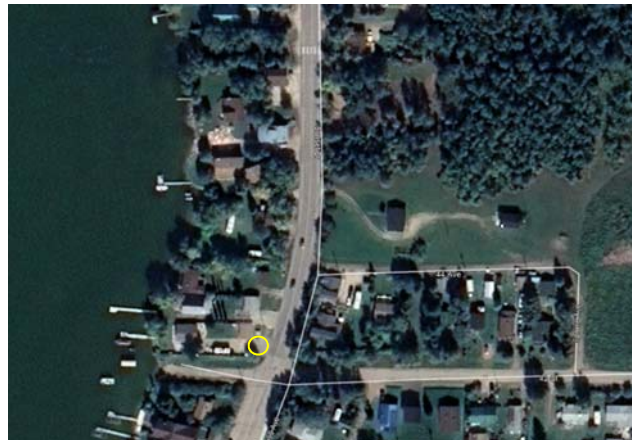
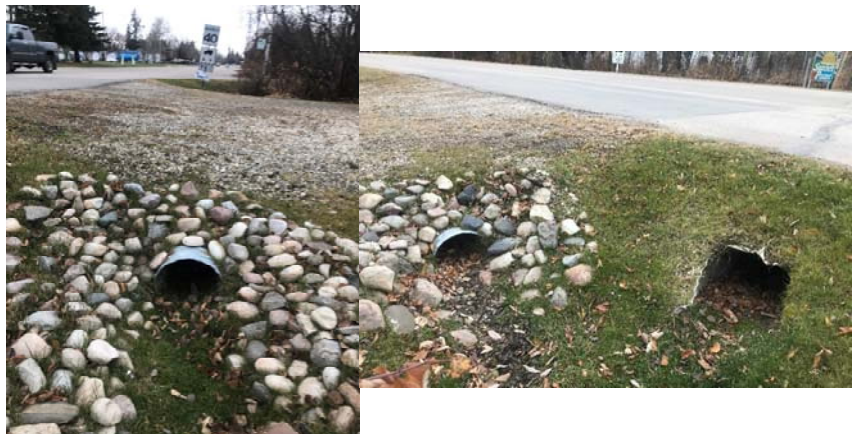
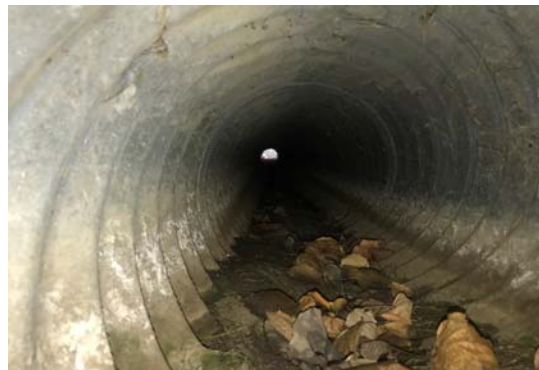
**Culvert Improvement
Cost Estimate**Date: February 15, 2020
Culvert: 2236 - A21

Comments
Culvert appears to be in fair to good condition. Small culvert that should be larger just to maintain flow and availability for cleaning out. Recommend when comes time for replacement, replace with 500mm Dia. CSP with sloped ends and rip rap. Check slope in culvert.

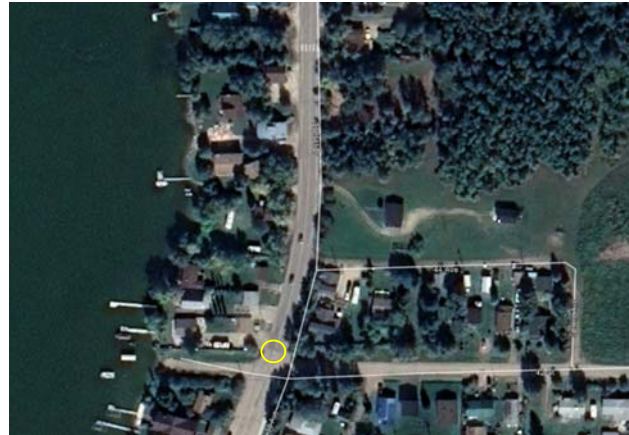
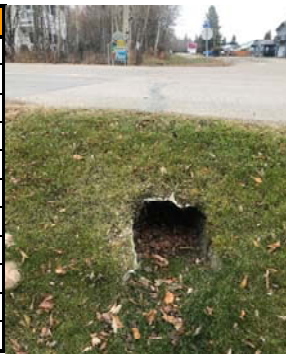
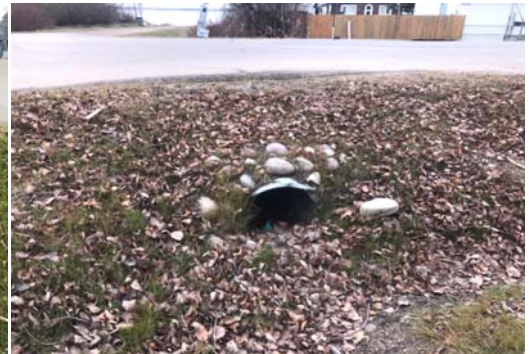
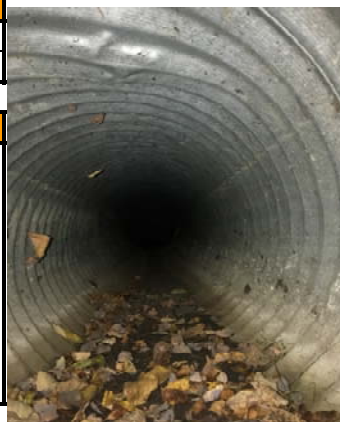
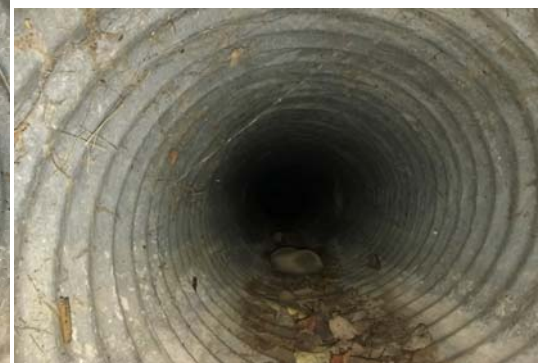
**Culvert Improvement
Cost Estimate**Date: February 15, 2020
Culvert: 2237 - A20

Inlet / Outlet Protection	Rating
Channel scour at Inlet/Outlet	No
Embankment Erosion	No
Sideslopes too Steep	Yes
Drift - wood, debris around pipe	No
Vegetation - trees, brush etc.	No
Silt	No
Rip Rap	None

Pipe Barrel	Rating
Blockage	Yes
Submerged in Water	No
Inlet Damage	No
Outlet damage	Yes
Corrosion / Abrasion	No
Out of Round	No
Settlement	No
Sag / Bow	No
Infiltration	No
Piping	No
Cracking	No

Comments
This crossing is for a Minor Flow Path but collects 2 Minor Flow Paths including for an undeveloped area. The existing 600mm Dia. culvert maybe too small for future flow upstream. Recommend upgrading this crossing to an 800mm Dia. CSP to increase capacity needed with sloped ends and rip rap. Down drain open channel may require review to ensure flow does not enter lot and ensure protection from erosion.

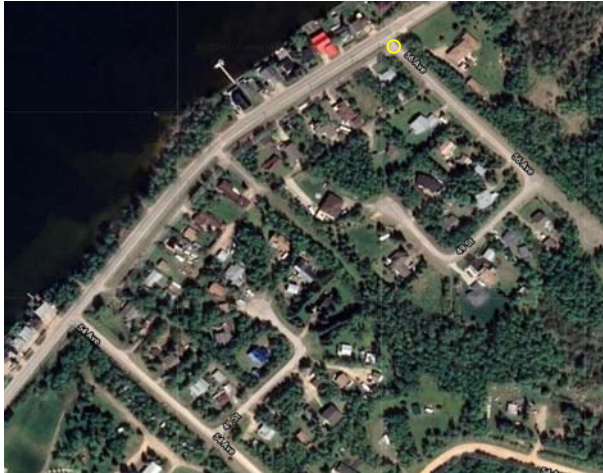
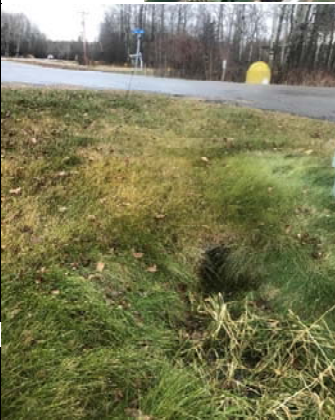
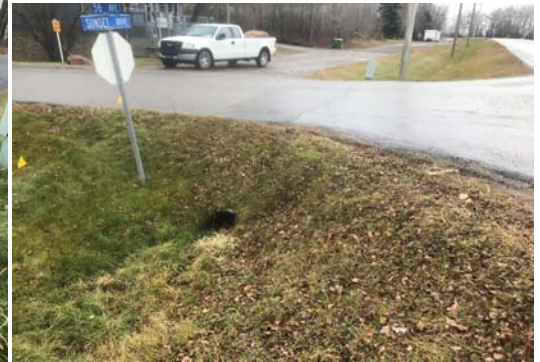
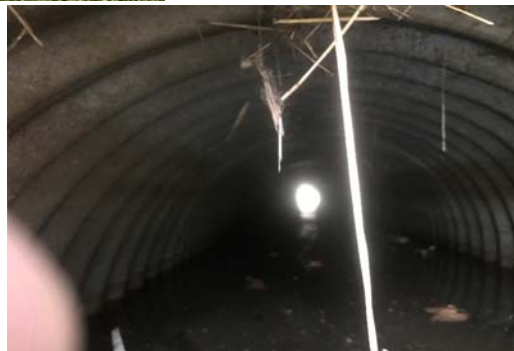
**Culvert Improvement
Cost Estimate**Date: February 15, 2020
Culvert: 2238 - A11

Comments
 Culvert is in fair to good condition. Need to clean out heavy grass at inlet and outlet. Widen out ditch. Re-check elevations as there is too much water being held within pipe which lowers capacity. Culvert needs sloped end on outlet side. Recommend once this culvert has aged and reached its design life, replace with one 800mm diameter culvert.

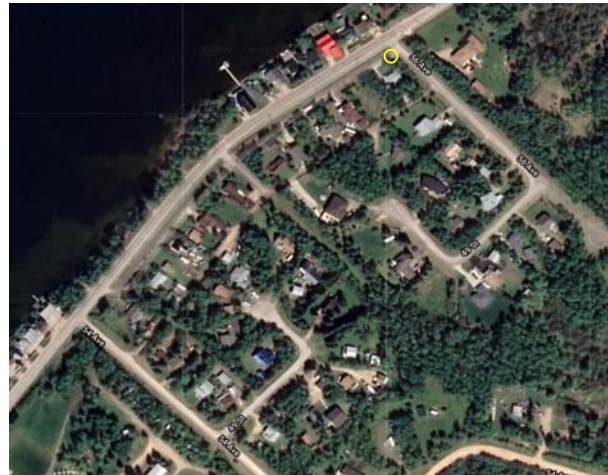
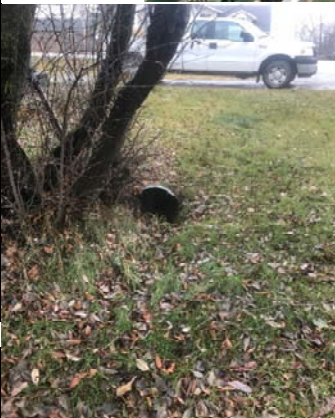
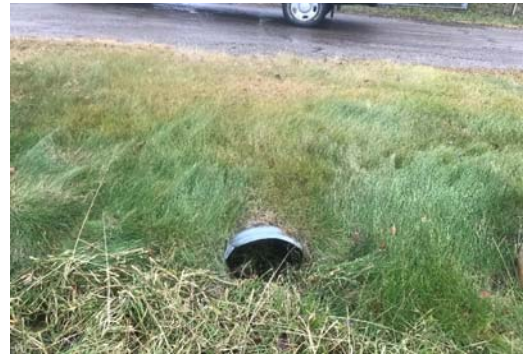
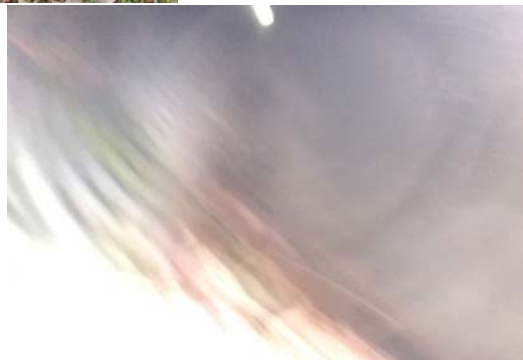
**Culvert Improvement
Cost Estimate**Date: February 15, 2020
Culvert: 2602-106

Comments
Culvert is in fair to good condition. Need to clean out heavy grass and tree at inlet and outlet. Widen out ditch. Culvert needs sloped end on outlet side. Recommend once this culvert has aged and reached its design life, replace with one 600mm diameter culvert.

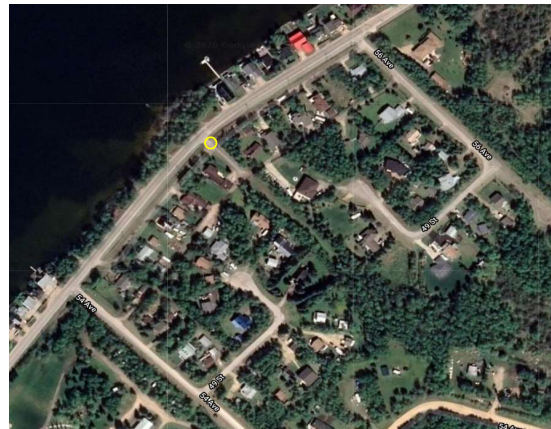
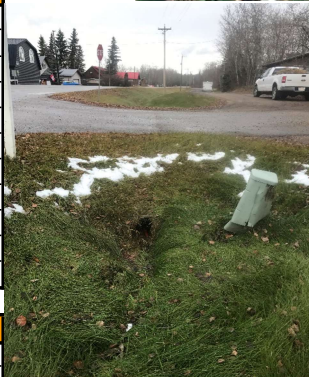
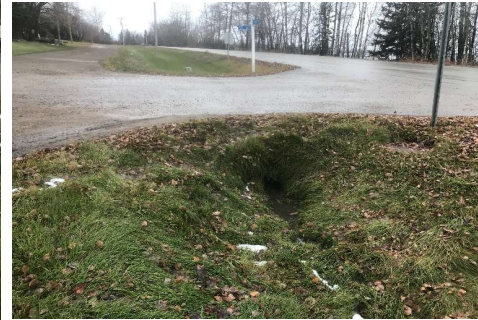
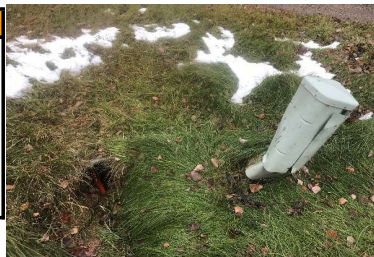
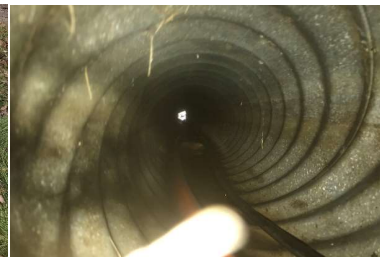
**Culvert Improvement
Cost Estimate**Date: February 15, 2020
Culvert: 26103-112

Comments
Culvert is in fair to good condition. but too small. Telephone cable is running inside culvert to pedestal. Need to clean out heavy grass at inlet and outlet. Widen out ditch. Culvert needs sloped end on outlet side. Recommend once this culvert has aged and reached its design life, replace with one 600mm diameter culvert.
