EXISTING INFRASTRUCTURE REVIEW

1. Drainage & Culvert Review

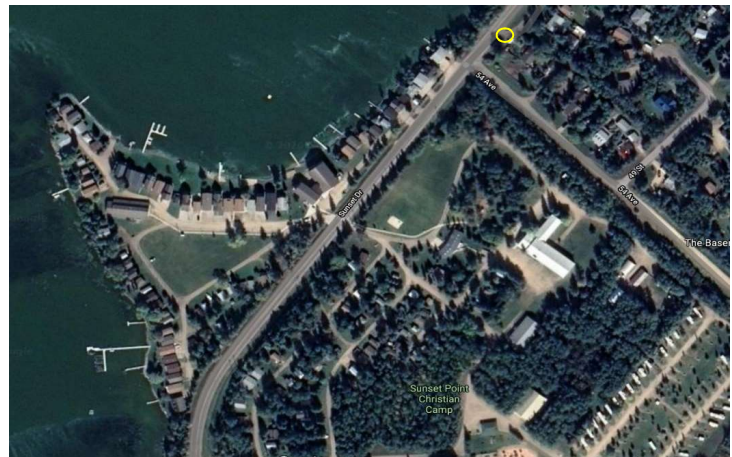
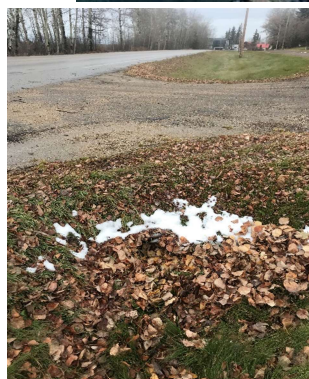
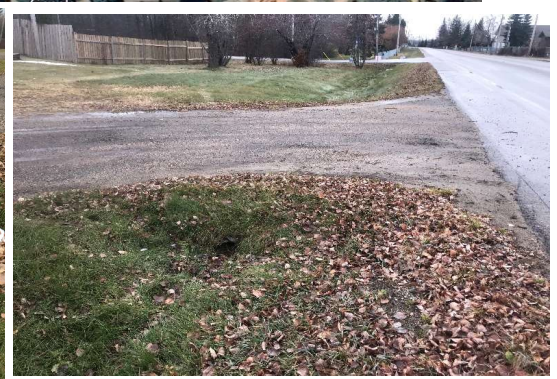
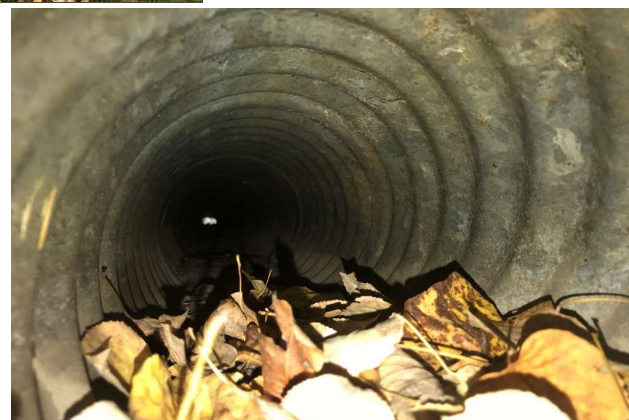
**Culvert Improvement
Cost Estimate**Date: February 15, 2020
Culvert: 2619 - I11

Comments
Culvert appears in fair to good condition. Culvert too small. Should be replaced with a 500mm CSP minimum with sloped ends and rip rap.

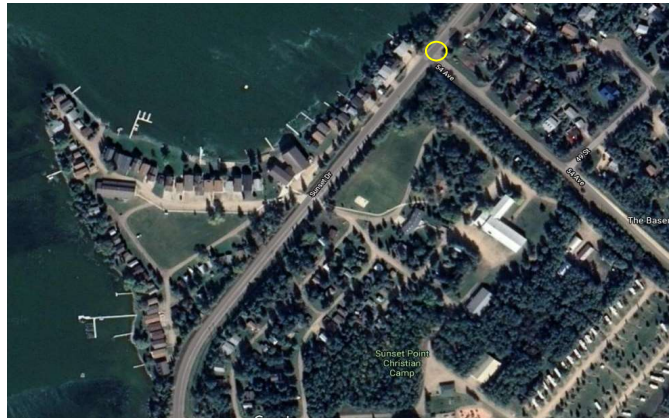
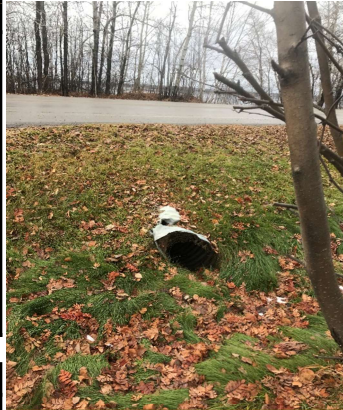
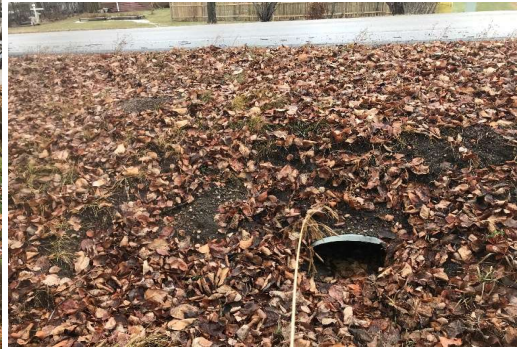
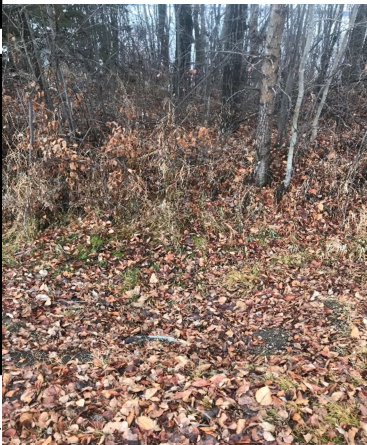
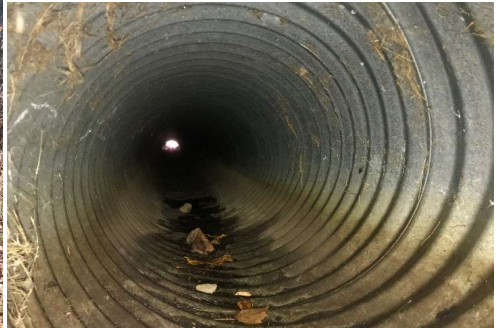
Pipe Barrel	Rating
Blockage	No
Submerged in Water	No
Inlet Damage	Yes
Outlet damage	No
Corrosion / Abrasion	Some
Out of Round	No
Settlement	No
Sag / Bow	No
Infiltration	No
Piping	No
Cracking	No

Comments
 The high water mark can clearly be seen in this culvert which appears to be at 1/3 of the culvert capacity. Culvert is fair to good condition. Some rusting on the bottom. Should be upgraded to at least an 800mm Dia. CSP when time for this culvert to be replaced. If more development to occur upstream, this crossing should be reviewed in order to determine if this crossing is sufficient. Culvert should be longer with sloped ends and sideslopes should be flattened.

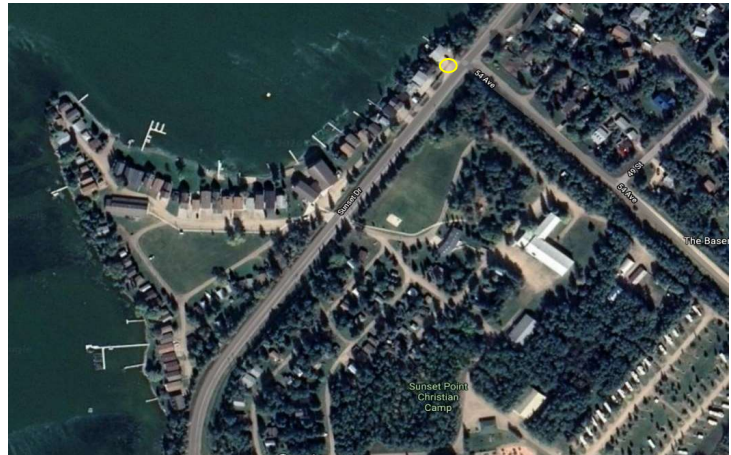
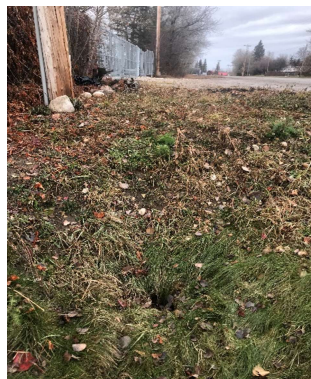
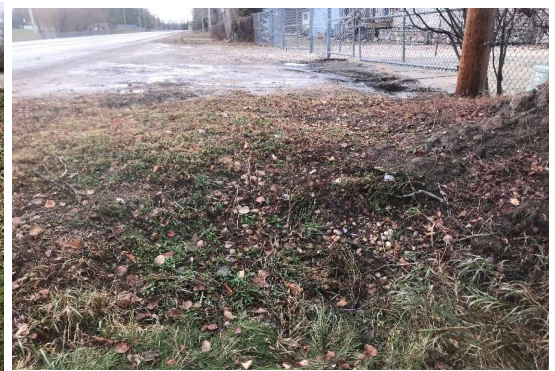
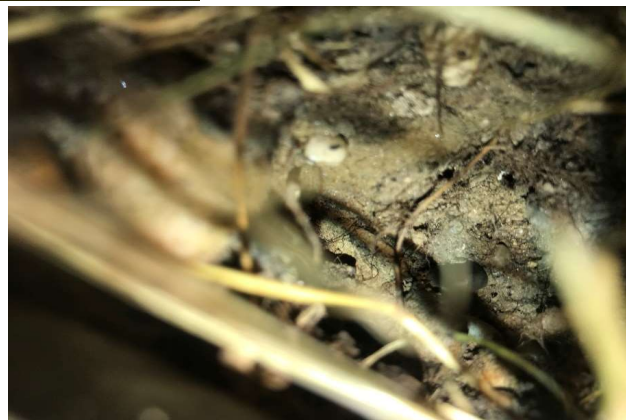
Pipe Barrel	Rating
Blockage	Could not see
Submerged in Water	No
Inlet Damage	No
Outlet damage	No
Corrosion / Abrasion	????
Out of Round	No
Settlement	No
Sag / Bow	No
Infiltration	No
Piping	No
Cracking	No

Comments
Culvert appears in poor to fair condition. North end is buried and S. end is 3/4 full of water. Culvert too small. This is a very long culvert that could be plugged. Should be replaced with a 500mm CSP minimum with sloped ends and rip rap.

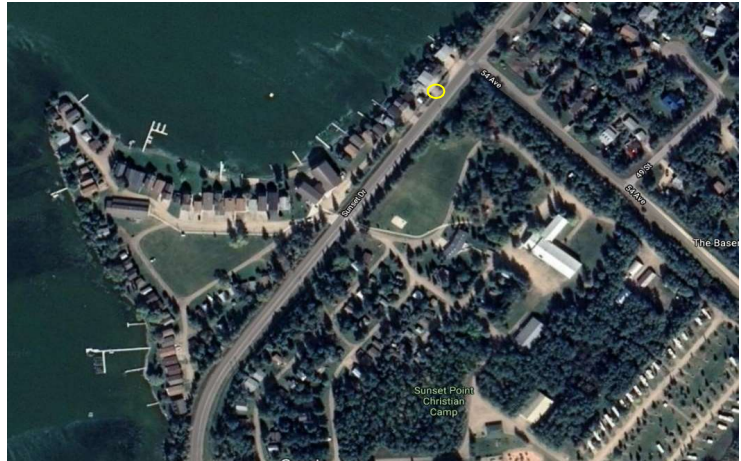
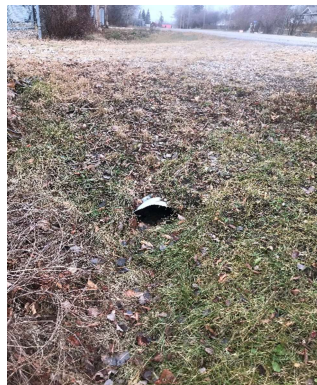
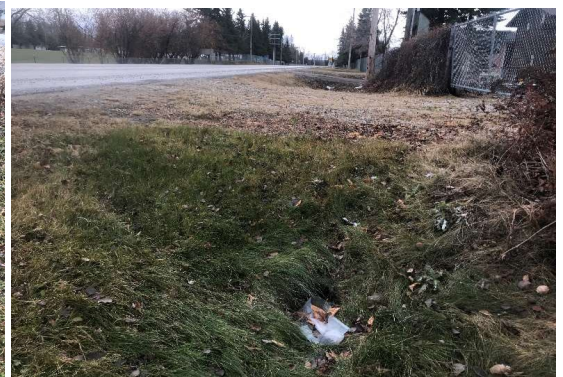
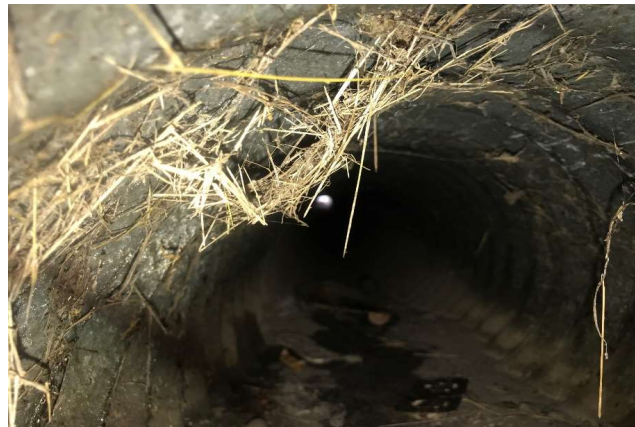
Comments
Culvert appears in poor to fair condition. Culvert too small. Should be replaced with a 500mm CSP minimum with sloped ends and rip rap. Ditch should be widened out; excess vegetation removed.

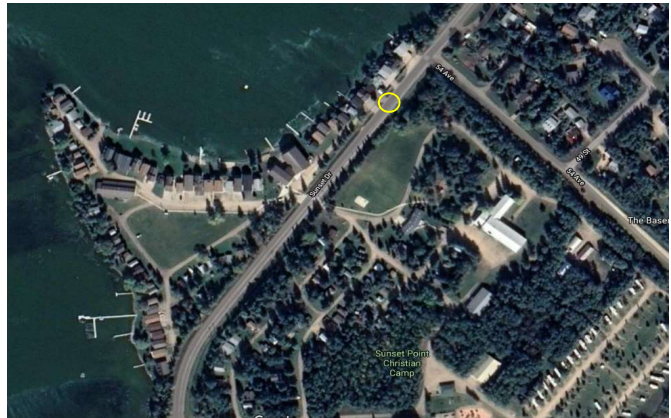
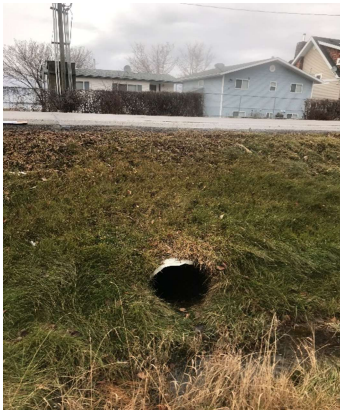
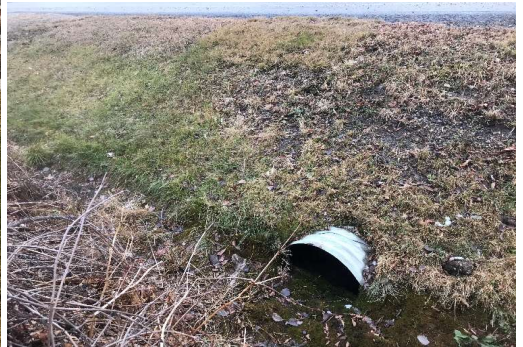
Inlet / Outlet Protection	Rating
Channel scour at Inlet/Outlet	No
Embankment Erosion	No
Sideslopes too Steep	Yes
Drift - wood, debris around pipe	No
Vegetation - trees, brush etc.	Yes
Silt	Yes
Rip Rap	None

Comments
 The high water mark can clearly be seen in this culvert which is concerning and indicates that this culvert should be upgraded to at least an 800mm Dia. CSP when time for this culvert to be replaced. If more development to occur upstream, this crossing should be reviewed in order to determine if this crossing is sufficient. Culvert should be longer with sloped ends and sideslopes should be flattened. Ideally, 2 - 800mm Dia. CSPs should be installed.

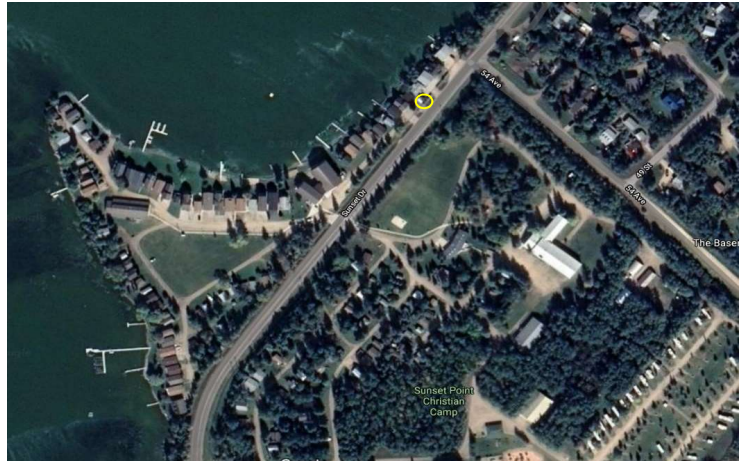
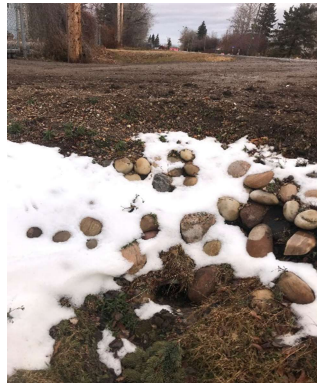
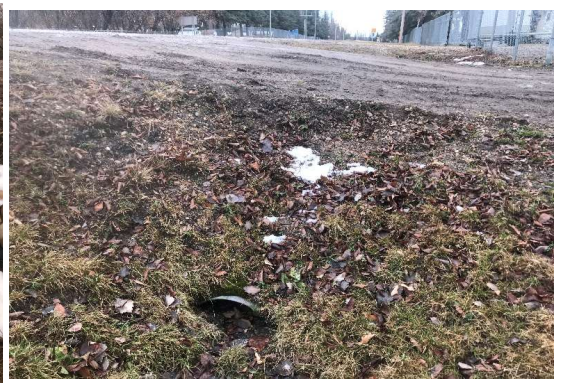
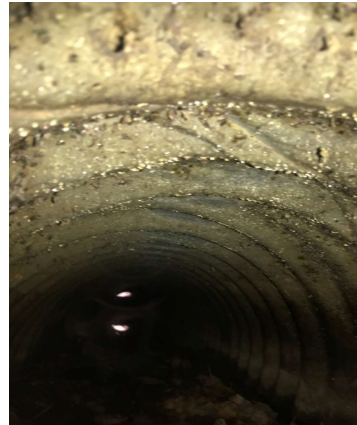
Comments
Culvert appears in poor to fair condition. Culvert too small. Should be replaced with a 500mm CSP minimum with sloped ends and rip rap. Ditch should be widened out; excess vegetation removed.

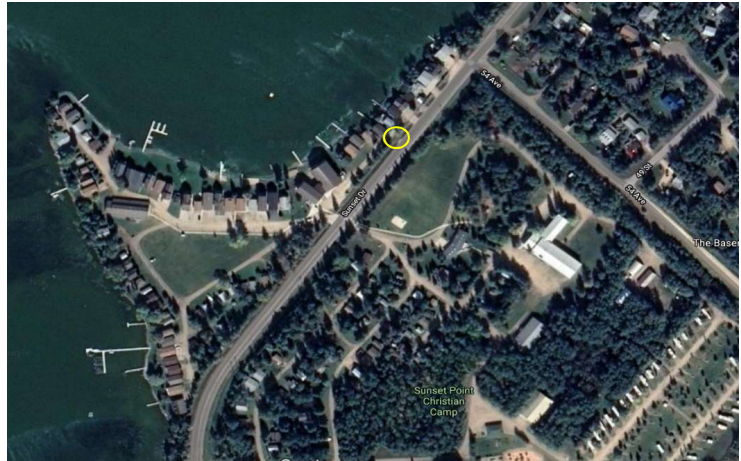
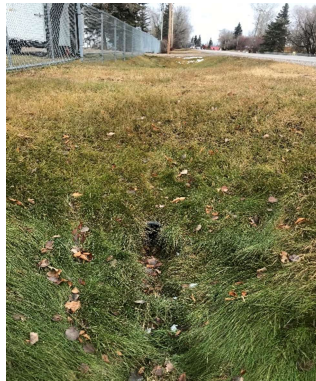
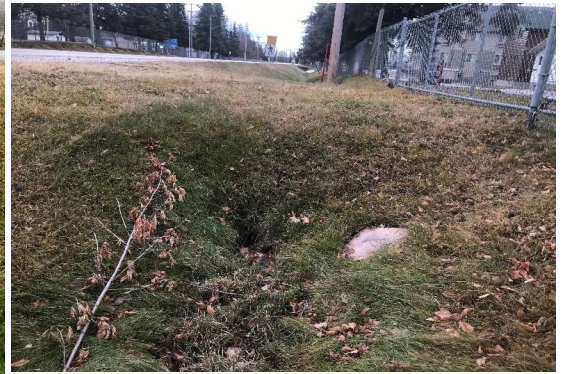
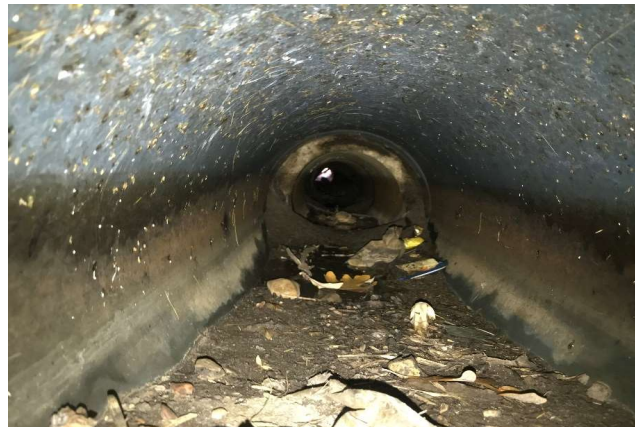
Comments
Appears to be concrete, therefore rusting not an issue. Condition is good but inside there appears to be separation. Approach is not paved. Partially silted. Culvert too small. Should be replaced with a 500mm CSP minimum with sloped ends and rip rap. Flatten out sideslopes to at least 5:1. Ditch should be widened out; excess vegetation removed.

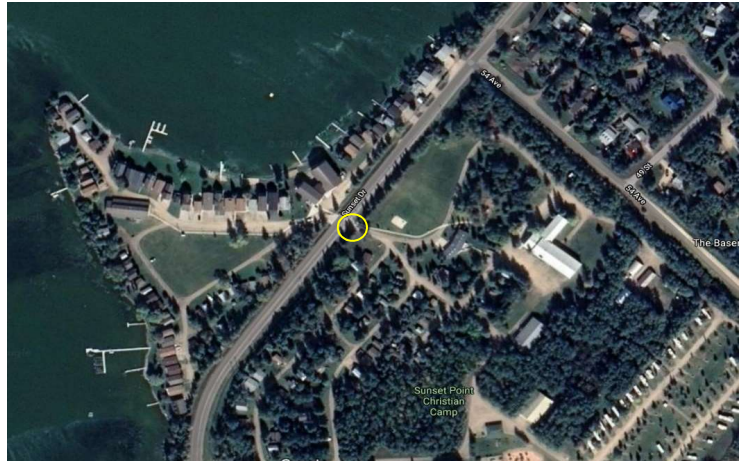
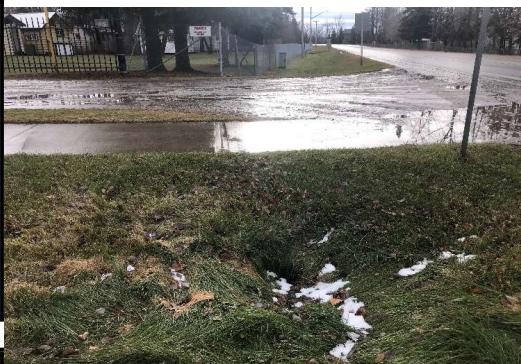
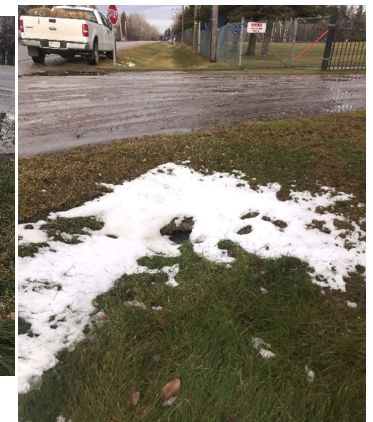
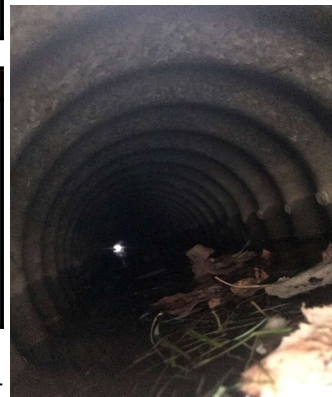
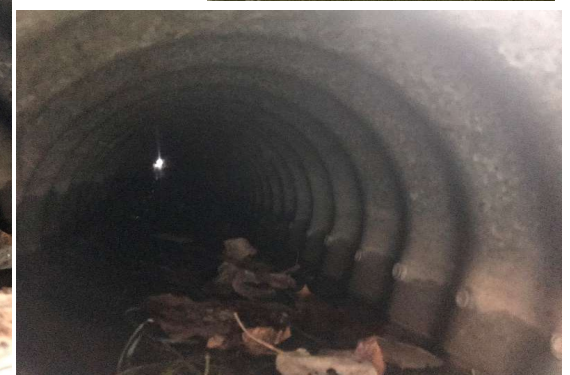
Comments
Culvert in fair to poor condition. Approach is paved. Culvert too small. Should be replaced with a 500mm CSP minimum with sloped ends and rip rap. Flatten out sideslopes to at least 5:1. Excess vegetation removed.

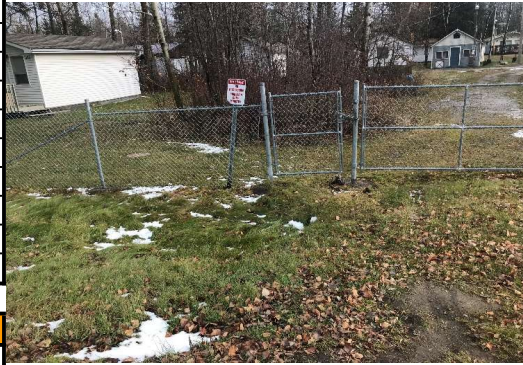
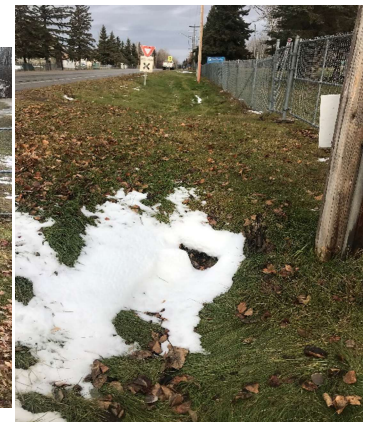
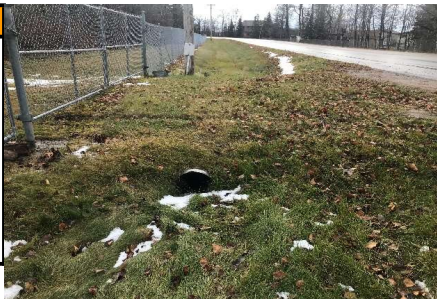
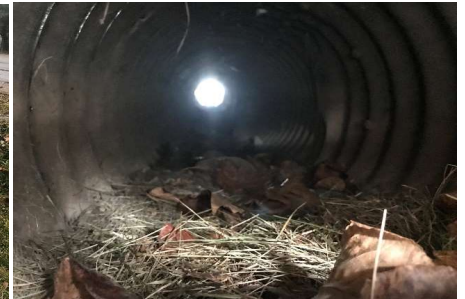
Comments
Culvert in fair to good condition. Approach is not paved. Culvert too small. Should be replaced with a 500mm CSP minimum with sloped ends and rip rap. Flatten out sideslopes to at least 5:1. Excess vegetation removed.

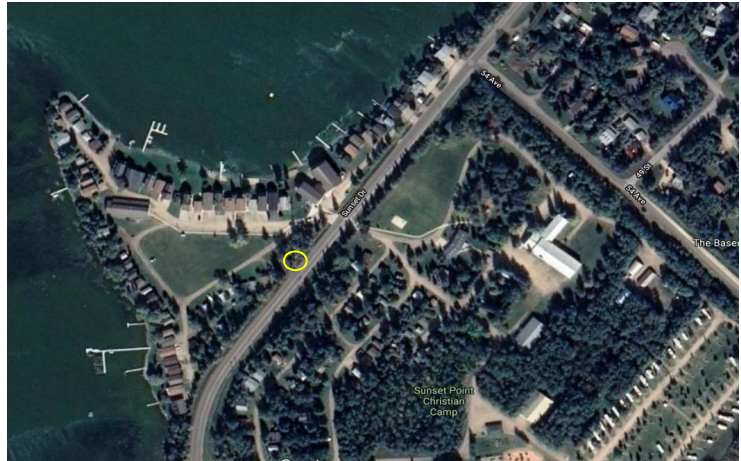
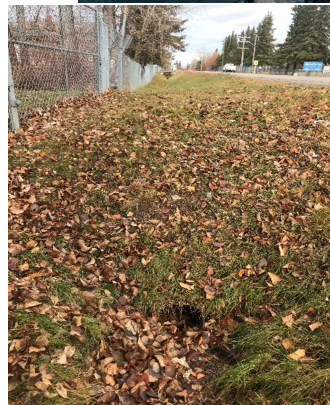
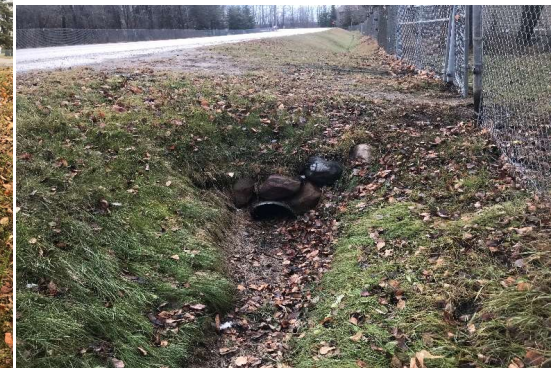
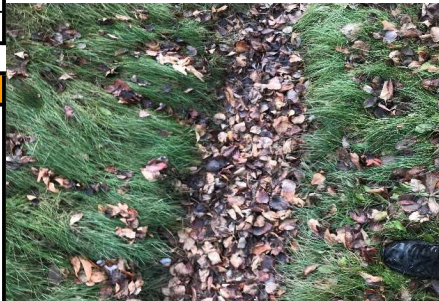
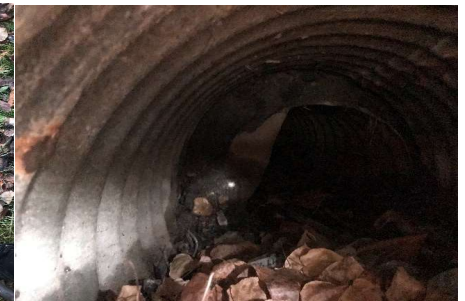
Comments
Culvert in fair to good condition. Approach is not paved. When comes time to be replaced, replace with a 600mm CSP minimum with sloped ends and rip rap. Flatten out sideslopes to at least 5:1. Excess vegetation removed.

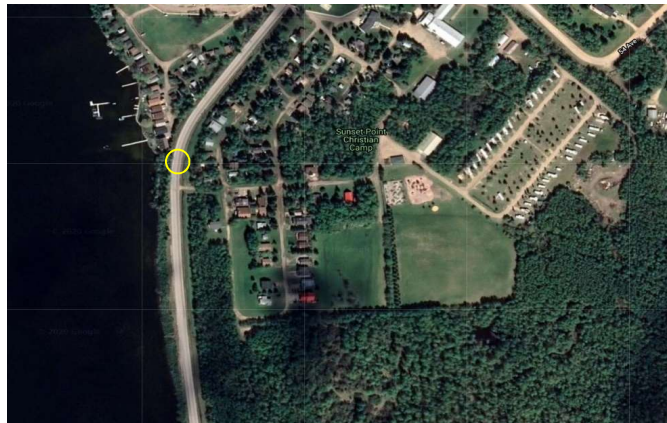
Pipe Barrel	Rating
Blockage	No
Submerged in Water	No
Inlet Damage	Yes
Outlet damage	No
Corrosion / Abrasion	Some
Out of Round	No
Settlement	No
Sag / Bow	No
Infiltration	No
Piping	No
Cracking	No

Comments
This crossing is for a Major Flow Path from the Christian Camp. The existing 600mm Dia. culvert is near capacity for a 25-Year Storm and it is recommended that it be upgraded to at least an 800mm Dia. CSP when time for this culvert to be replaced. If more development to occur upstream, this crossing should be reviewed in order to determine if this crossing is sufficient. Culvert should be longer with sloped ends and sideslopes should be flattened. Ideally, 2 - 800mm Dia. CSPs should be installed. Alignment should also be reviewed at the culvert alignment does not seem to align with drainage path on west side.

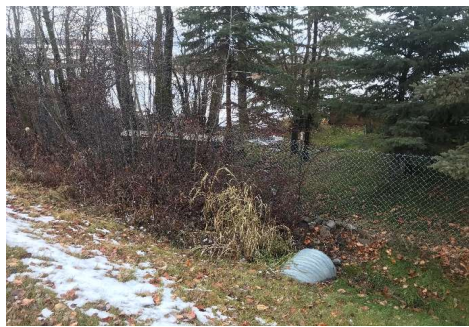
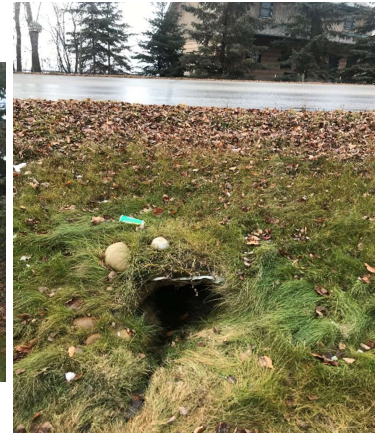
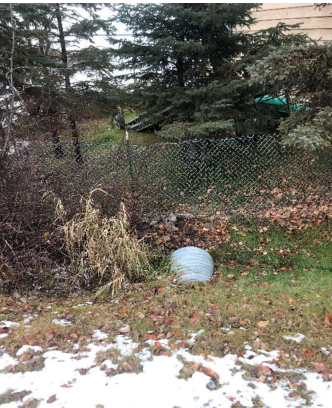
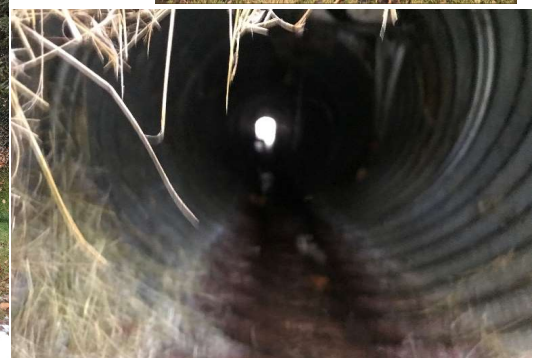
Inlet / Outlet Protection	Rating
Channel scour at Inlet/Outlet	No
Embankment Erosion	No
Sideslopes too Steep	Yes
Drift - wood, debris around pipe	No
Vegetation - trees, brush etc.	Yes
Silt	No
Rip Rap	None

Capacity	Rating
Flow Path Type	Major
Function of size, slope and condition	Inadequate

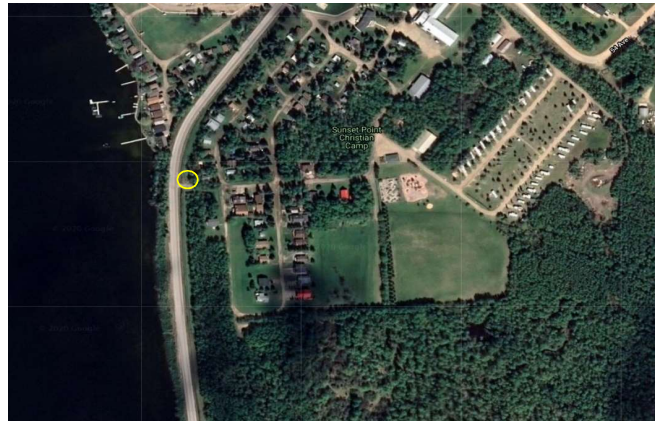
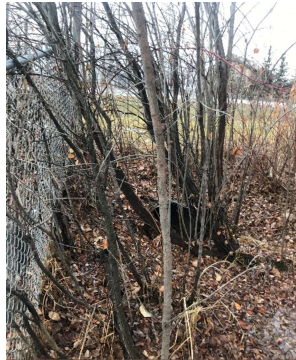
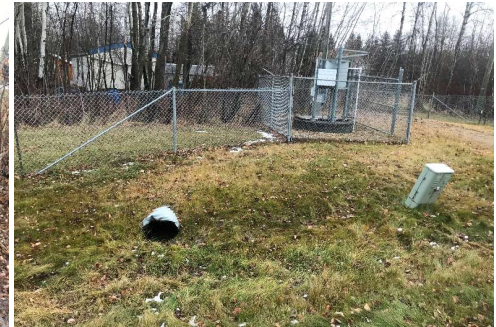
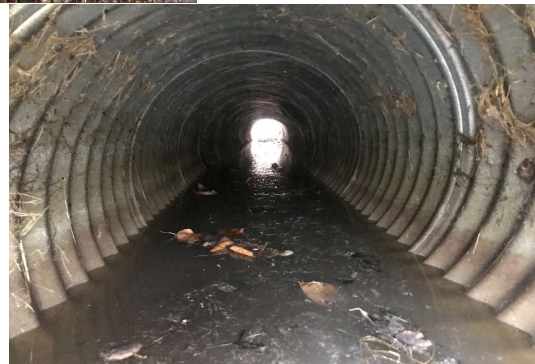
Capacity	Rating
Flow Path Type	Major
Function of size, slope and condition	10-Year

Comments
This culvert will need to be replaced in conjunction with Culvert 2705, the centerline culvert under Sunset Drive. To match the centerline culvert, this culvert should be replaced with 2-800mm diameter CSPs.

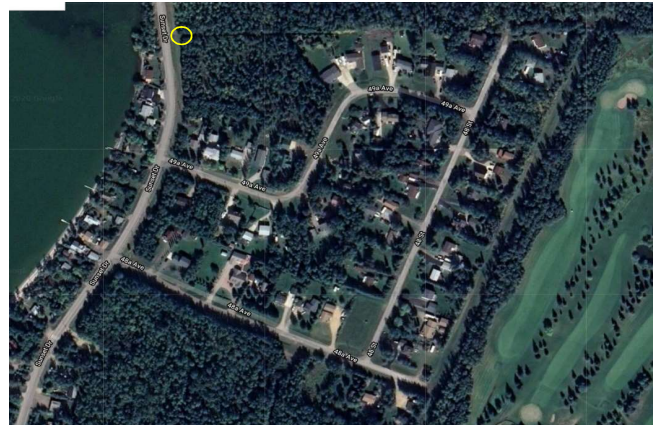
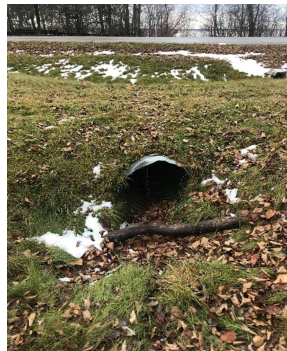
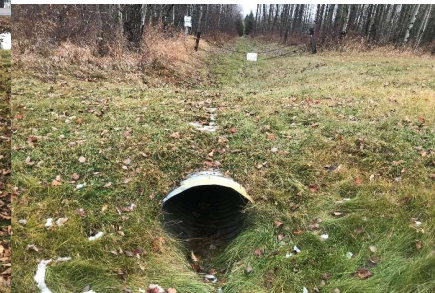
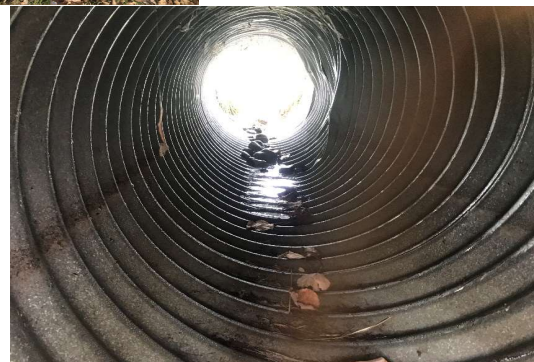
Capacity	Rating
Flow Path Type	Major
Function of size, slope and condition	10-Year

Comments
This culvert will need to be replaced in conjunction with Culvert 2713, the centerline culvert under Sunset Drive. To match the centerline culvert, this culvert should be replaced with 2 800mm diameter CSPs.

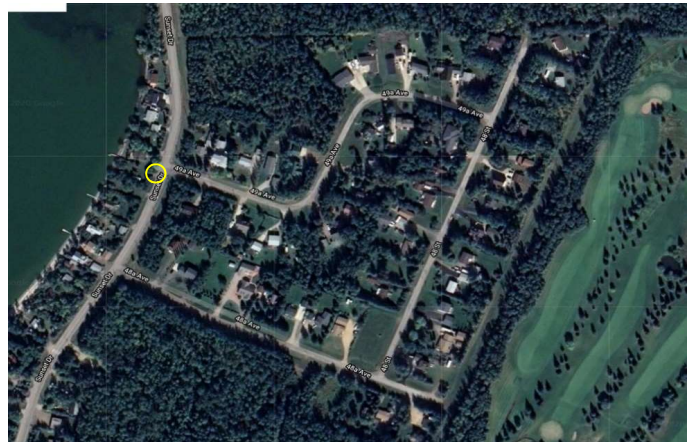
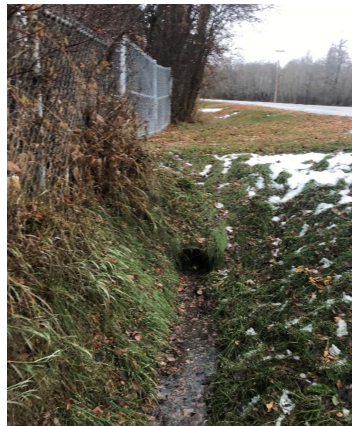
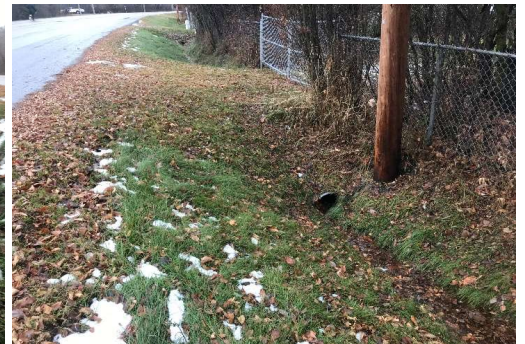
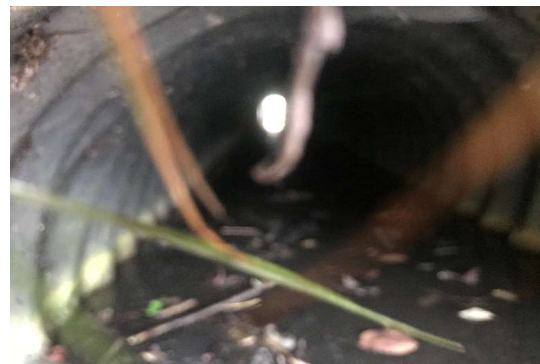
Capacity	Rating
Flow Path Type	Minor
Function of size, slope and condition	5-Year

Comments
Small culvert that should be larger just to maintain flow and availability for cleaning out. Only other concern is the narrow V-Ditch which is a common problem along this drainage path. Since this drainage path is along the lake, recommend replacing with 600mm.

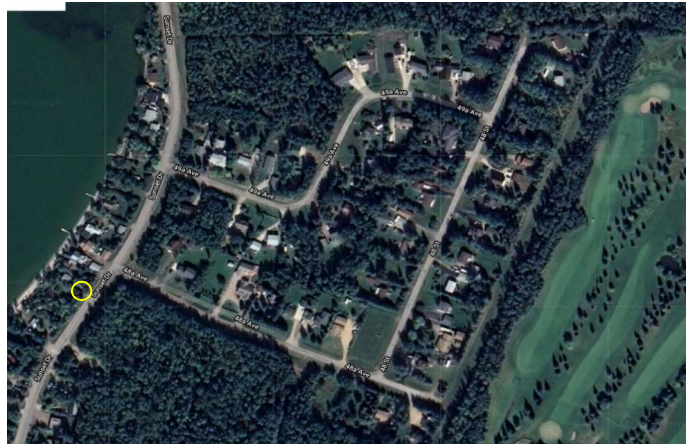
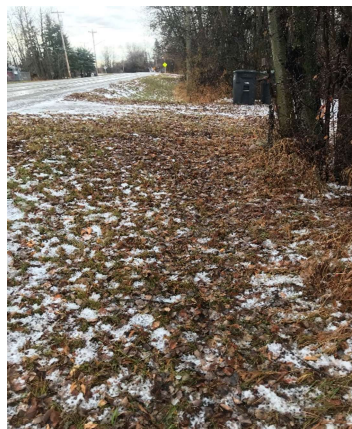
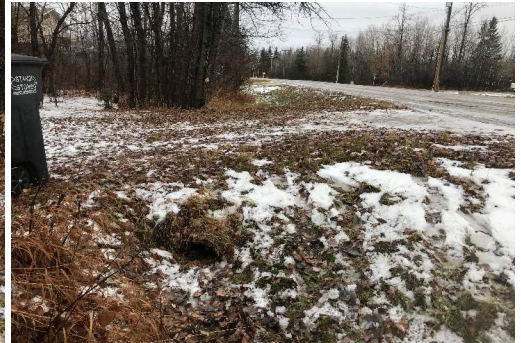
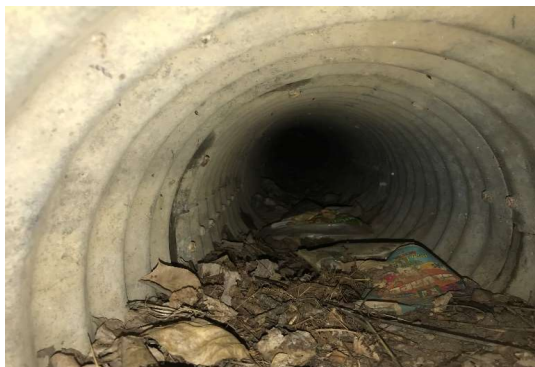
Pipe Barrel	Rating
Blockage	Yes
Submerged in Water	No
Inlet Damage	Yes
Outlet damage	No
Corrosion / Abrasion	Yes
Out of Round	No
Settlement	No
Sag / Bow	No
Infiltration	No
Piping	No
Cracking	No

Capacity	Rating
Flow Path Type	Minor
Function of size, slope and condition	100-Year

Comments
Culvert appears to be blocked or covered on one end. Small culvert that should be larger just to maintain flow and availability for cleaning out. Since this drainage path is along the lake, recommend replacing with 600mm.

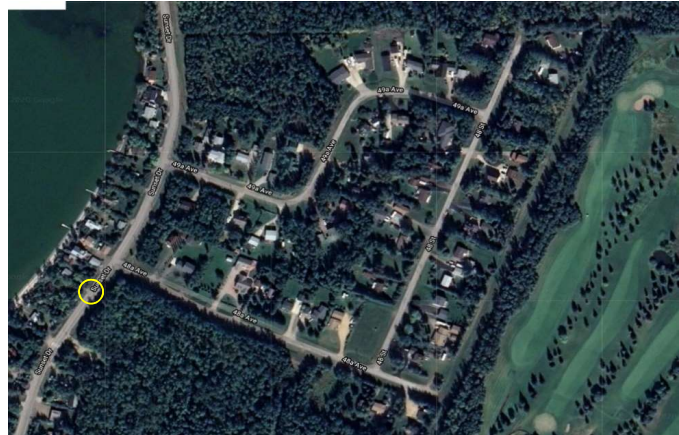
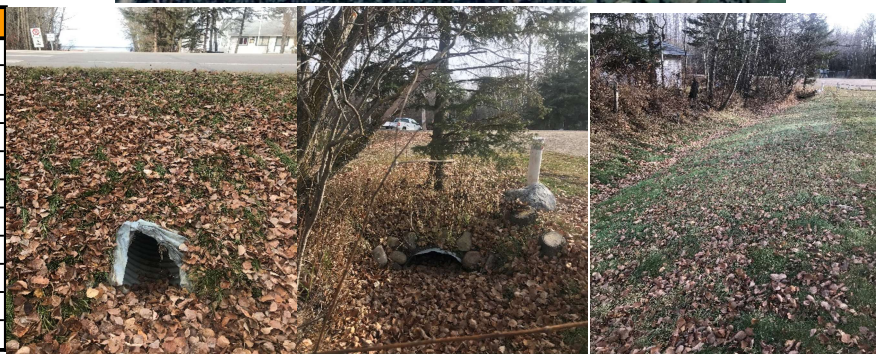
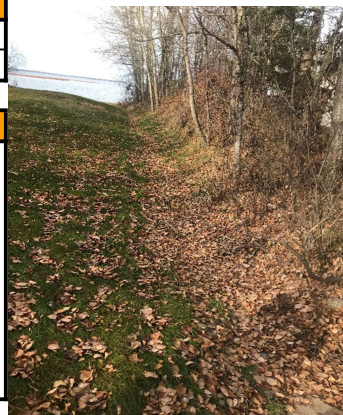
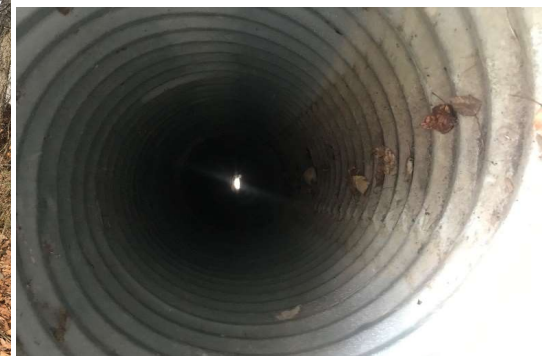
Inlet / Outlet Protection	Rating
Channel scour at Inlet/Outlet	No
Embankment Erosion	No
Sideslopes too Steep	Yes
Drift - wood, debris around pipe	No
Vegetation - trees, brush etc.	Yes
Silt	No
Rip Rap	None

Pipe Barrel	Rating
Blockage	No
Submerged in Water	No
Inlet Damage	Yes
Outlet damage	No
Corrosion / Abrasion	No
Out of Round	No
Settlement	No
Sag / Bow	No
Infiltration	No
Piping	No
Cracking	No

Comments
This crossing is for a Major Flow Path for the subdivision in the 48th Street area. The existing 600mm Dia. culvert maybe too small and needs to be lowered by 0.7m at the inlet and 0.5m at the outlet in order to improvement flow upstream. Recommend 2 - 800mm Dia. CSPs since more flow may be directed this way in future. Needs sloped ends with rip rap. Make longer 1m per end. **INCLUDED IN PROJECT #1. Replacement is part of PROJECT #1 as a larger improvement project. Sideslopes should be flattened.**

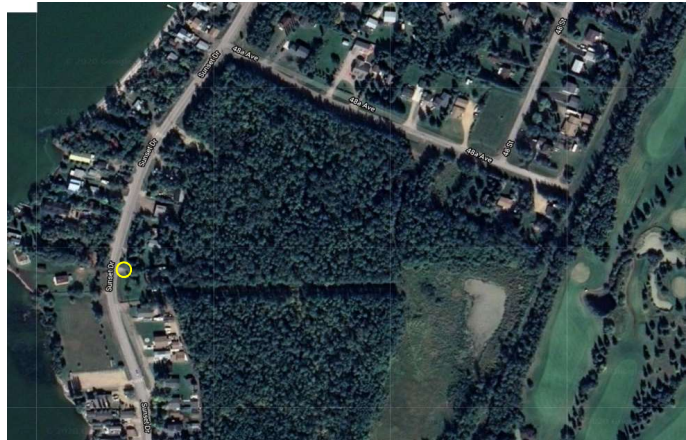
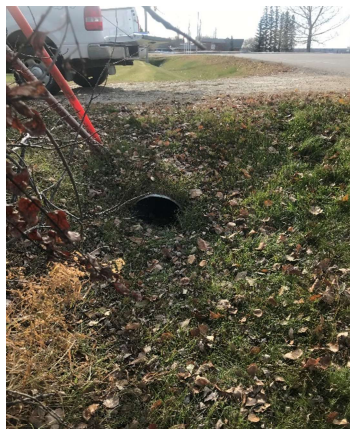
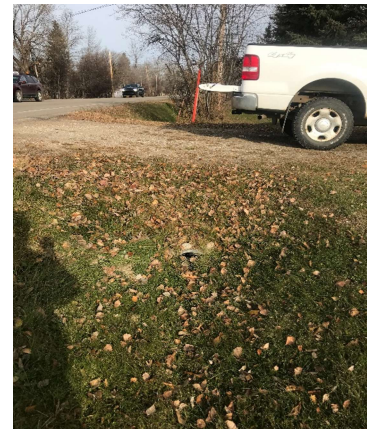
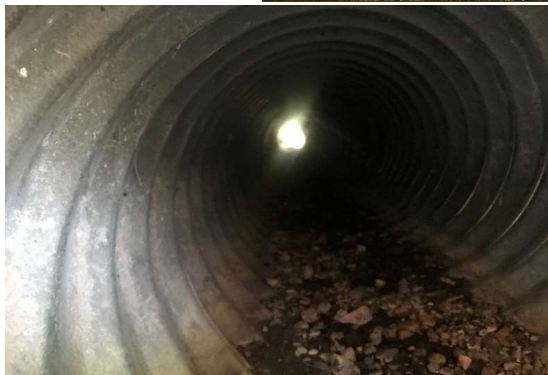
Pipe Barrel	Rating
Blockage	No
Submerged in Water	No
Inlet Damage	No
Outlet damage	No
Corrosion / Abrasion	Yes
Out of Round	No
Settlement	No
Sag / Bow	No
Infiltration	No
Piping	No
Cracking	No

Comments
Culvert appears to be in fair to good condition but undersized. When time to be replaced, replace with 500mm Dia. CSP with sloped ends with rip rap.

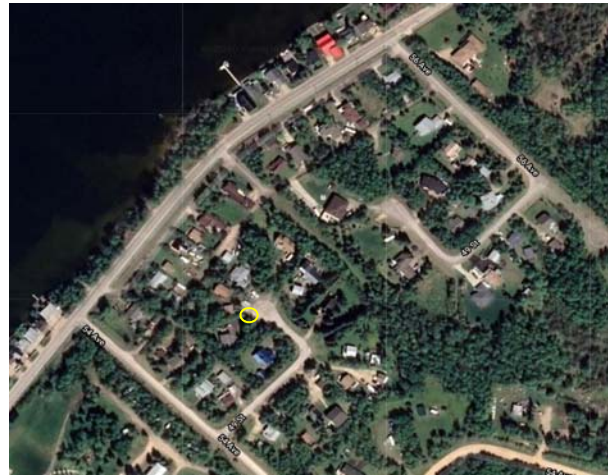
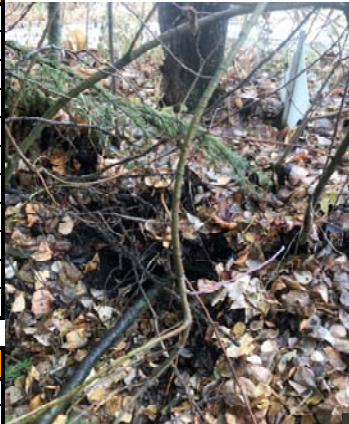
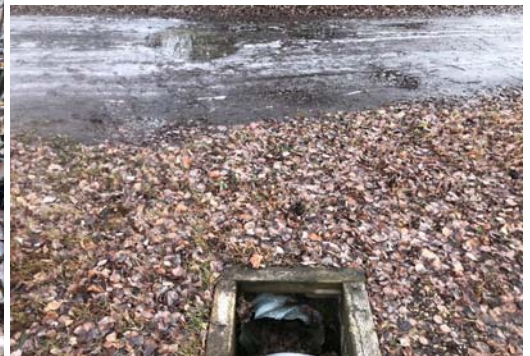
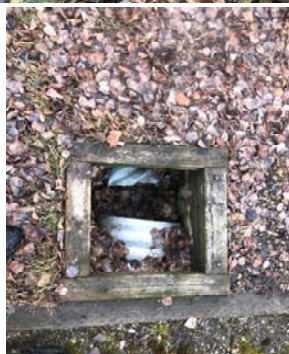
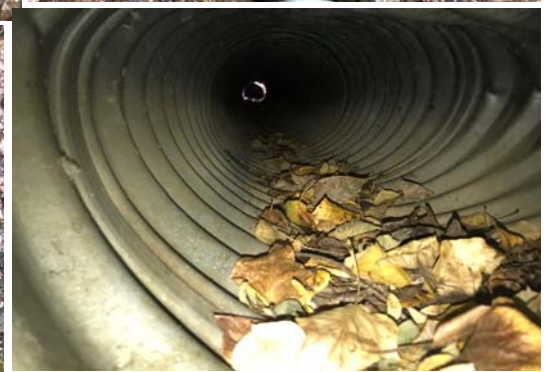
Comments
Culvert is in good condition. Inlet is near blocked and needs maintenance. Homemade opening between culverts should be replaced with proper catchbasin or drop inlet. Culvert needs sloped end on inlet side. Recommend once this culvert has aged and reached its design life, replace with one 500mm diameter culvert.

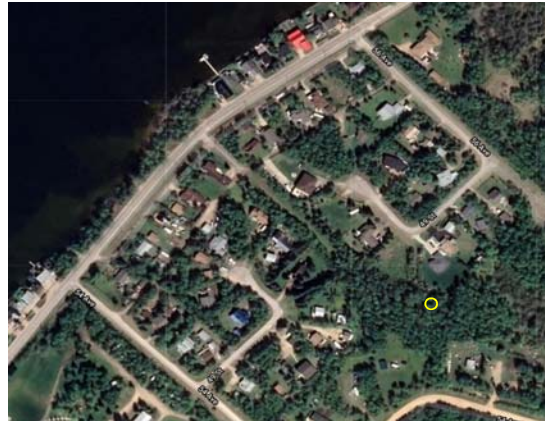
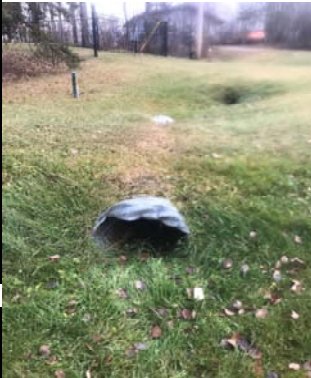
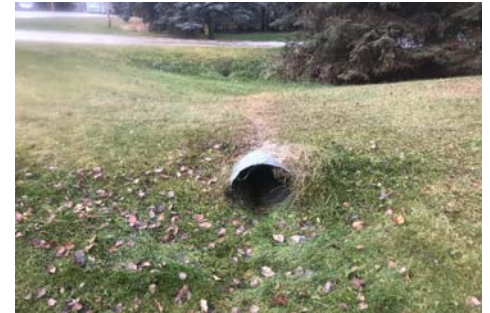
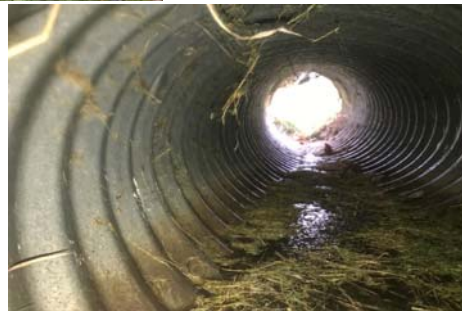
Pipe Barrel	Rating
Blockage	No
Submerged in Water	No
Inlet Damage	Yes
Outlet damage	No
Corrosion / Abrasion	No
Out of Round	No
Settlement	No
Sag / Bow	No
Infiltration	No
Piping	No
Cracking	No

Comments
Culvert is in good condition. Culvert needs sloped ends. Recommend once this culvert has aged and reached its design life, replace with one 500mm diameter culvert.

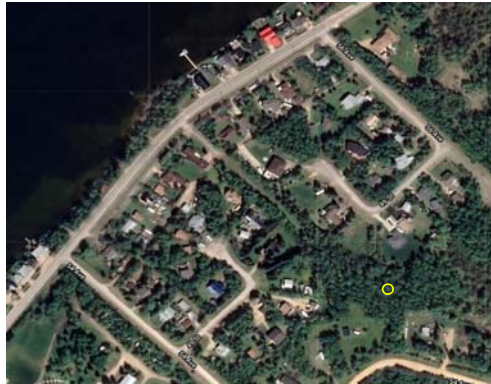
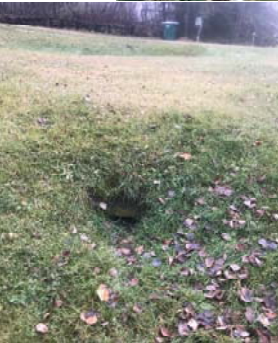
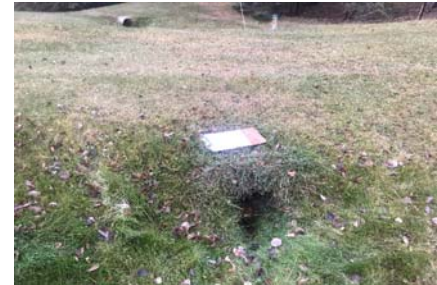
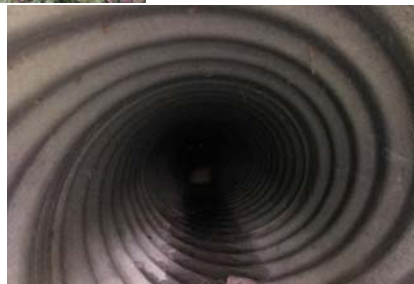
Pipe Barrel	Rating
Blockage	???
Submerged in Water	No
Inlet Damage	No
Outlet damage	No
Corrosion / Abrasion	No
Out of Round	No
Settlement	No
Sag / Bow	No
Infiltration	No
Piping	No
Cracking	No

Comments
Cannot see through. Maybe be blocked. Culvert is in good condition. Culvert needs sloped end on outlet side. Recommend once this culvert has aged and reached its design life, replace with one 500mm diameter culvert.

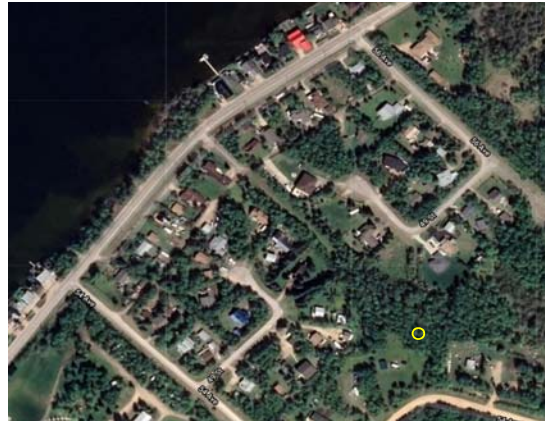
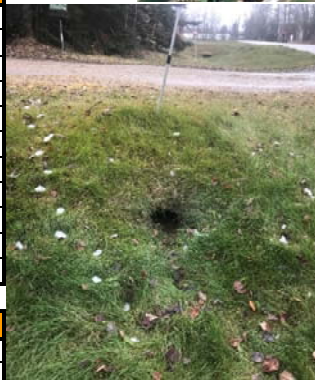
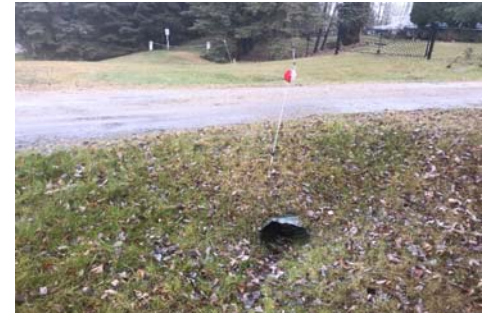
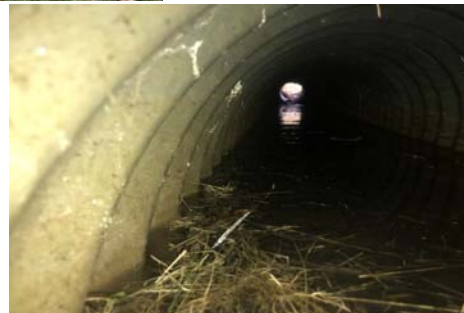
**Culvert Improvement
Cost Estimate**Date: February 15, 2020
Culvert: 2629 - I21

Inlet / Outlet Protection	Rating
Channel scour at Inlet/Outlet	No
Embankment Erosion	No
Sideslopes too Steep	No
Drift - wood, debris around pipe	No
Vegetation - trees, brush etc.	No
Silt	Yes
Rip Rap	None

Comments
Culvert is in fair condition. Culvert needs sloped end on outlet side. Recommend once this culvert has aged and reached its design life, replace with one 500mm diameter culvert.

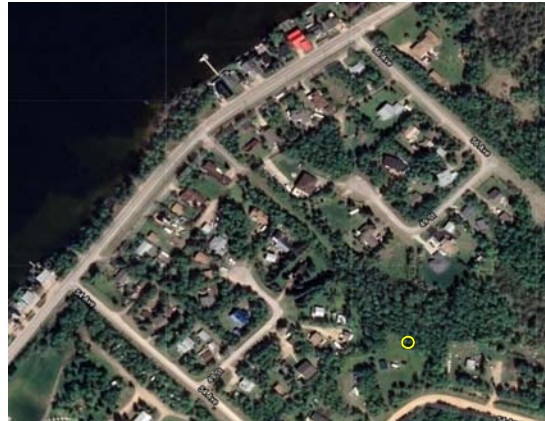
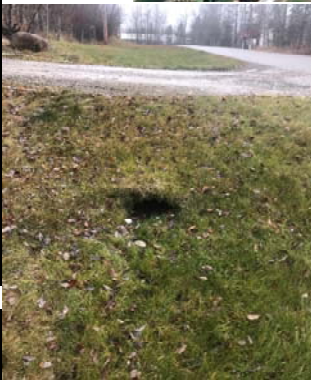
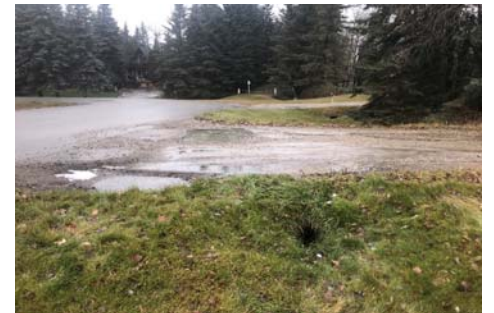
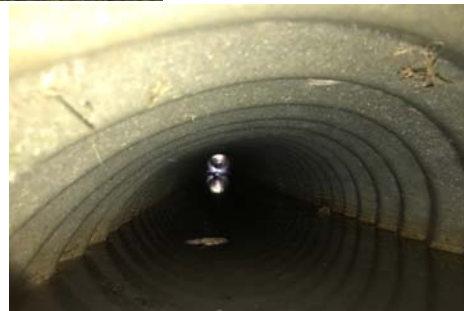
**Culvert Improvement
Cost Estimate**Date: February 15, 2020
Culvert: 2630 - I22

Inlet / Outlet Protection	Rating
Channel scour at Inlet/Outlet	No
Embankment Erosion	No
Sideslopes too Steep	No
Drift - wood, debris around pipe	No
Vegetation - trees, brush etc.	Yes
Silt	Yes
Rip Rap	None

Pipe Barrel	Rating
Blockage	No
Submerged in Water	Partial
Inlet Damage	No
Outlet damage	No
Corrosion / Abrasion	No
Out of Round	No
Settlement	No
Sag / Bow	No
Infiltration	No
Piping	No
Cracking	No

Comments
Culvert is in fair condition. Inlet and Outlet areas need to be cleared out so water flows better and does not sit inside culvert. Culvert needs sloped end on outlet side. Recommend once this culvert has aged and reached its design life, replace with one 500mm diameter culvert.

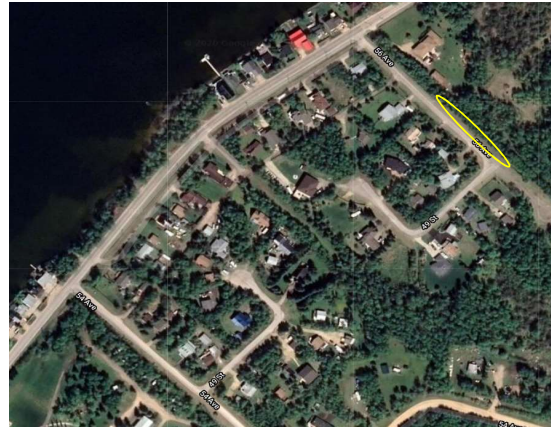
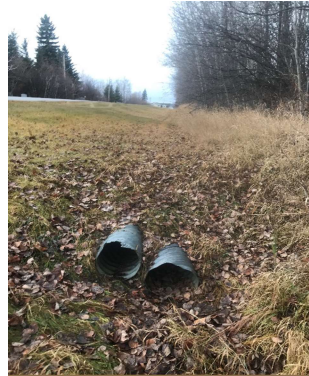
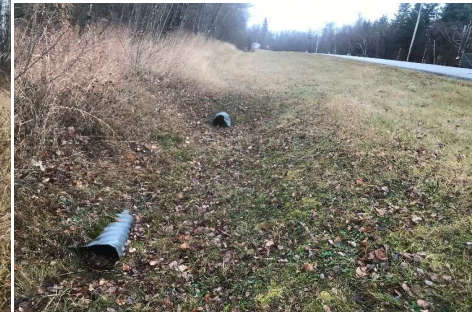
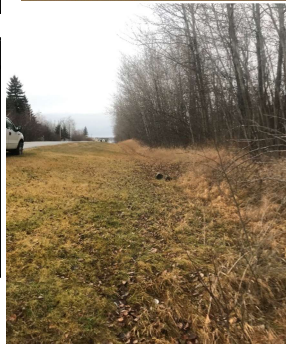
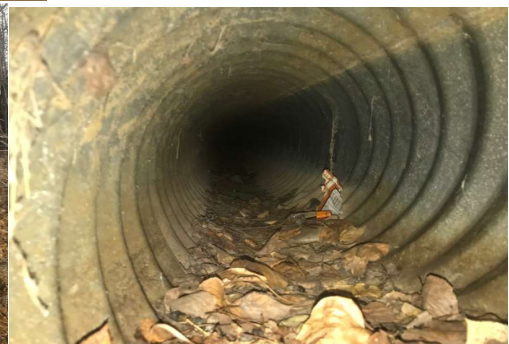
**Culvert Improvement
Cost Estimate**Date: February 15, 2020
Culvert: 2631 - I23

Pipe Barrel	Rating
Blockage	No
Submerged in Water	No
Inlet Damage	Yes
Outlet damage	No
Corrosion / Abrasion	Yes
Out of Round	No
Settlement	No
Sag / Bow	No
Infiltration	No
Piping	No
Cracking	No

Capacity	Rating
Flow Path Type	MAJOR
Function of size, slope and condition	5-Year

Comments
Culvert is in fair condition but small in size. INCLUDED IN PROJECT #3. Project # 3 indicates replacing this culvert with an 800mm Dia. CSP with sloped ends.

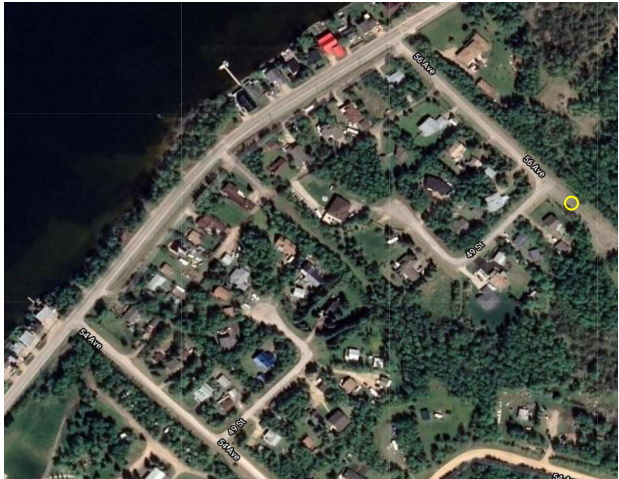
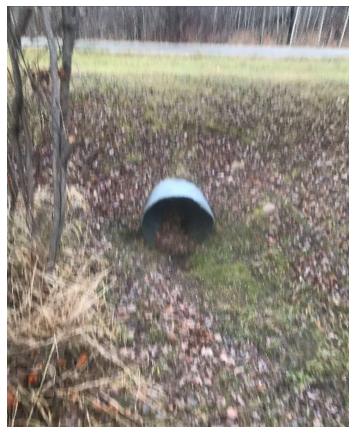
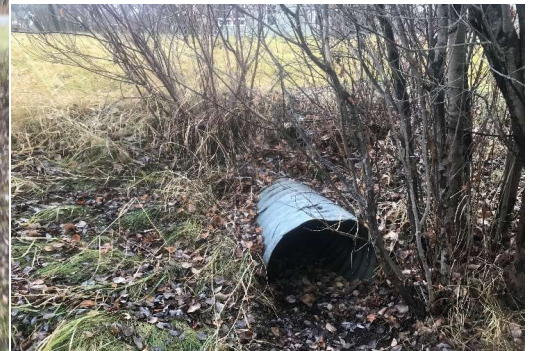
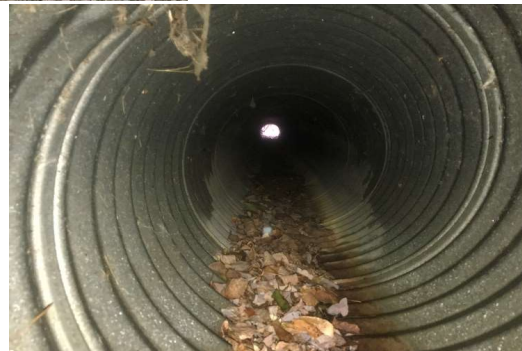
**Culvert Improvement
Cost Estimate**Date: February 15, 2020
Culvert: 2605- 103

Comments
Culvert is in good condition. Water marks inside culvert indicates that flow is very low and not a large concern. Need to review sizing if development occurs upstream. Culvert needs sloped end on outlet side. Recommend once this culvert has aged and reached its design life, replace with one 800mm diameter culvert. **INCLUDED IN PROJECT #3. Project # 3 indicates leaving this culvert in place, just add sloped ends. New culvert to be placed in parallel.**
