EXISTING INFRASTRUCTURE REVIEW

1. Drainage & Culvert Review

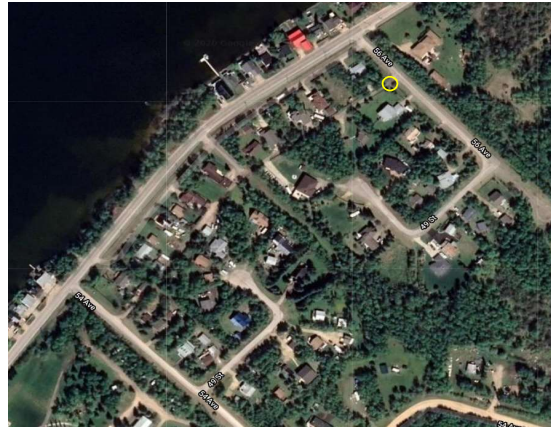
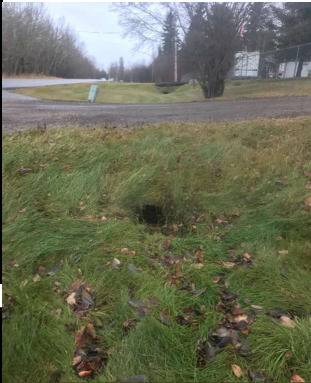
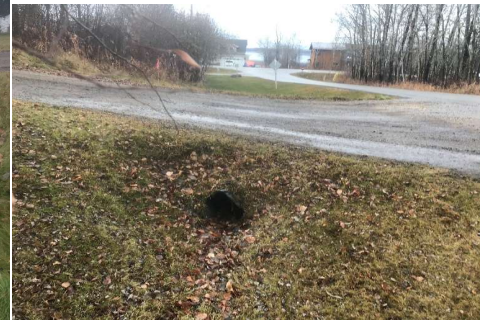
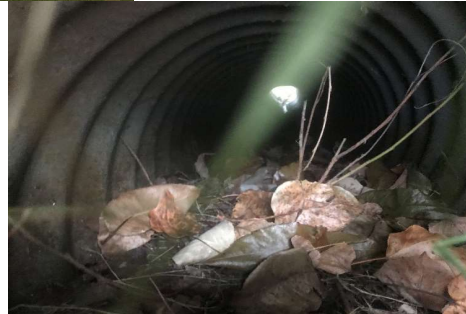
**Culvert Improvement
Cost Estimate**Date: February 15, 2020
Culvert: 2606- 104

Comments
Culvert is in fair to good condition. Culverts need sloped ends. Recommend once this culvert has aged and reached its design life, replace with one 600mm diameter culvert.

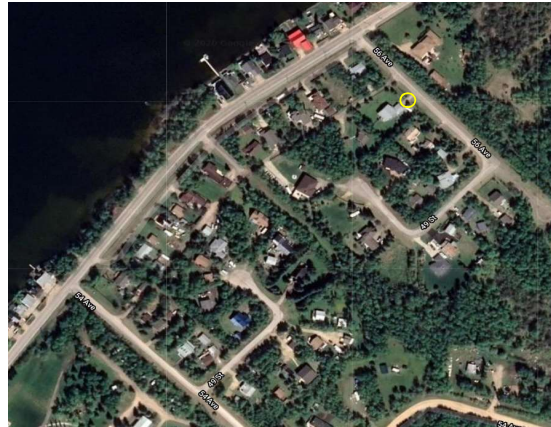
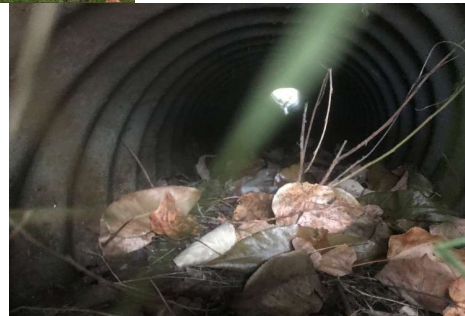
**Culvert Improvement
Cost Estimate**Date: February 15, 2020
Culvert: 2607 - H13

Comments
Culvert is in fair to good condition. Culverts need sloped ends. Recommend once this culvert has aged and reached its design life, replace with one 600mm diameter culvert.

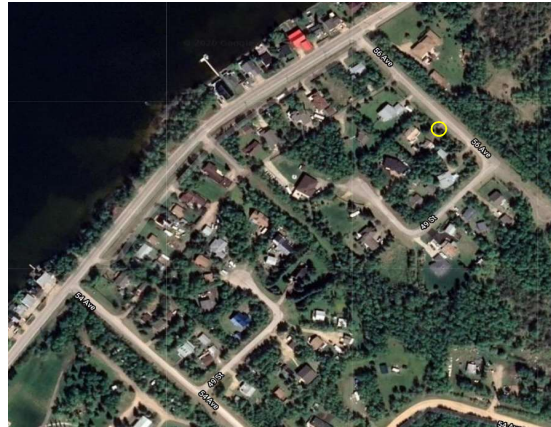
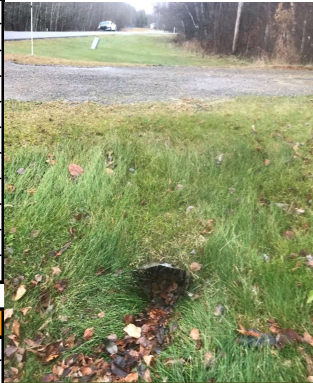
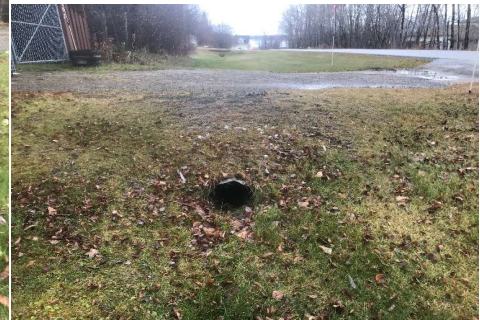
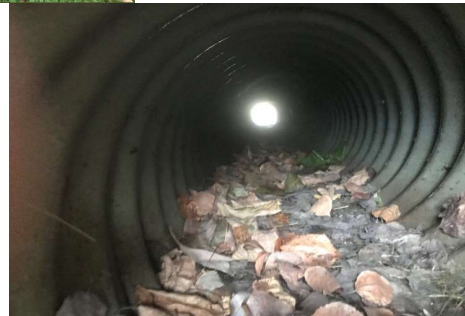
**Culvert Improvement
Cost Estimate**Date: February 15, 2020
Culvert: 2608 - I14

Comments
Culvert is in fair to good condition. Culverts need sloped ends. Recommend once this culvert has aged and reached its design life, replace with one 500mm diameter culvert.

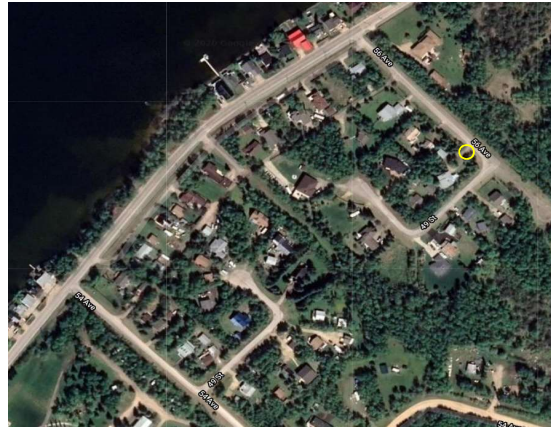
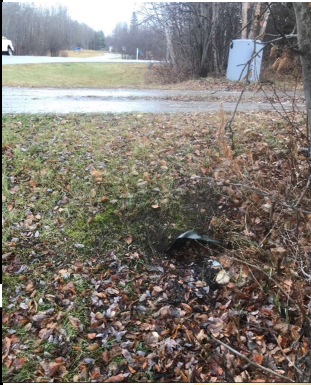
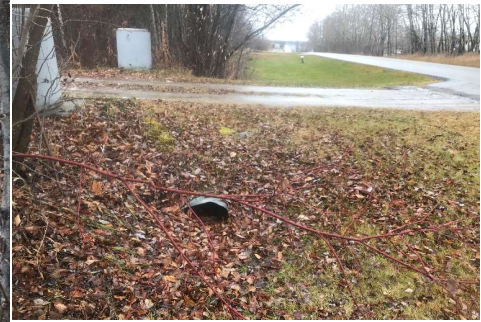
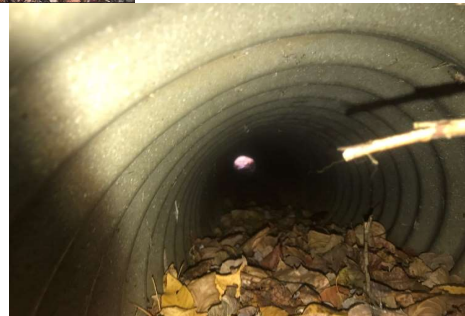
**Culvert Improvement
Cost Estimate**Date: February 15, 2020
Culvert: 2609 - I15

Comments
Culvert is in fair to good condition. Culverts need sloped ends. Recommend once this culvert has aged and reached its design life, replace with one 500mm diameter culvert.

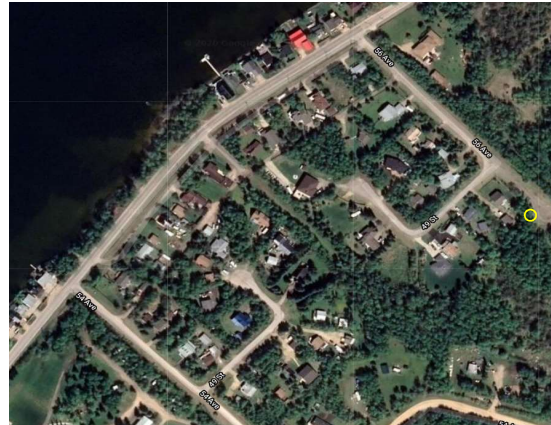
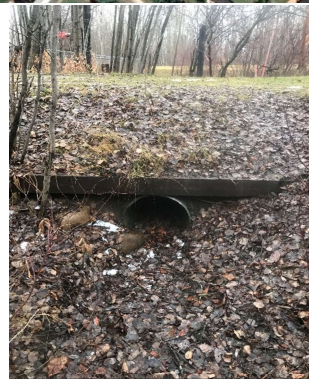
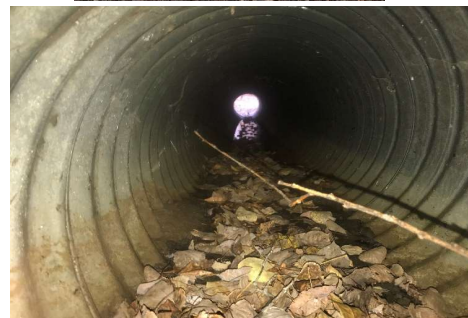
**Culvert Improvement
Cost Estimate**Date: February 15, 2020
Culvert: 2610 - I16

Pipe Barrel	Rating
Blockage	No
Submerged in Water	No
Inlet Damage	No
Outlet damage	No
Corrosion / Abrasion	Yes
Out of Round	No
Settlement	No
Sag / Bow	No
Infiltration	No
Piping	No
Cracking	No

Capacity	Rating
Flow Path Type	MAJOR
Function of size, slope and condition	5-Year

Comments
Culvert is in fair to good condition. Water marks inside culvert indicates that flow goes only 1/3 up, so capacity not a large concern. Need to review sizing if development occurs upstream. Culvert needs sloped end on outlet side. INCLUDED IN PROJECT #3. Project # 3 indicates replacing this culvert. Consideration should be to leave in place, just add sloped ends. New culvert to be placed in parallel.

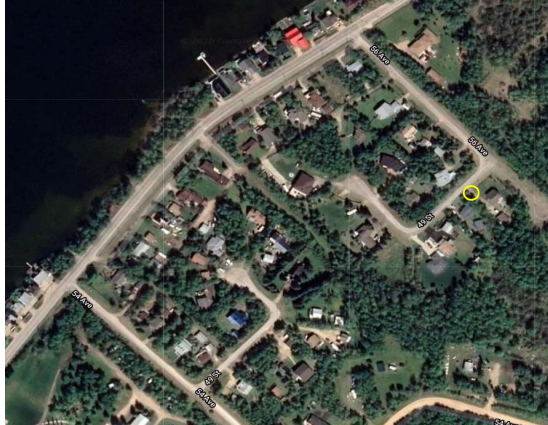
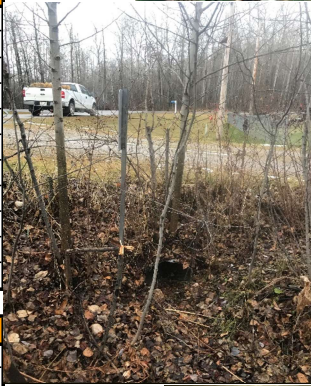
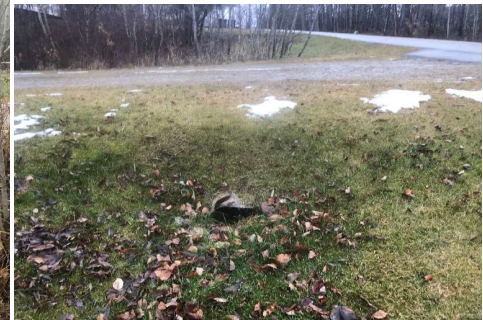
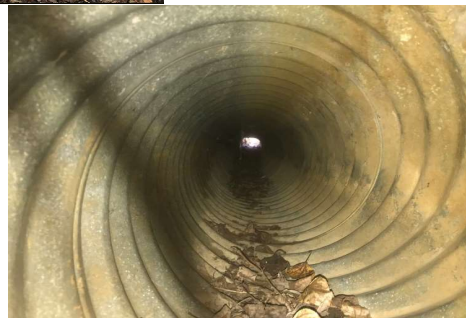
Pipe Barrel	Rating
Blockage	No
Submerged in Water	No
Inlet Damage	Yes
Outlet damage	No
Corrosion / Abrasion	No
Out of Round	No
Settlement	No
Sag / Bow	No
Infiltration	No
Piping	No
Cracking	No

Comments
Culvert is in fair to good condition. Culverts need sloped ends. Recommend once this culvert has aged and reached its design life, replace with one 500mm diameter culvert.

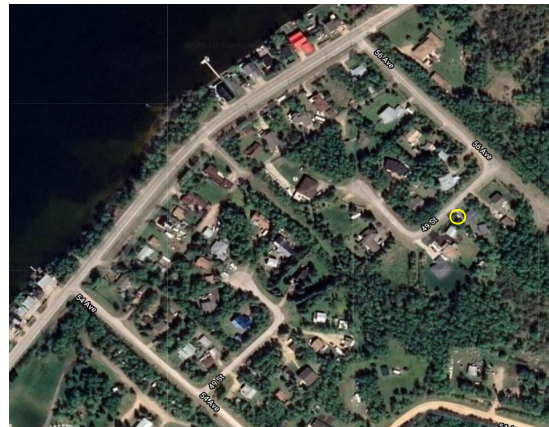
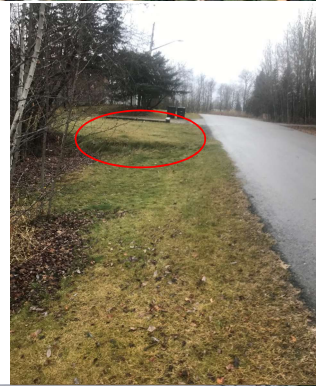
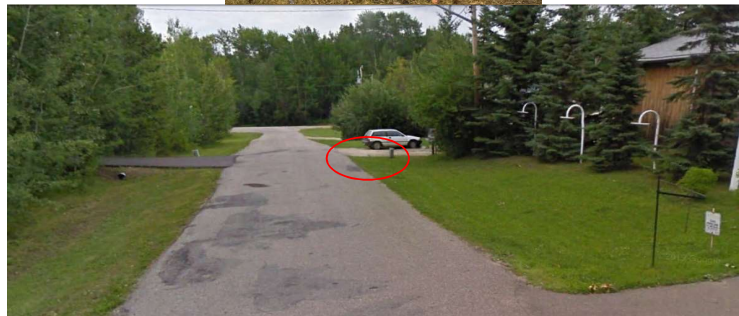
Comments
 No culvert at this approach to the lot. Drainage appears to flow through and over driveway and head toward buildings.
 Recommend that a 500mm Dia. CSP with sloped ends be installed under the approach to ensure drainage head down along the ditch to the north.

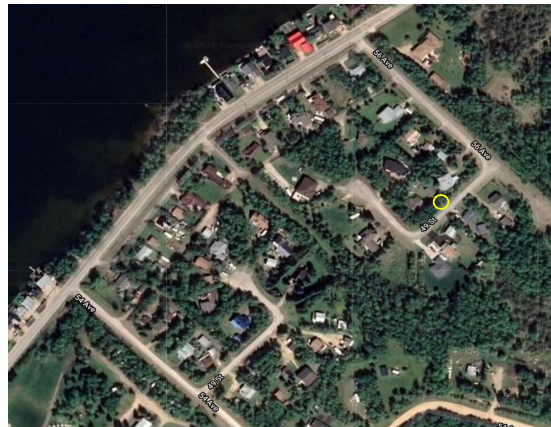
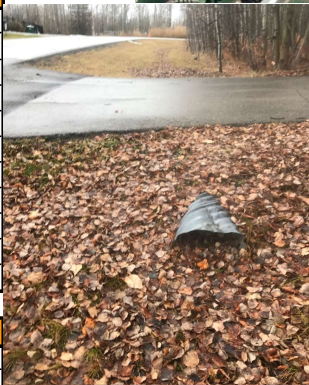
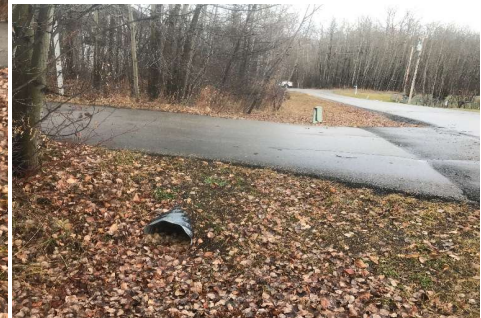
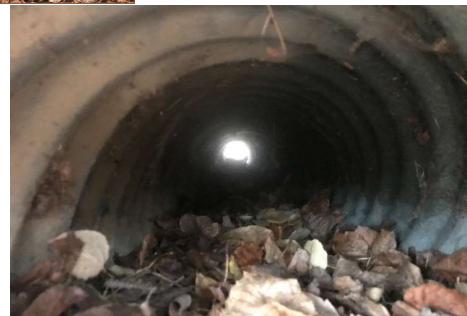
Pipe Barrel	Rating
Blockage	No
Submerged in Water	No
Inlet Damage	No
Outlet damage	Yes
Corrosion / Abrasion	No
Out of Round	No
Settlement	No
Sag / Bow	No
Infiltration	No
Piping	No
Cracking	No

Comments
Culvert is in fair to good condition. Culverts need sloped ends. Recommend once this culvert has aged and reached its design life, replace with one 500mm diameter culvert.

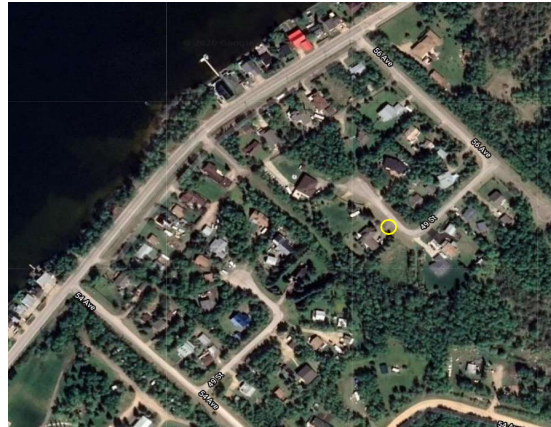
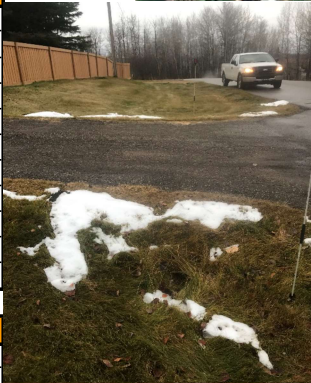
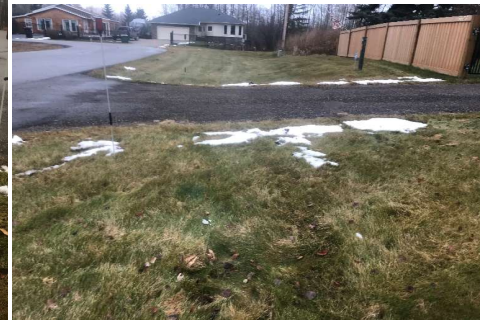
Comments
Culvert is in fair to good condition. Culverts need sloped ends. Recommend once this culvert has aged and reached its design life, replace with one 500mm diameter culvert.

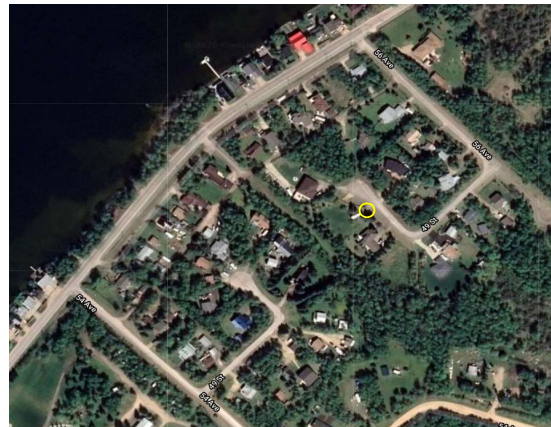
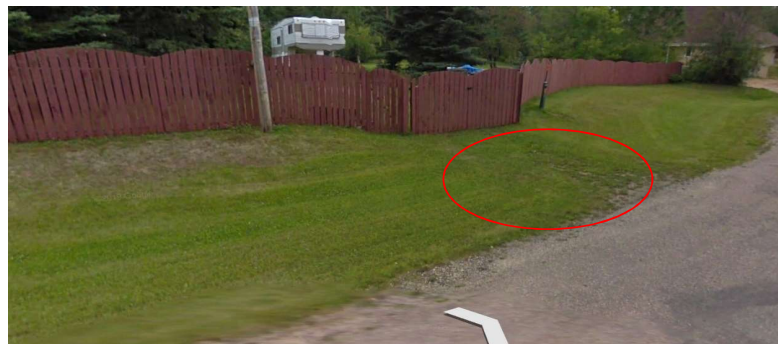
Comments
No culvert at this approach to the lot. Drainage appears to not flow past this point. Recommend that a 500mm Dia. CSP with sloped ends be installed under the approach to ensure drainage head down along the ditch to the west.

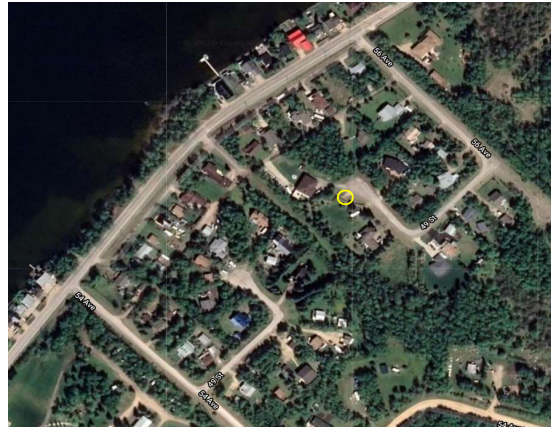
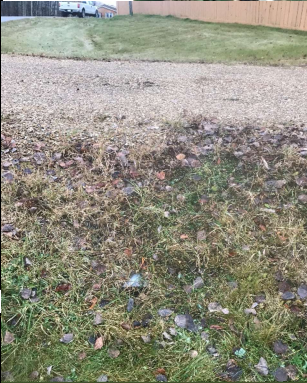
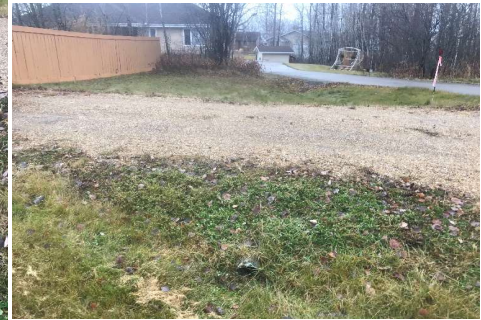
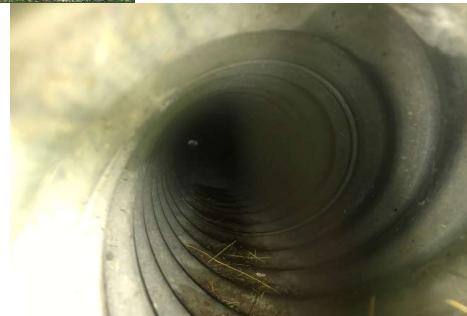
Pipe Barrel	Rating
Blockage	Partial
Submerged in Water	No
Inlet Damage	No
Outlet damage	No
Corrosion / Abrasion	No
Out of Round	No
Settlement	No
Sag / Bow	No
Infiltration	No
Piping	No
Cracking	No

Comments
 Can't see fully through culvert. Culvert is in fair to good condition. Culverts need sloped ends. Recommend once this culvert has aged and reached its design life, replace with one 500mm diameter culvert.

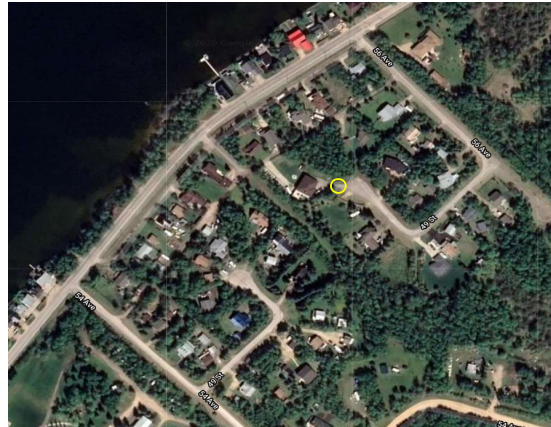
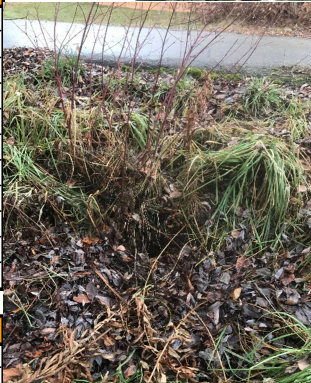
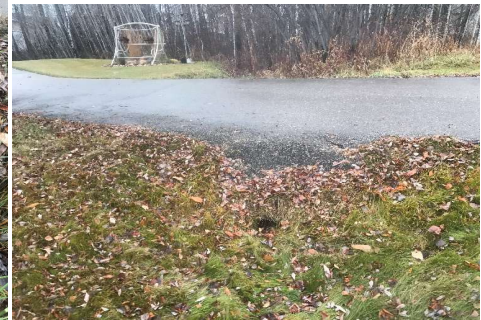
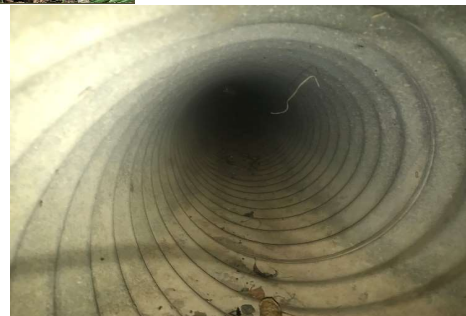
Pipe Barrel	Rating
Blockage	Partial
Submerged in Water	No
Inlet Damage	No
Outlet damage	No
Corrosion / Abrasion	No
Out of Round	No
Settlement	No
Sag / Bow	No
Infiltration	No
Piping	No
Cracking	No

Comments
 Can't see fully through culvert. Culvert is in fair to good condition. Culverts need sloped ends. Recommend once this culvert has aged and reached its design life, replace with one 500mm diameter culvert.

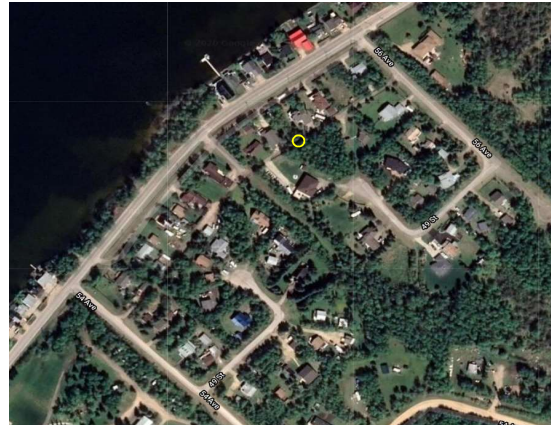
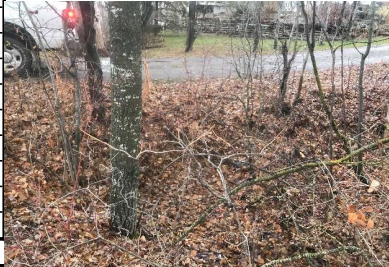
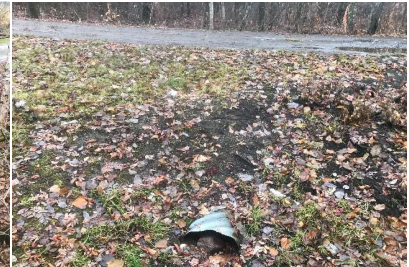
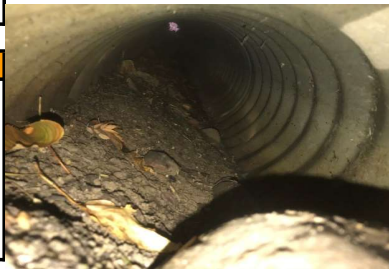
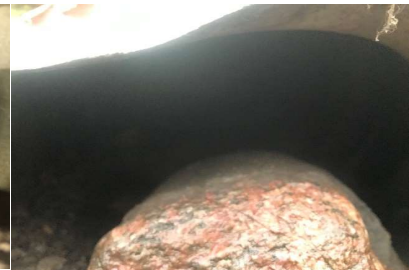
Pipe Barrel	Rating
Blockage	Yes
Submerged in Water	No
Inlet Damage	Yes
Outlet damage	Yes
Corrosion / Abrasion	No
Out of Round	Yes
Settlement	No
Sag / Bow	No
Infiltration	No
Piping	No
Cracking	No

Capacity	Rating
Flow Path Type	Minor
Function of size, slope and condition	Inadequate

Comments
Culvert is in poor condition, is too small and appears to be partially blocked. Need to clean out trees and heavy grass at inlet and outlet. Culvert needs sloped end on outlet side. Recommend to replace with 600mm diameter culvert.

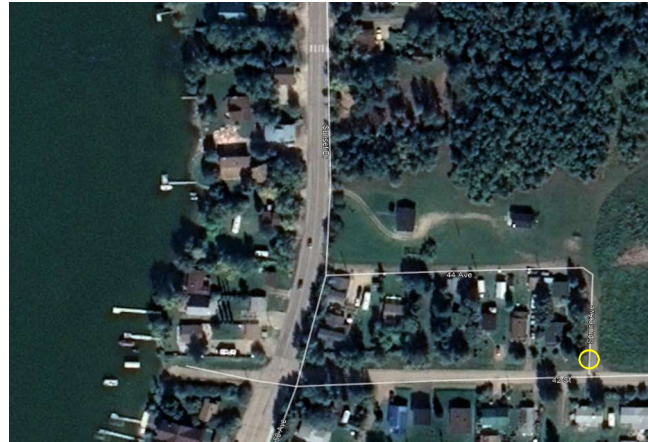
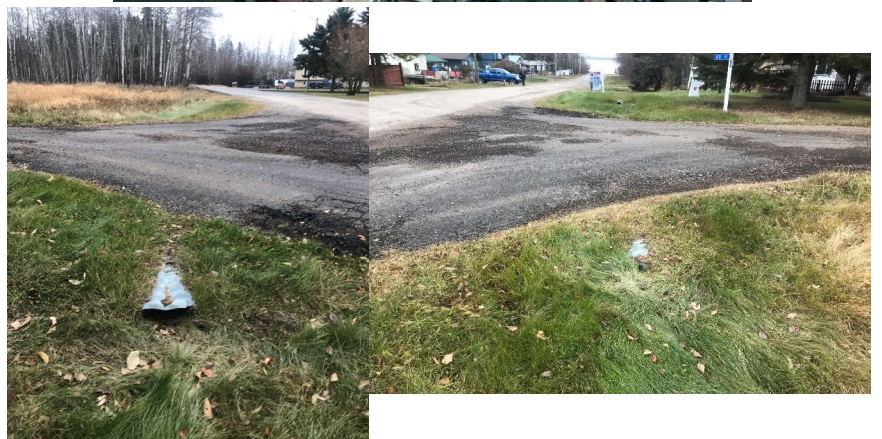
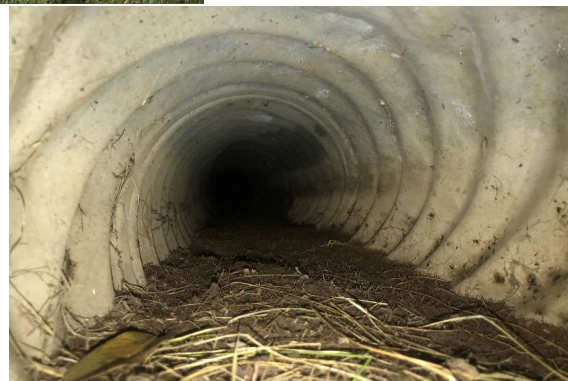
Pipe Barrel	Rating
Blockage	????
Submerged in Water	No
Inlet Damage	Yes
Outlet damage	Yes
Corrosion / Abrasion	No
Out of Round	No
Settlement	No
Sag / Bow	No
Infiltration	No
Piping	No
Cracking	No

Comments
Culvert appears to be in fair to good condition. Small culvert that should be larger just to maintain flow and availability for cleaning out. Recommend when comes time for replacement, replace with 500mm Dia. CSP with sloped ends and rip rap. Check slope in culvert.

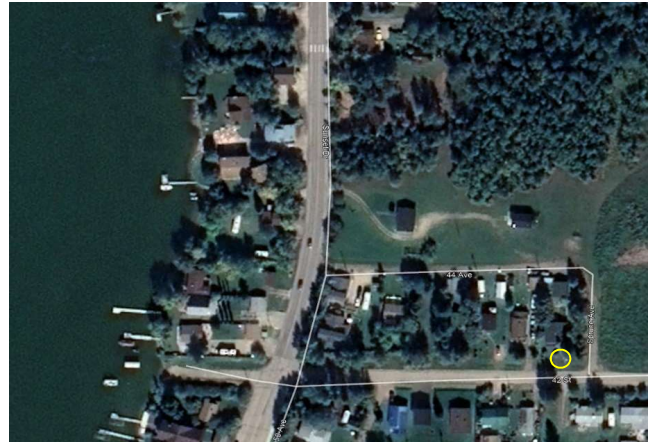
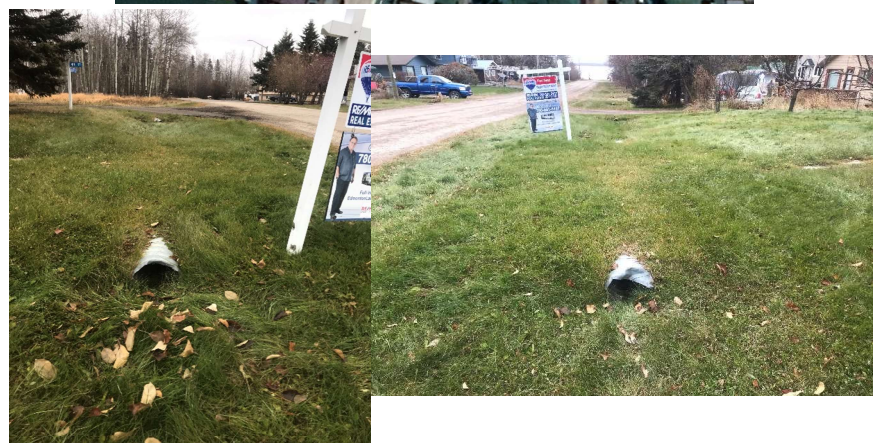
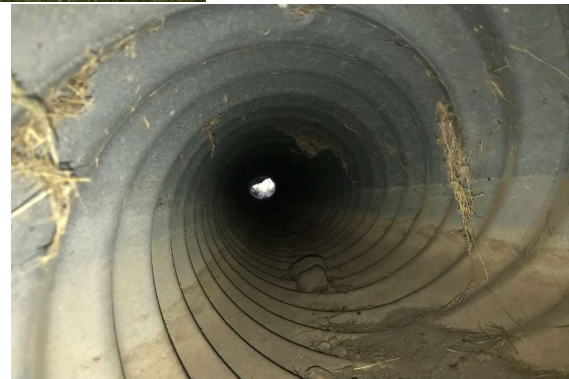
Pipe Barrel	Rating
Blockage	No
Submerged in Water	No
Inlet Damage	Yes
Outlet damage	No
Corrosion / Abrasion	No
Out of Round	No
Settlement	No
Sag / Bow	No
Infiltration	No
Piping	No
Cracking	No

Comments
Culvert appears to be in fair to good condition. Small culvert that should be larger just to maintain flow and availability for cleaning out. Recommend when comes time for replacement, replace with 500mm Dia. CSP with sloped ends and rip rap. Check slope in culvert.

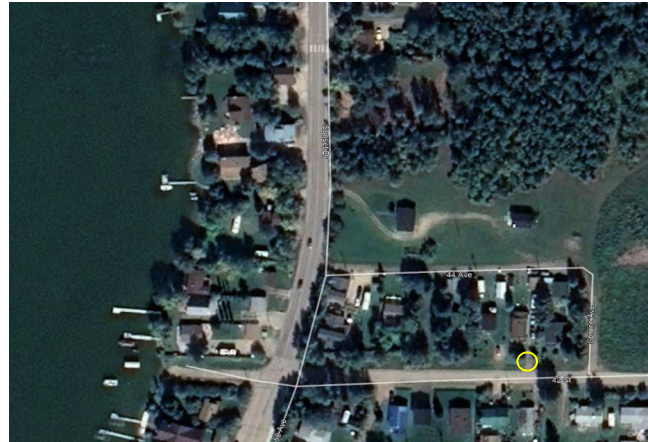
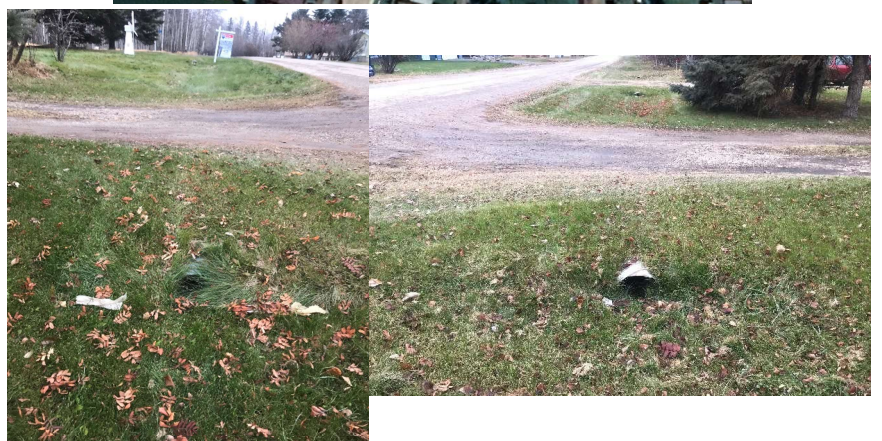
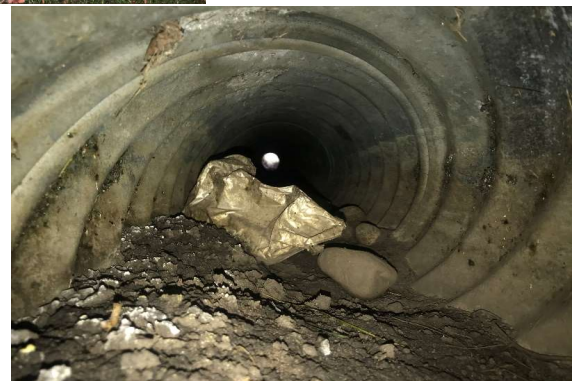
Inlet / Outlet Protection	Rating
Channel scour at Inlet/Outlet	No
Embankment Erosion	No
Sideslopes too Steep	No
Drift - wood, debris around pipe	No
Vegetation - trees, brush etc.	No
Silt	Yes
Rip Rap	None

Comments
Culvert appears to be in fair to good condition. Small culvert that should be larger just to maintain flow and availability for cleaning out. Recommend when comes time for replacement, replace with 500mm Dia. CSP with sloped ends and rip rap. Check slope in culvert.

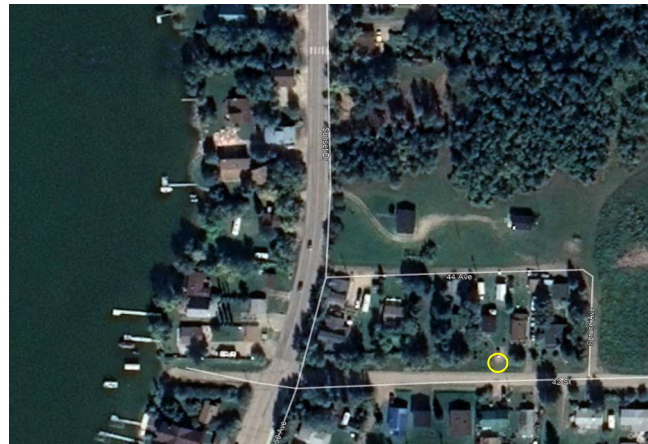
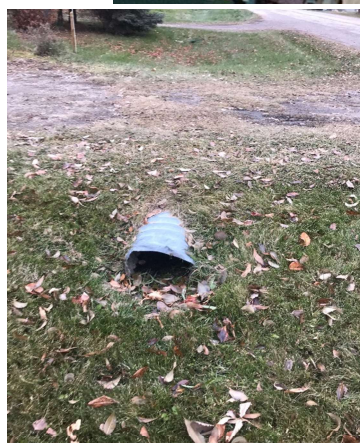
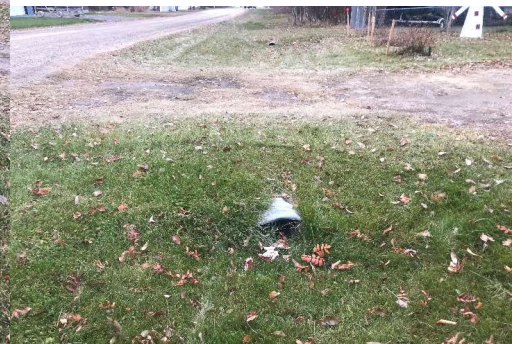
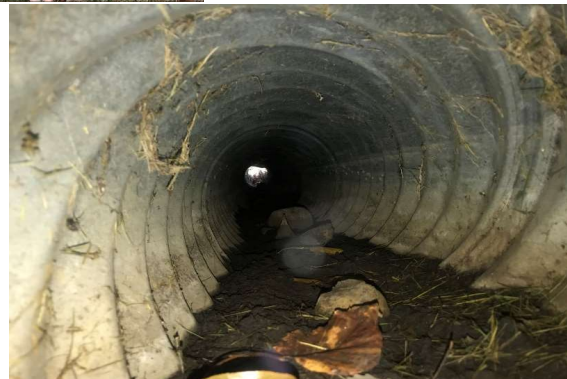
Pipe Barrel	Rating
Blockage	No
Submerged in Water	No
Inlet Damage	Yes
Outlet damage	Yes
Corrosion / Abrasion	No
Out of Round	No
Settlement	No
Sag / Bow	No
Infiltration	No
Piping	No
Cracking	No

Capacity	Rating
Flow Path Type	Minor
Function of size, slope and condition	5-Year

Comments
Culvert appears to be in fair to good condition. Small culvert that should be larger just to maintain flow and availability for cleaning out. Recommend when comes time for replacement, replace with 500mm Dia. CSP with sloped ends and rip rap. Check slope in culvert.

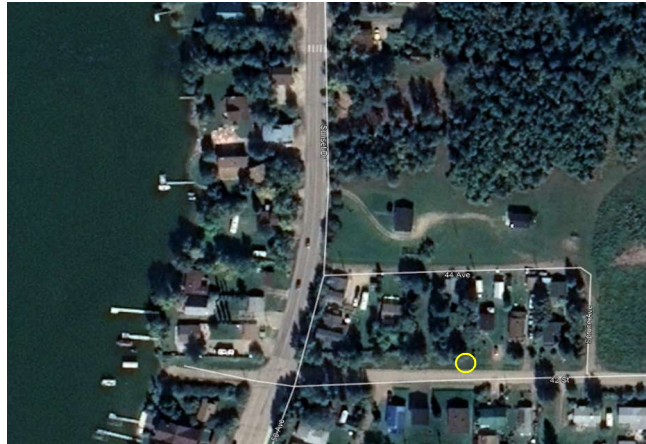
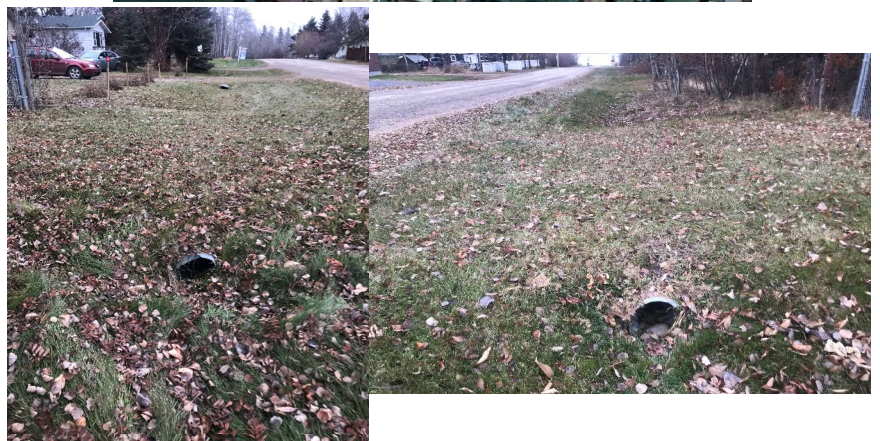
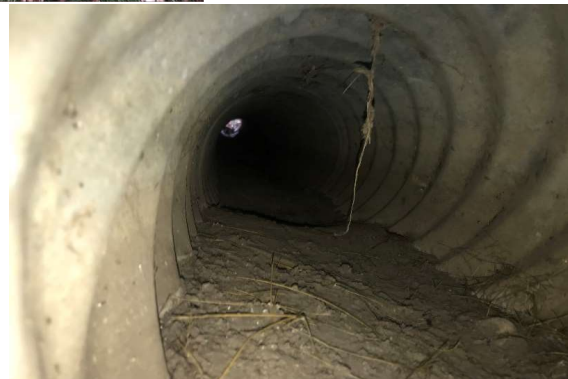
**Culvert Improvement
Cost Estimate**Date: February 15, 2020
Culvert: 2232 - A16

Inlet / Outlet Protection	Rating
Channel scour at Inlet/Outlet	No
Embankment Erosion	No
Sideslopes too Steep	No
Drift - wood, debris around pipe	No
Vegetation - trees, brush etc.	No
Silt	Yes
Rip Rap	None

Pipe Barrel	Rating
Blockage	No
Submerged in Water	No
Inlet Damage	No
Outlet damage	No
Corrosion / Abrasion	No
Out of Round	No
Settlement	No
Sag / Bow	No
Infiltration	No
Piping	No
Cracking	No

Capacity	Rating
Flow Path Type	Minor
Function of size, slope and condition	10-Year

Comments
Culvert appears to be in fair to good condition. Small culvert that should be larger just to maintain flow and availability for cleaning out. Recommend when comes time for replacement, replace with 500mm Dia. CSP with sloped ends and rip rap. Check slope in culvert.

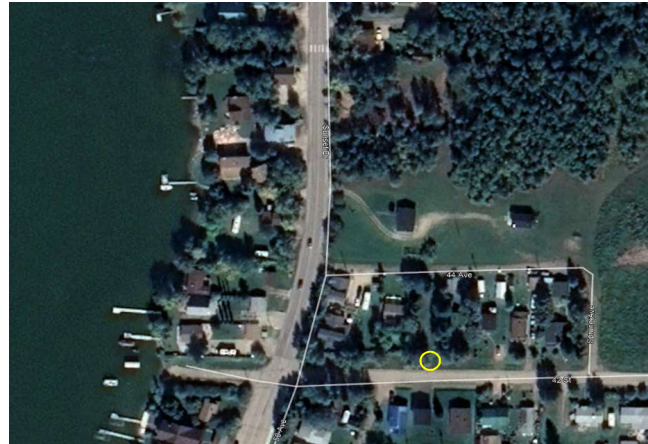
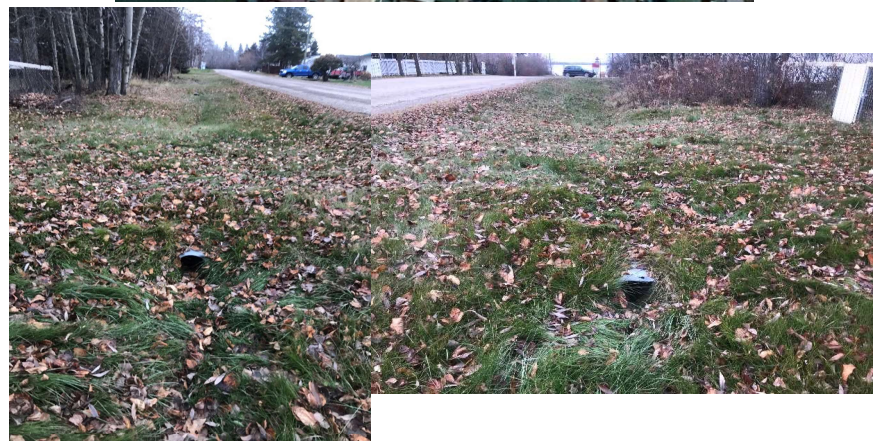
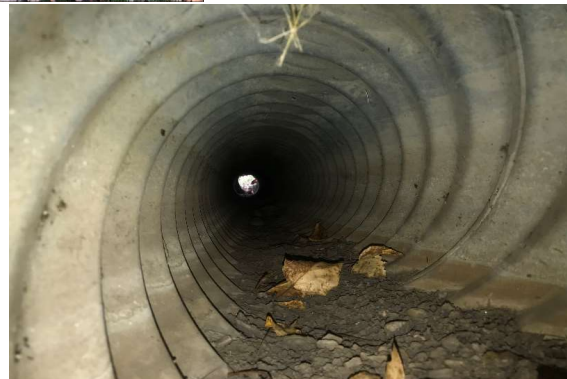
**Culvert Improvement
Cost Estimate**Date: February 15, 2020
Culvert: 2233 - A15

Inlet / Outlet Protection	Rating
Channel scour at Inlet/Outlet	No
Embankment Erosion	No
Sideslopes too Steep	No
Drift - wood, debris around pipe	No
Vegetation - trees, brush etc.	No
Silt	No
Rip Rap	None

Pipe Barrel	Rating
Blockage	No
Submerged in Water	No
Inlet Damage	No
Outlet damage	No
Corrosion / Abrasion	No
Out of Round	No
Settlement	No
Sag / Bow	No
Infiltration	No
Piping	No
Cracking	No

Capacity	Rating
Flow Path Type	Minor
Function of size, slope and condition	10-Year

Comments
Culvert appears to be in fair to good condition. Small culvert that should be larger just to maintain flow and availability for cleaning out. Recommend when comes time for replacement, replace with 500mm Dia. CSP with sloped ends and rip rap. Check slope in culvert.

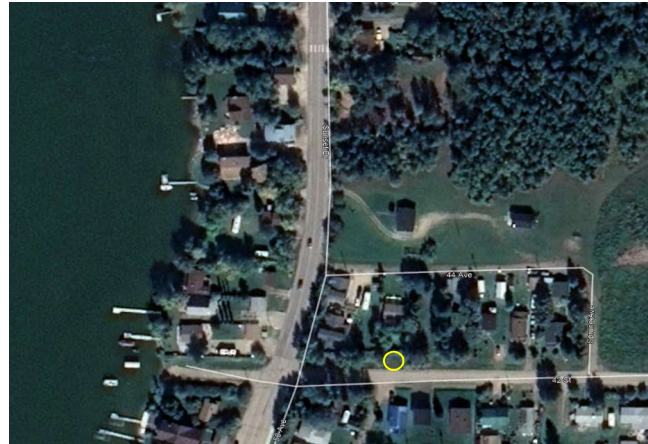
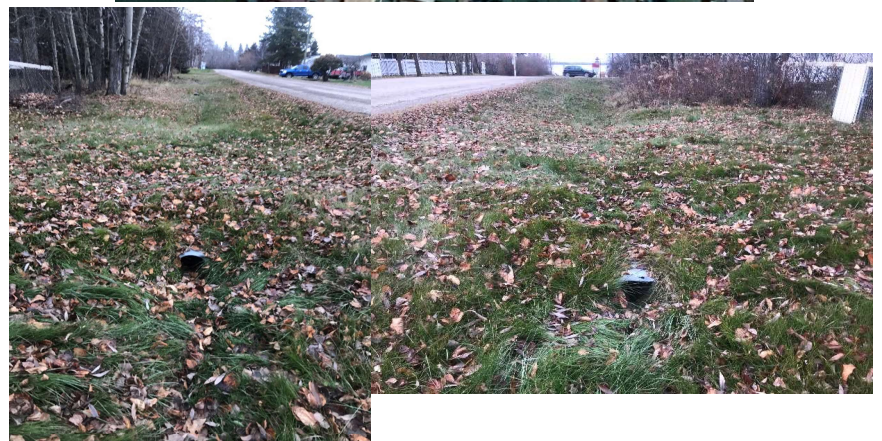
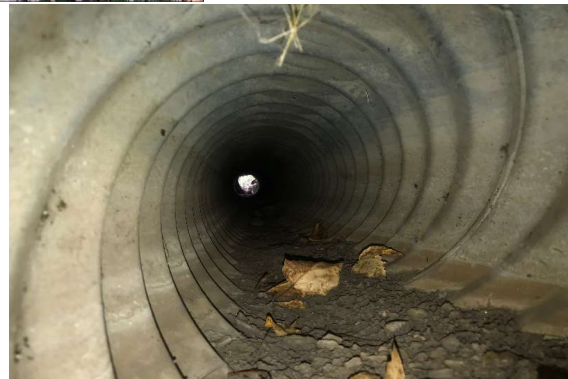
**Culvert Improvement
Cost Estimate**Date: February 15, 2020
Culvert: 2234 - A14

Inlet / Outlet Protection	Rating
Channel scour at Inlet/Outlet	No
Embankment Erosion	No
Sideslopes too Steep	No
Drift - wood, debris around pipe	No
Vegetation - trees, brush etc.	No
Silt	No
Rip Rap	None

Pipe Barrel	Rating
Blockage	No
Submerged in Water	No
Inlet Damage	No
Outlet damage	No
Corrosion / Abrasion	No
Out of Round	No
Settlement	No
Sag / Bow	No
Infiltration	No
Piping	No
Cracking	No

Capacity	Rating
Flow Path Type	Minor
Function of size, slope and condition	10-Year

Comments
Culvert appears to be in fair to good condition. Small culvert that should be larger just to maintain flow and availability for cleaning out. Recommend when comes time for replacement, replace with 500mm Dia. CSP with sloped ends and rip rap. Check slope in culvert.
