Stormwater Management Plan
Final Report - Issued for Approval

Summer Village of Sunset Point

Sections W26 54-3-5, NW23 54-3-5, and
NE22 54-3-5
Lac Ste. Anne County

*Summer Village of Sunset Point
June 2020*

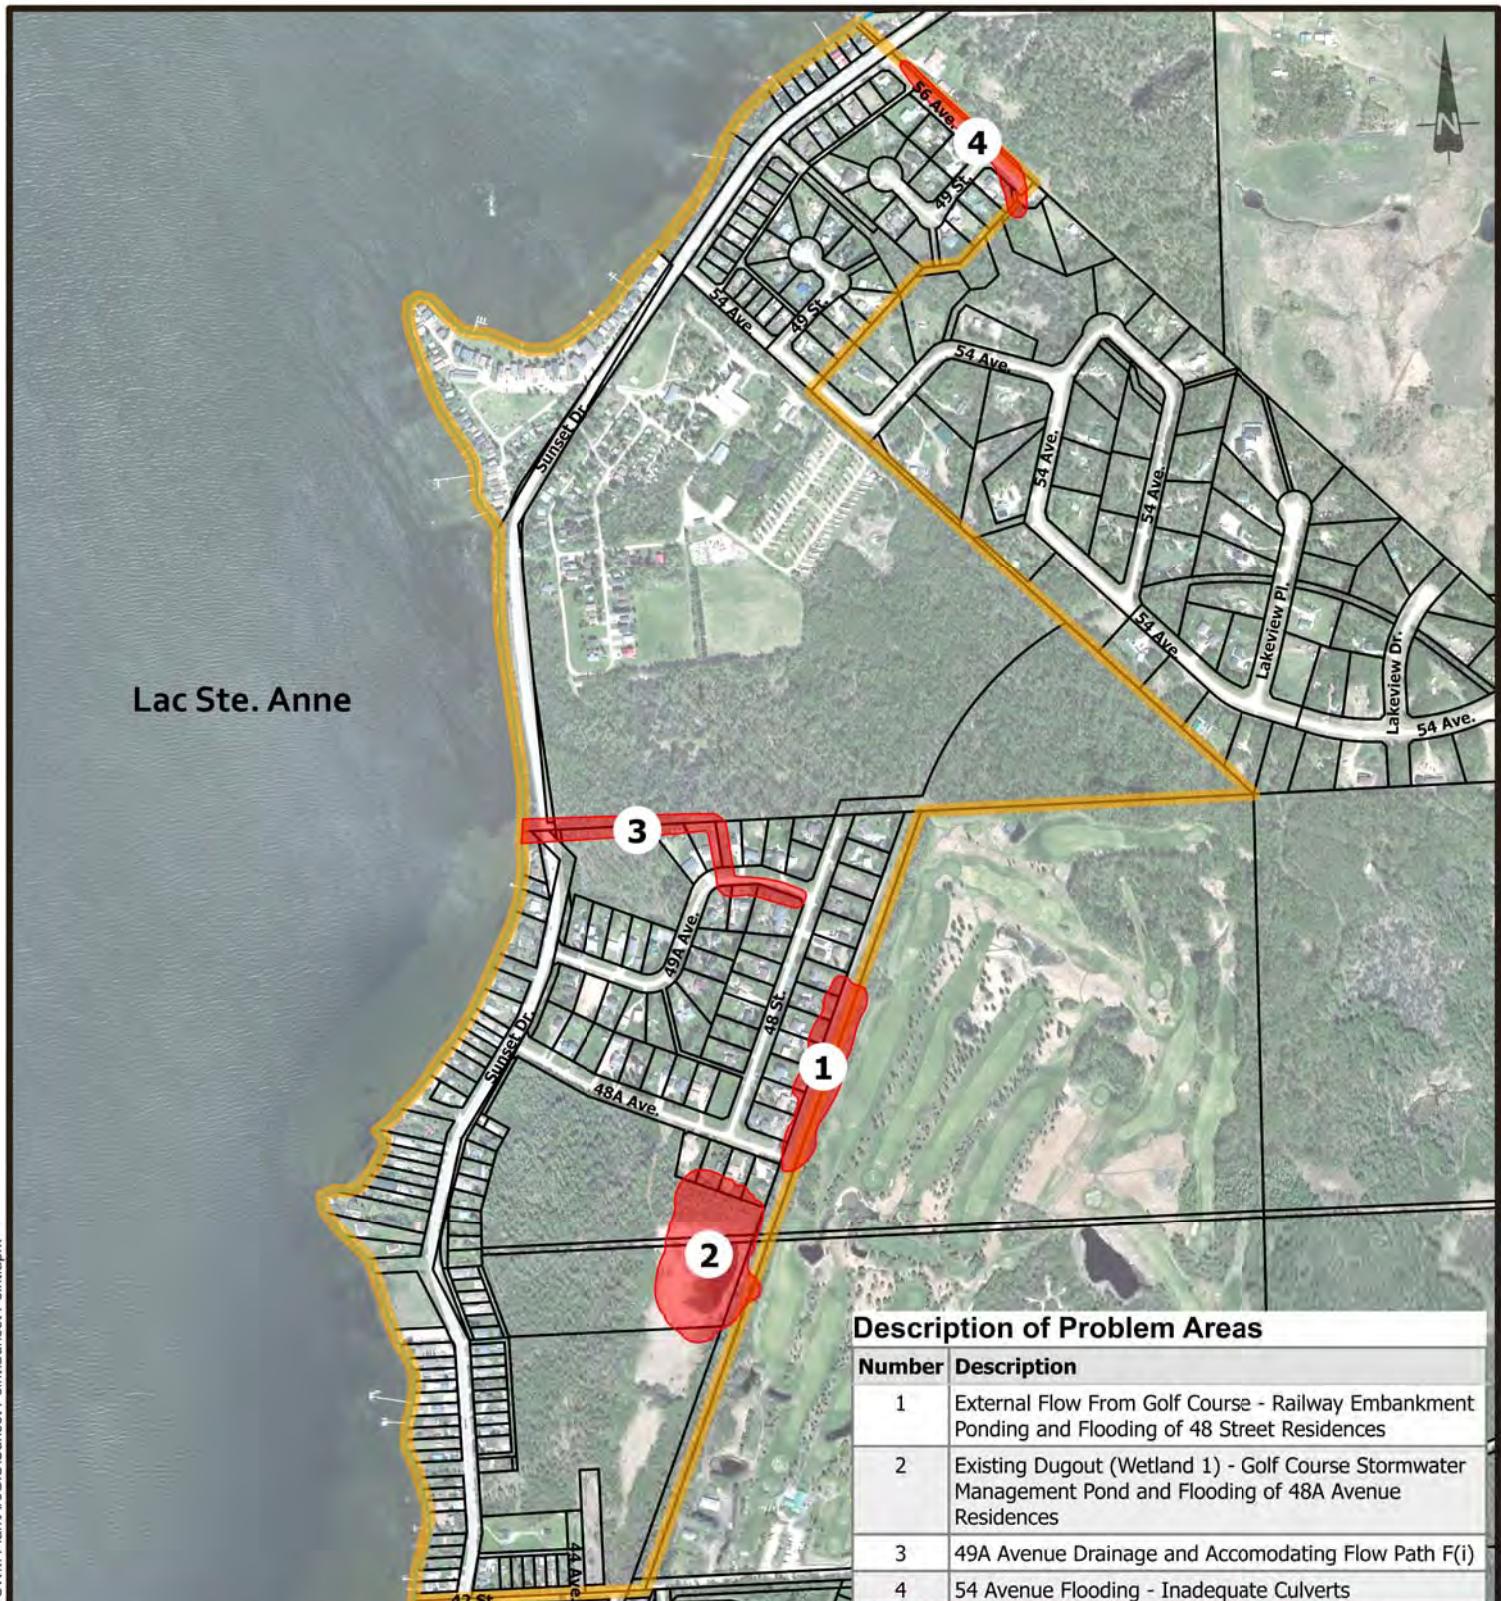
The north railway embankment crossing, culvert RE02, crosses the embankment 125m northeast of the 48A Avenue centreline (behind Lot 51, Block 15) and drains to the ditch on the west side of the embankment, as shown in **Appendix A, Figure A-14**. The existing culvert RE02 is 600mm in size, has 31 hectares of contributing area and is graded from east to west at a slope of 1.8%. With such a large contributing area, the service level of the culvert is inadequate in all scenarios studied. The RE02 culvert inlet (east invert) is too high to allow the standing water in the east ditch to drain across the embankment, so it is directly contributing to the embankment ponding and seepage issues.

The most significant drainage issue related to the external runoff from the golf course is that the downstream flow paths were not designed to convey this large external flow, they were likely only designed to convey internally-generated runoff from the Summer Village. In some cases, the external flow doubles or triples the area contributing to a flow path.

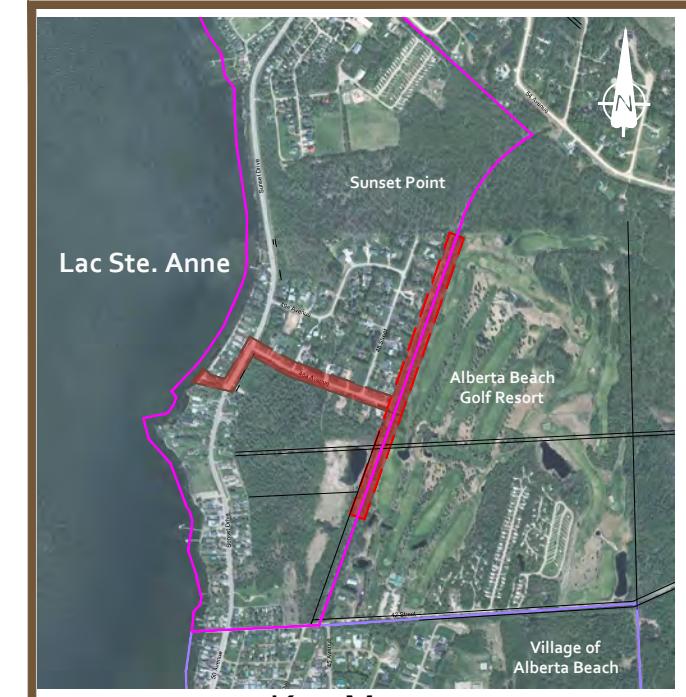
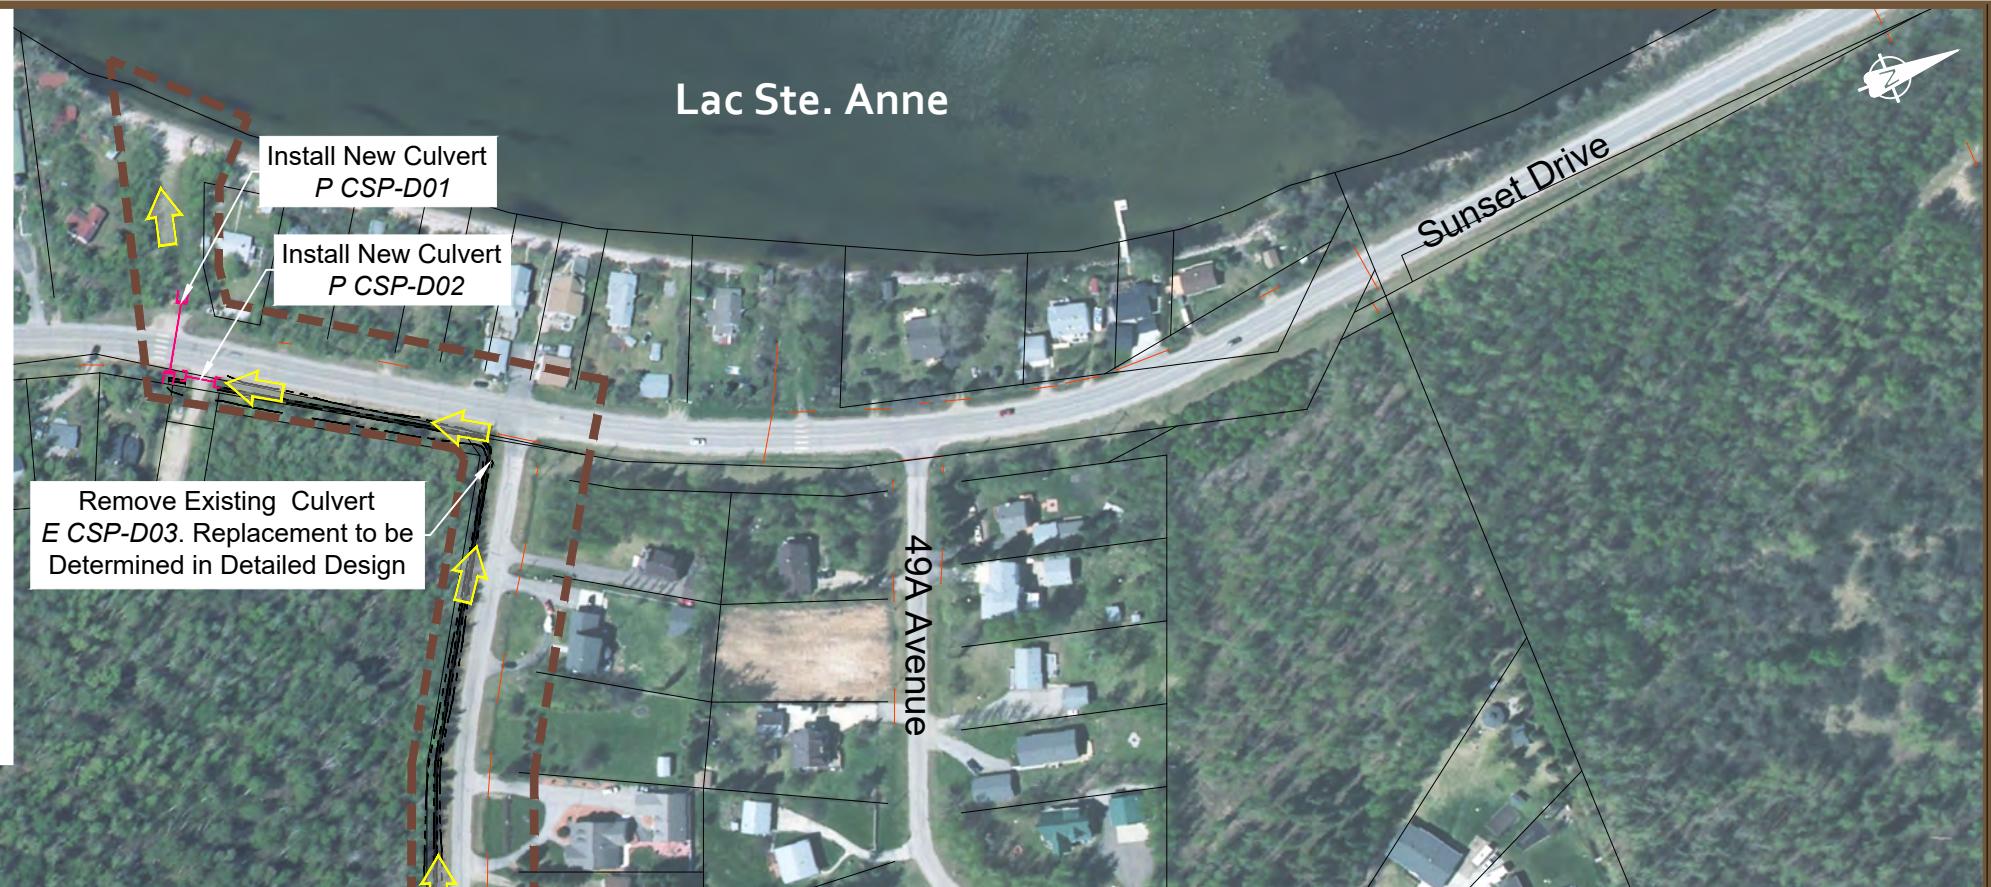
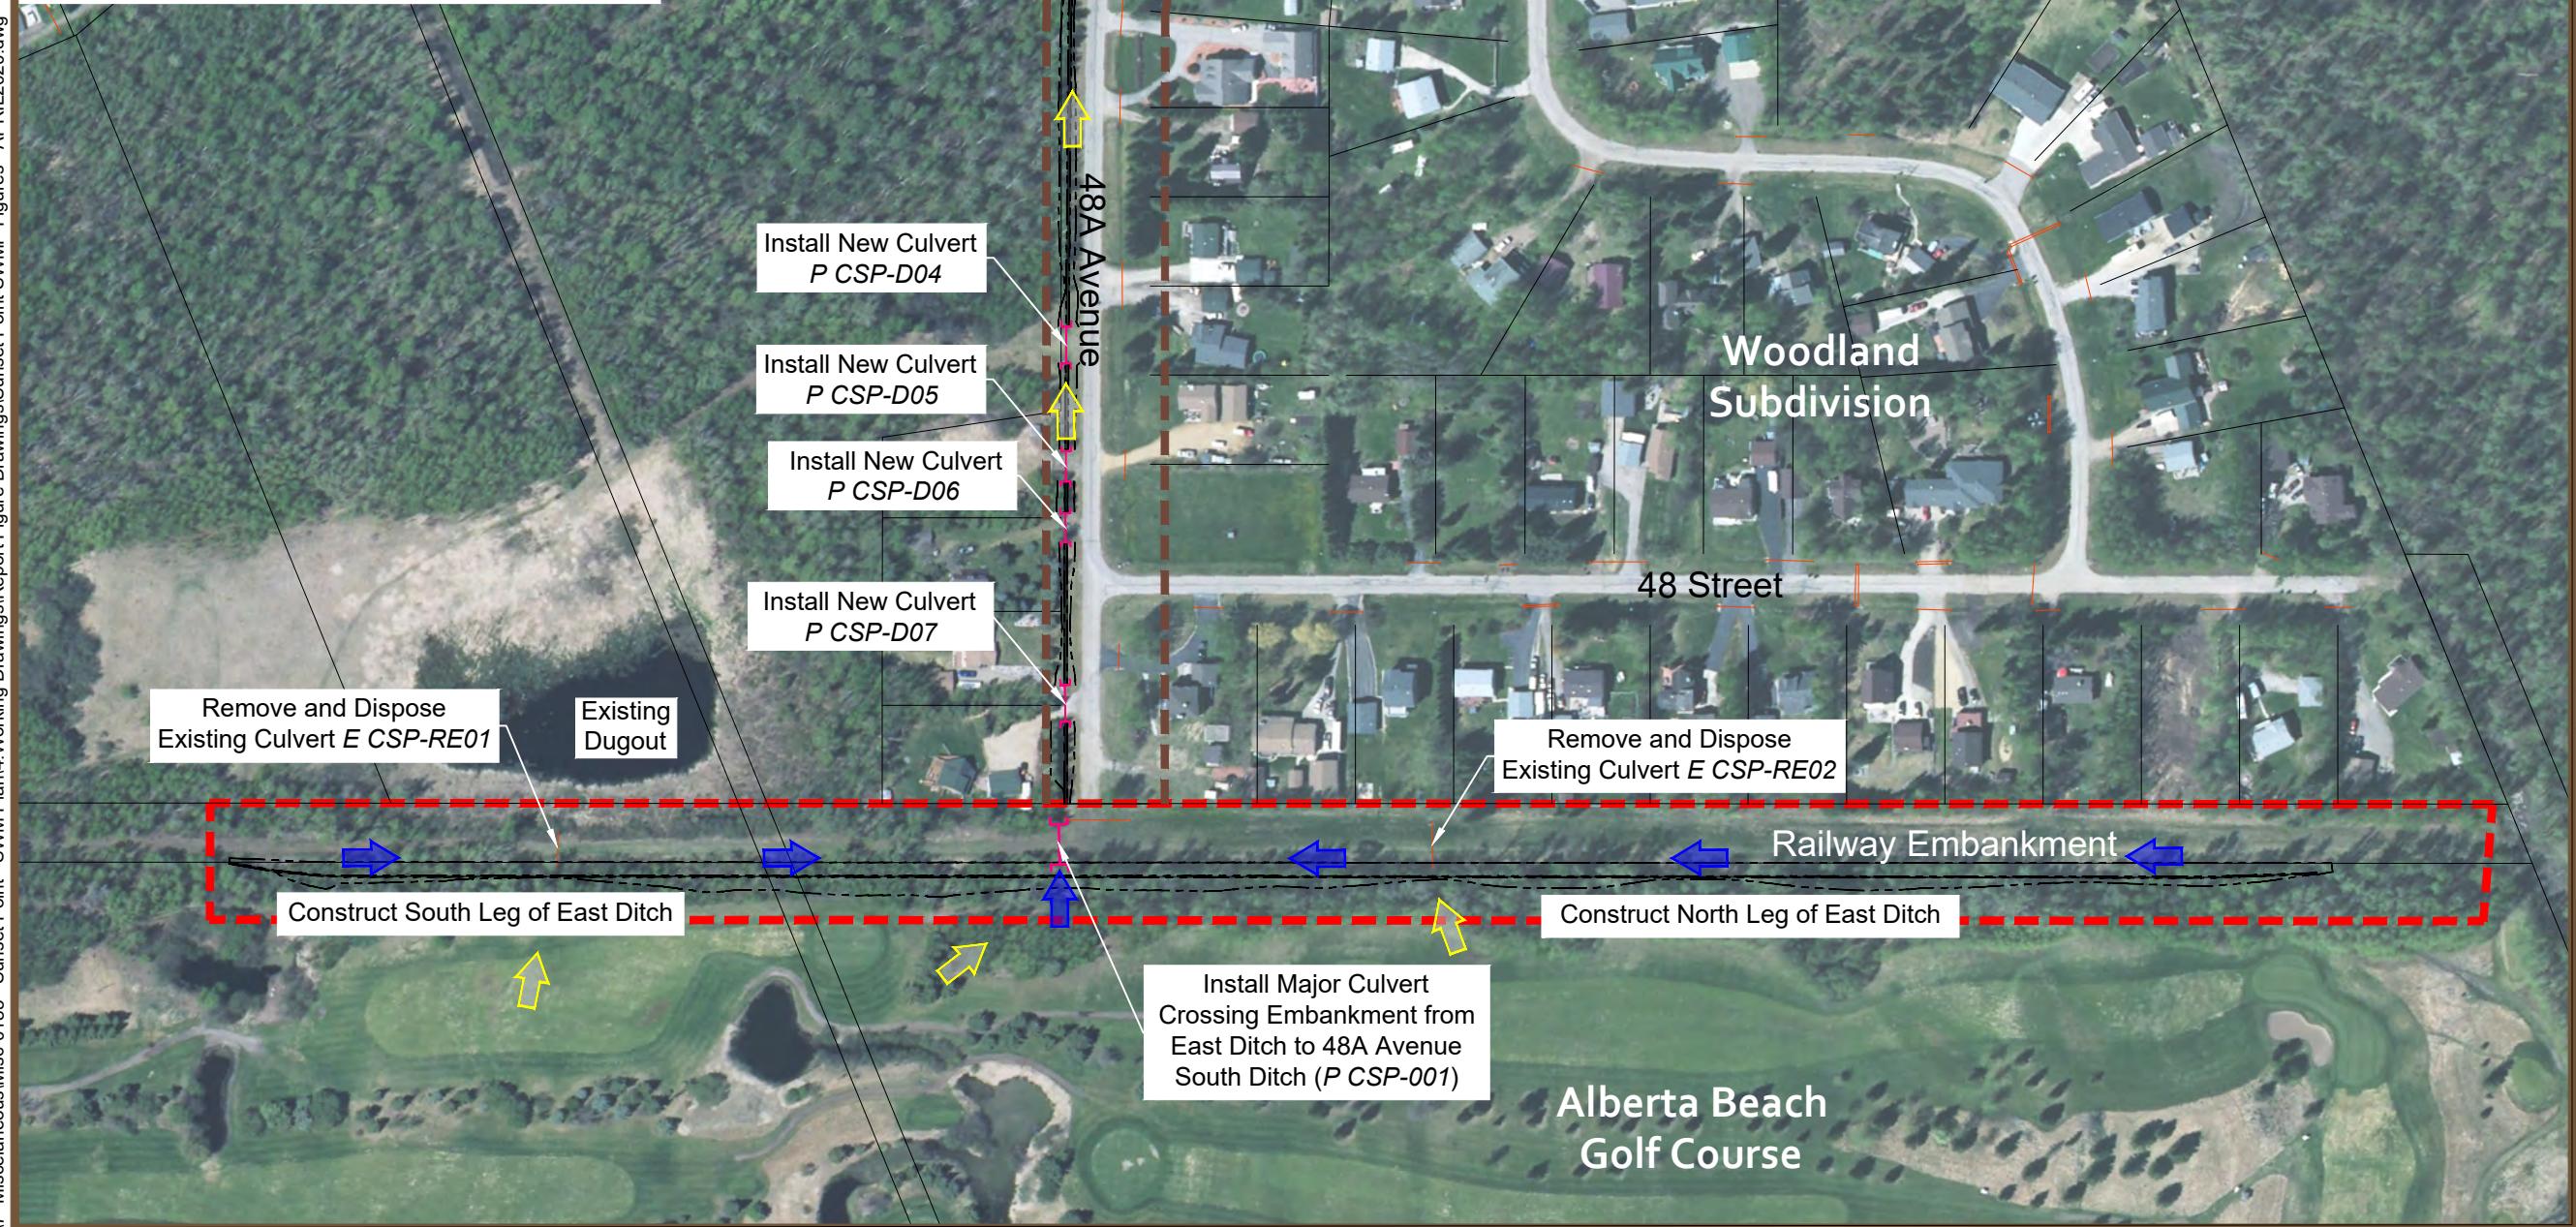
Figure 10
Project 1: Embankment
Drainage System

The above summary shows that for almost the same cost, Option 1 offers significantly greater benefits than Option 2. Two disbenefits were identified for Option 1: flow control and landowner cooperation. Although Option 1 does not allow for flow control, we believe that with the proposed downstream improvements to the D(i) flow path (culvert and ditch improvements); the flow path will be adequate to convey the flow from the golf course without causing adverse flood risk. Additionally, during the design 1:25-year event, the 800mm culvert in the embankment will provide some restriction of the flow from the golf course (as it will have approximately 0.5m head). Landowner cooperation introduces a degree of risk for the project as land acquisition is required for the utility right of way along the east side of the embankment. However, we are confident that with the strong commitment and support that has been obtained from the key stakeholders, this risk has been minimized. SE Design recommends Option 1, an East Ditch along the Railway Embankment and improvement of the D(i) flow path. The components of the proposed embankment drainage system are shown in **Figure 10 – Project 1: Embankment Drainage System**.

Phase 1: North of 48A Avenue

- a. Remove and dispose of existing culvert RE02.

- b. Install a storm collection system along the bottom of the east ditch of the railway embankment, starting in-line with the south ditch of 48A Avenue and terminating 120m north (near RE02).

- c. Install a catchbasin at the north end of the main line and a catchbasin manhole at the south end of the main line. The catchbasins will collect runoff from the bottom of the embankment east ditch. The south catchbasin manhole will also include a control structure to prevent water from crossing the embankment if needed.

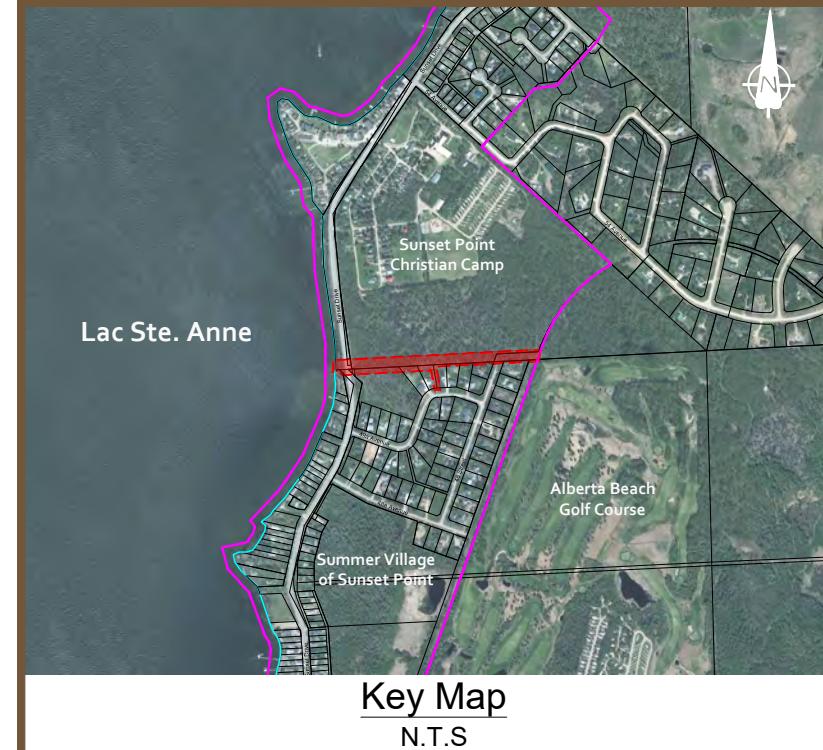
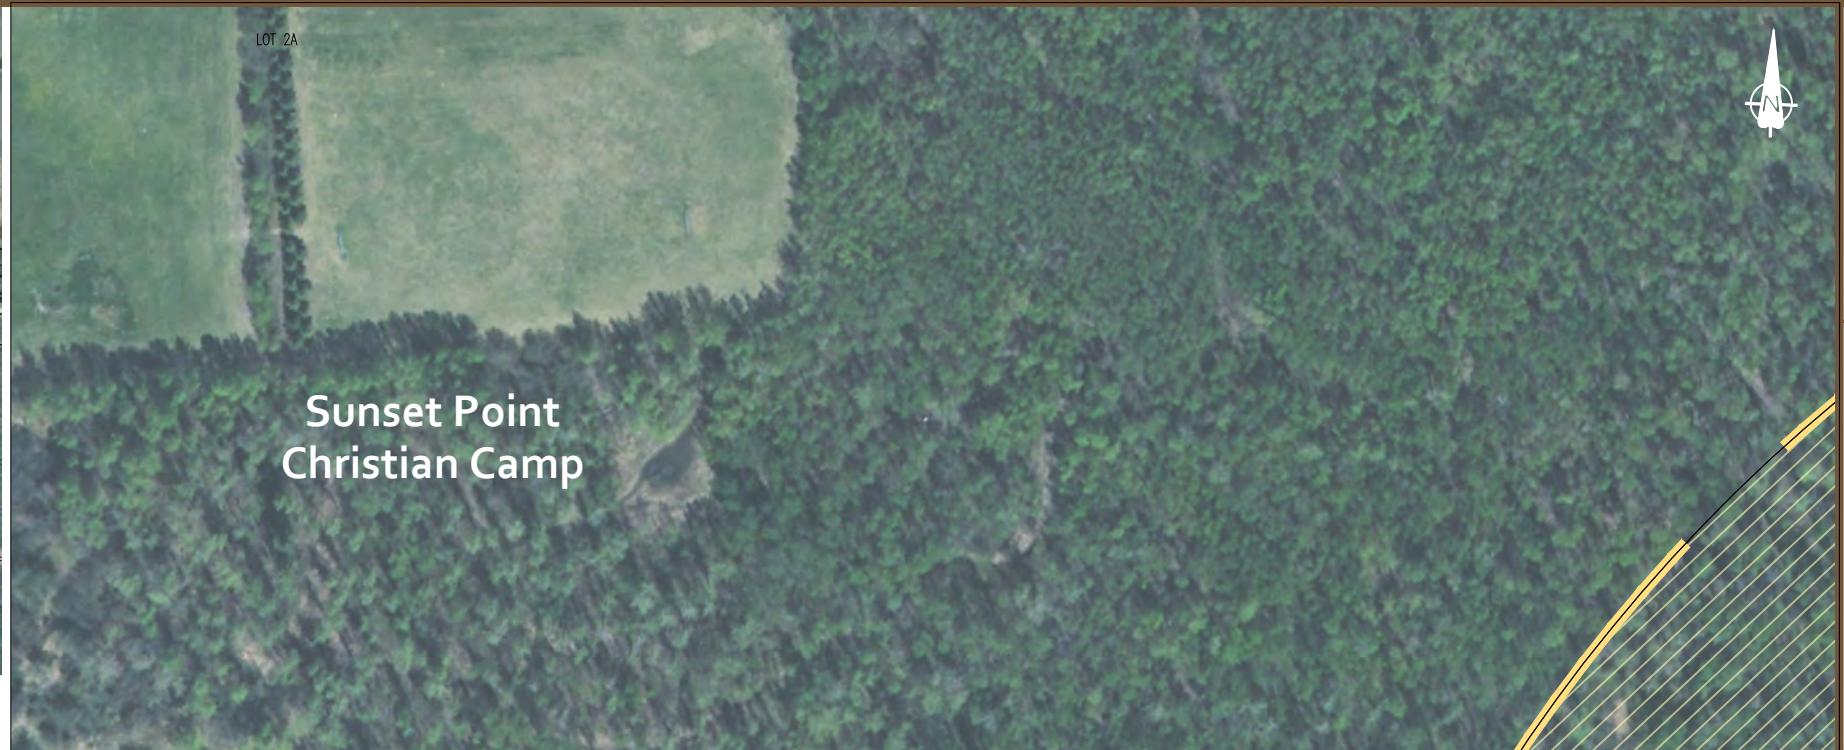
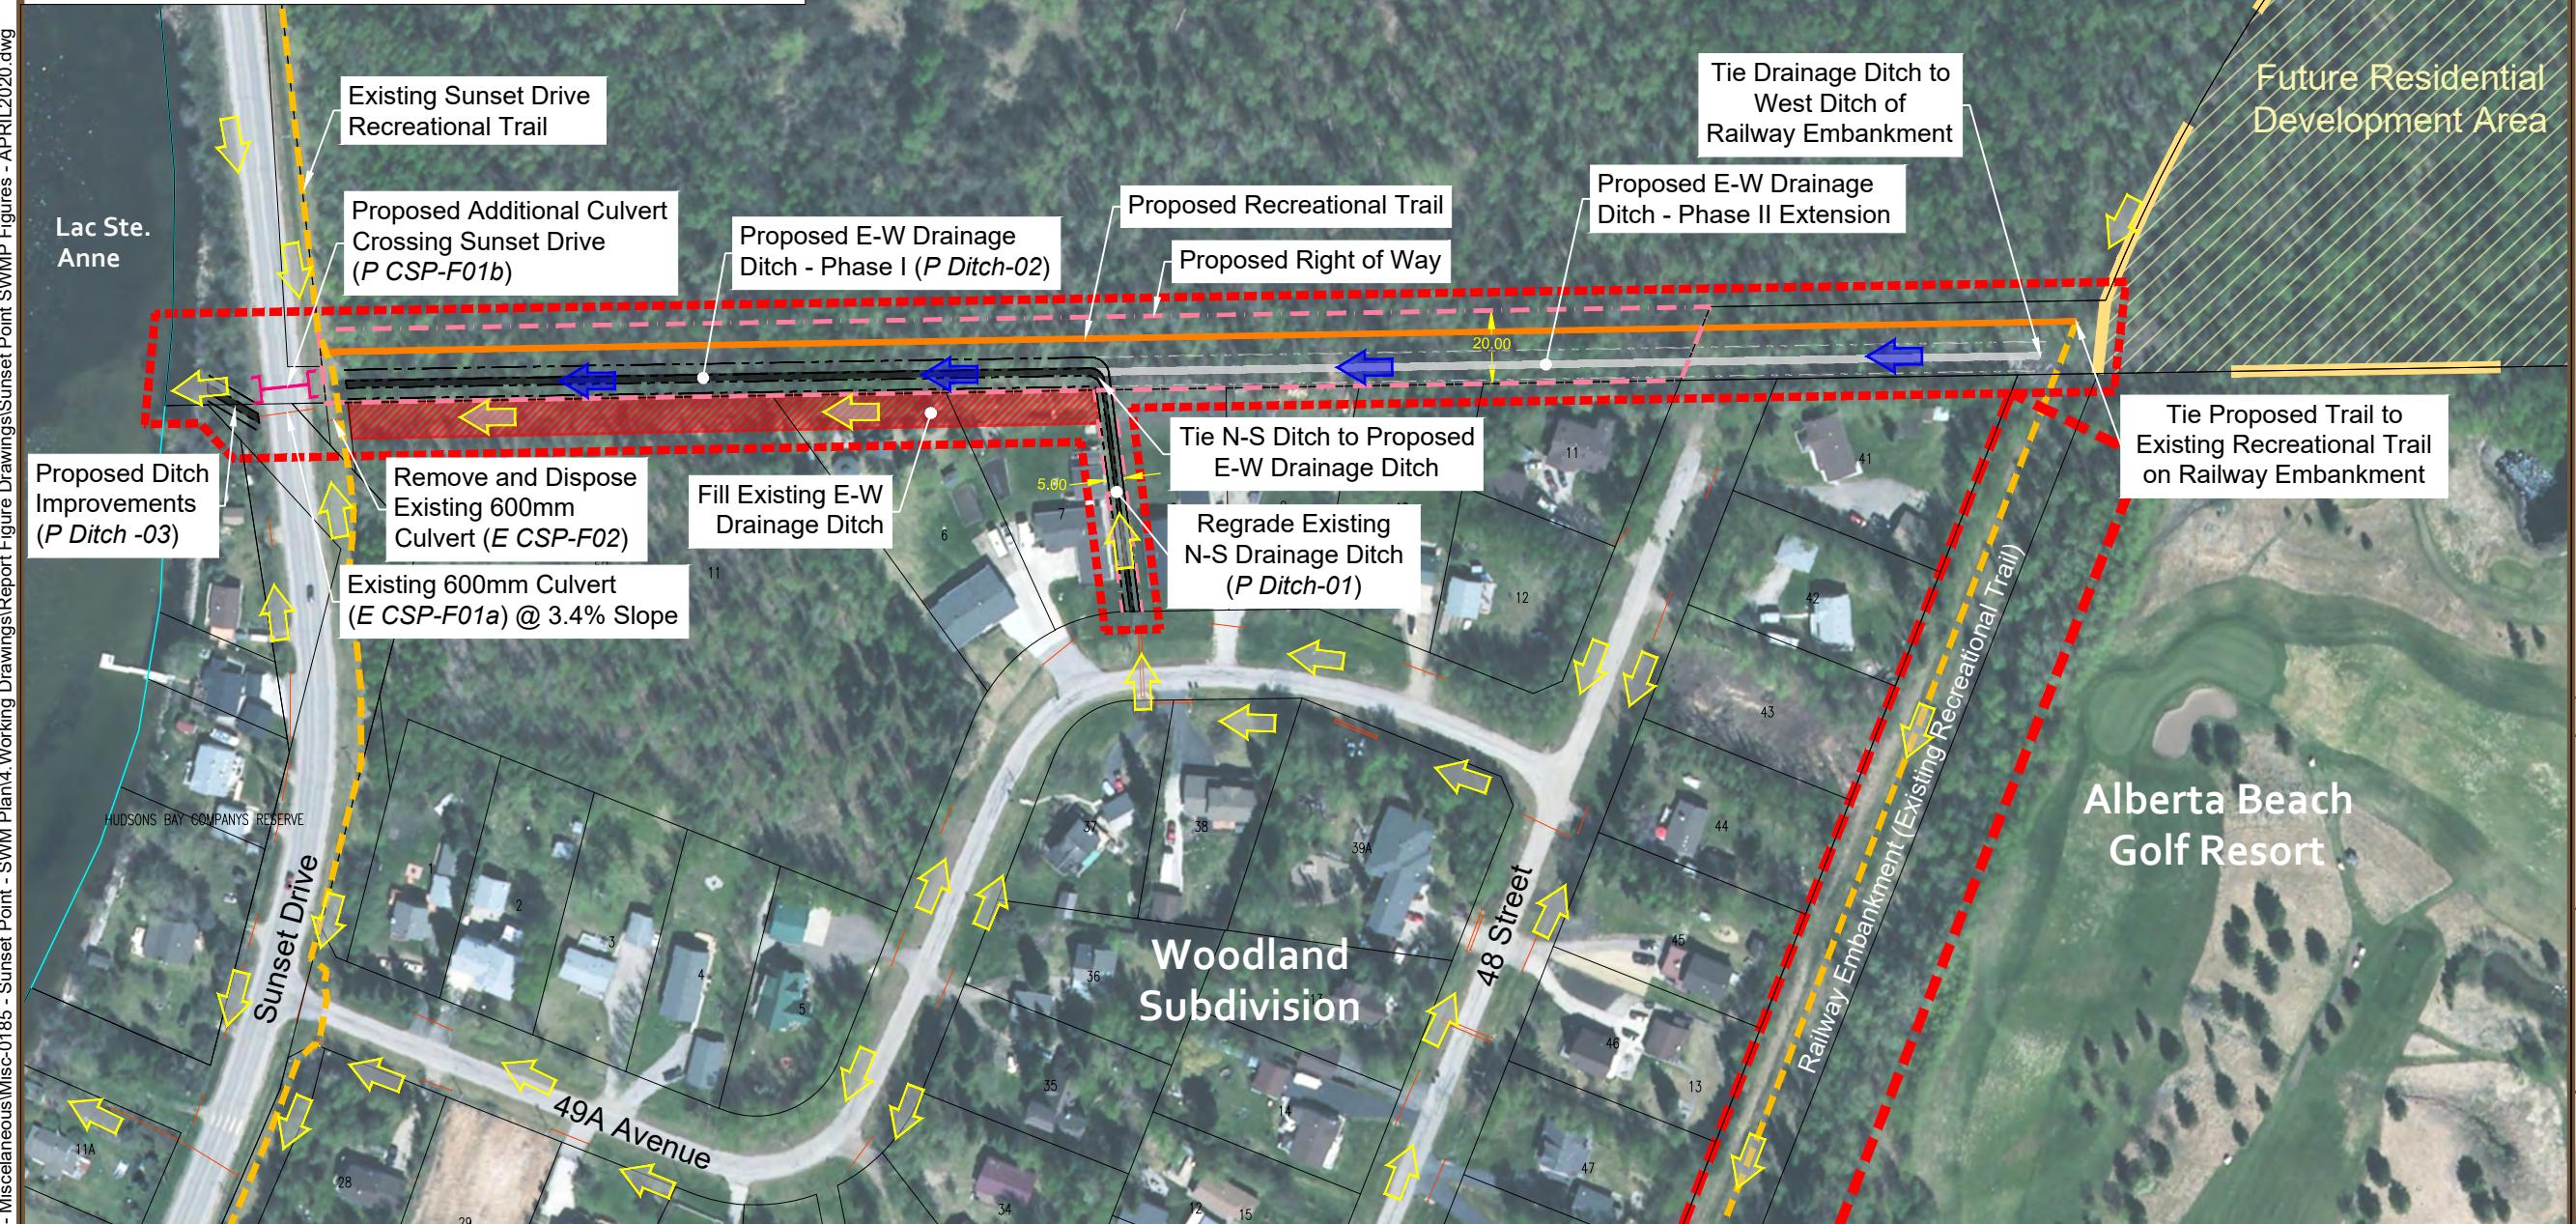
Figure 11
Project 2: Central
Drainage Way

To accomplish these criteria and accommodate major Flow Path F(i), we proposed to construct a central drainage way that can convey stormwater from the Woodland Subdivision and future residential developments to the lake. The proposed Central Drainage Way includes the following drainage improvements, as shown on **Figure 11 – Project 2: Central Drainage Way**.

6. Rehabilitate culvert F01 (crossing Sunset Drive) as required. Install a second major culvert crossing Sunset Drive so that the combined capacity of F01 and the new culvert (F01b) accommodates the proposed Drainage Parkway flows. F01 shall now be designated F01a, for clarity.
7. Rehabilitate and armour the ditch (P Ditch-03) at the outlet of culvert F01a and F01b as needed to ensure the flow path to the lake is accommodated within the existing road right of way and adequately protected from erosion and scour.

The 20m right of way could be terminated at the Lot 7/8 ditch; however, extension of the right of way to the railway embankment offered 2 advantages. The first is the multi-use recreational trail opportunity. The second is the potential to provide a stormwater outlet for the future development area (Lot 1 Plan 972 2687) as indicated in **Figure 11** and **Figure 14**. Within the newly established right-of-way, the stormwater management outlet for the development could be accommodated by a simple extension of the drainage ditch. This is indicated as the “Proposed E-W Drainage Ditch – Phase II Extension”.
